ACCIDENT

Aircraft Type and Registration:	Agusta A109E G-CRST
No & Type of Engines:	2 x Pratt & Whitney Canada PW206C
Year of Manufacture:	1998
Location:	St George Wharf, Vauxhall, London
Date & Time (UTC):	16 January 2013 at 0759 hrs
Type of Flight:	Commercial Air Transport (Passenger)
Persons on Board:	Crew -1 Passengers - None
Injuries:	Crew - 1 (Fatal) Passengers - N/A
Nature of Damage:	Helicopter destroyed
Commander's Licence:	Air Transport Pilot's Licence
Commander's Age:	50 years
Commander's Flying Experience:	To be confirmed
Information Source:	AAIB Field Investigation

Synopsis

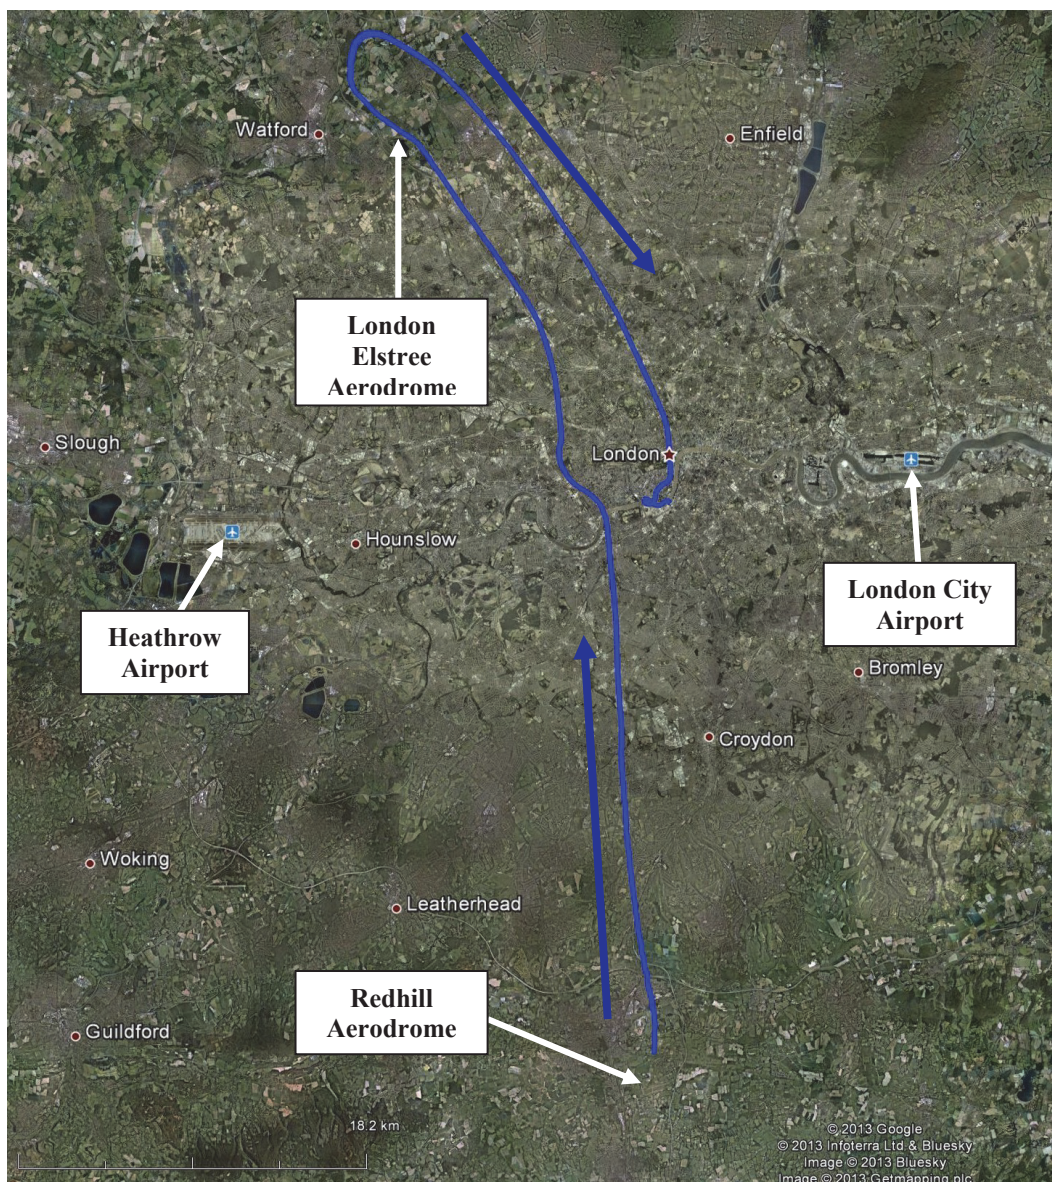
Figure 1

The helicopter, callsign Rocket 2, lifted at 0735 hrs and departed to the north climbing to 1,300 ft amsl¹ (see Figures 1 - 3). The pilot called Thames Radar on frequency 125.625 MHz and stated that he was en route from Redhill Aerodrome to Elstree Aerodrome and wished to route overhead London Heliport (near Battersea) with a Special VFR (SVFR) clearance. He was cleared to transit the London Control Zone (CTR) via Battersea, under SVFR, not above 1,000 ft. The helicopter descended to 1,000 ft before entering the London CTR.

At 0742 hrs, G-CRST was abeam London Heliport at 1,100 ft heading approximately north. It crossed the River Thames 15 seconds later and altered track left towards Holland Park, towards a point immediately east of Brent Reservoir. At 0745 hrs, when 2 nm southeast of the reservoir, ATC amended the helicopter's clearance to "NOT ABOVE 2,000 FT".

G-CRST climbed to 1,500 ft on track to Elstree and cleared the northern boundary of the London CTR at 0746 hrs, when it began a descent. It passed Elstree Aerodrome at 0748 hrs in a descent through 1,200 ft before reaching a minimum altitude of 1,000 ft. At

0749 hrs, G-CRST was 2 nm north-west of Elstree Aerodrome when it climbed and turned right onto a south-easterly track towards central London.

G-CRST radar track

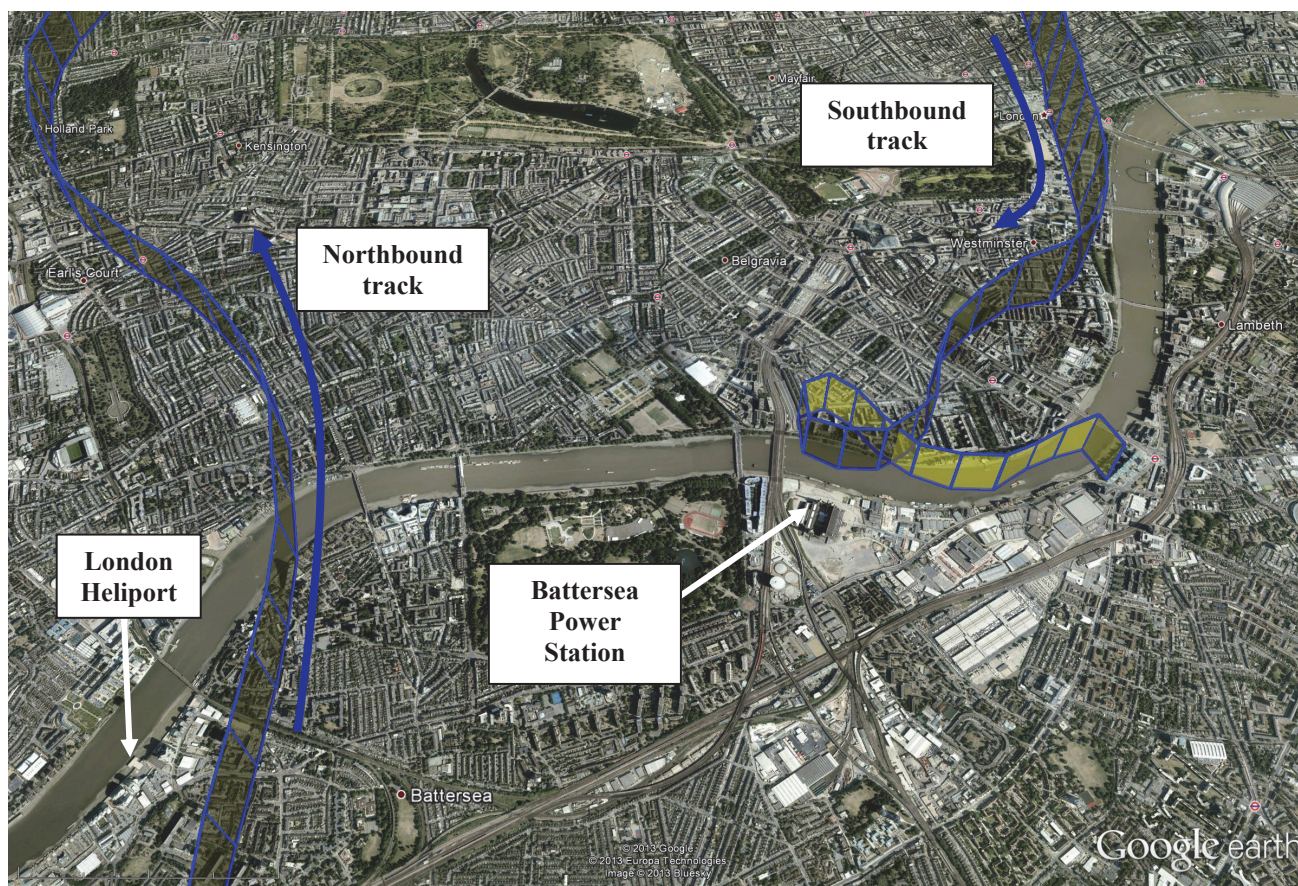
Figure 2

G-CRST radar track showing London Heliport

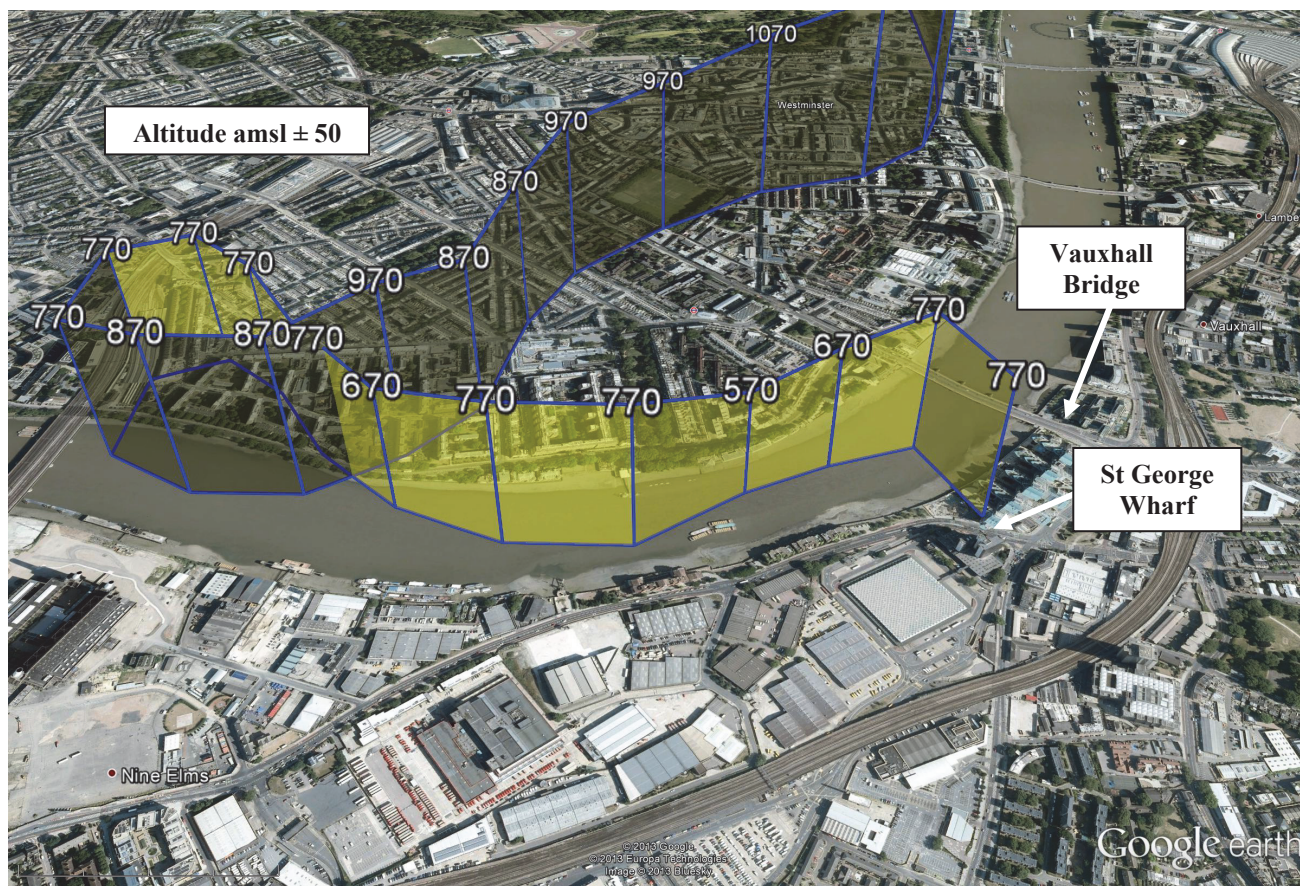
Figure 3

The helicopter arrived over the River Thames adjacent to Battersea Power Station at 07:58:35 hrs at a recorded altitude of 900 ft before performing a right turn to track along the river towards Vauxhall Bridge. The final two recorded positions show a turn to the right abeam St George Wharf at 800 ft, with the final position recorded at 07:59:24 hrs.

G-CRST radar track final positions showing altitude amsl
