ACCIDENT

Aircraft Type and Registration:	Cirrus SR22, N936CT	
No & Type of Engines:	1 Continental Motors IO-550-N piston engine	
Year of Manufacture:	2009 (Serial no: 3111)	
Date & Time (UTC):	6 June 2013 at 0947 hrs	
Location:	On approach to Gloucestershire Airport	
Type of Flight:	Private	
Persons on Board:	Crew - 1	Passengers - None
Injuries:	Crew - None	Passengers - N/A
Nature of Damage:	Substantial damage to wings and fuselage	
Commander's Licence:	UK Private Pilot's Licence FAA Instrument rating	
Commander's Age:	76 years	
Commander's Flying Experience:	673 hours (of which 443 were on type) Last 90 days - 19 hours Last 28 days - 6 hours	
Information Source:	Aircraft Accident Report Form submitted by the pilot and further enquiries by the AAIB

Synopsis

The pilot deployed the aircraft ballistic recovery system after he became disorientated on an instrument approach into Gloucester Airport. He was not injured.

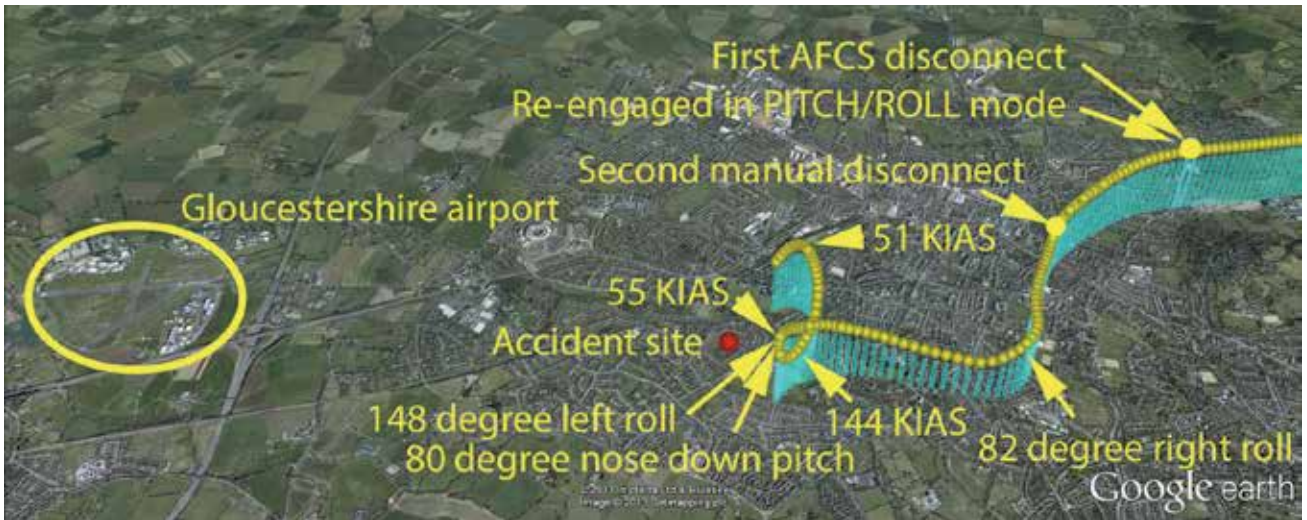
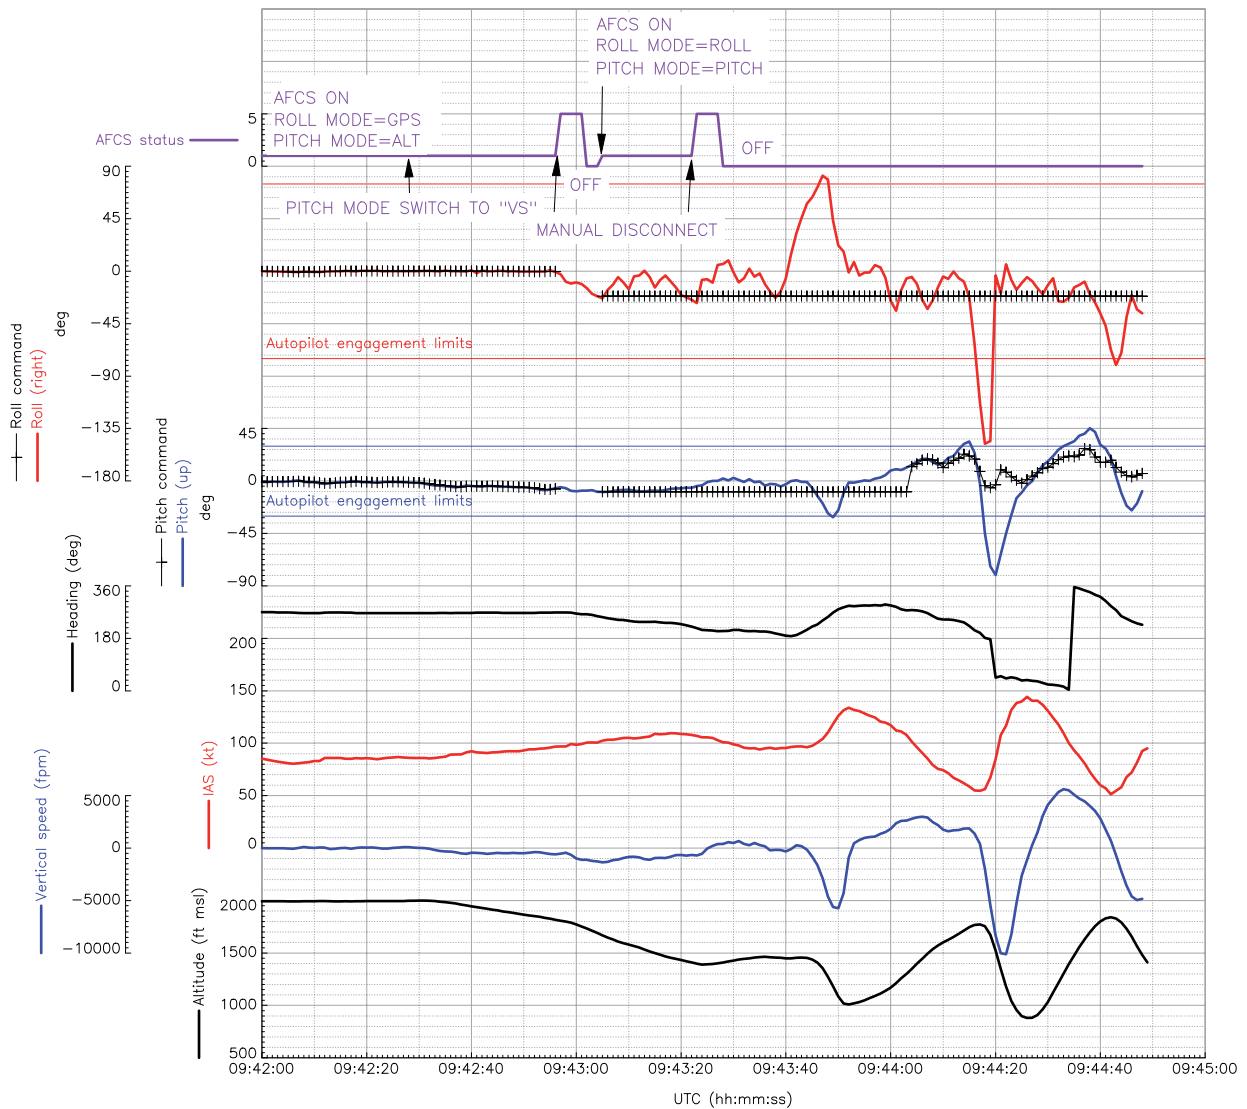
Figure 1

The aircraft was fitted with a Cirrus Perspective avionic system, based on the Garmin G1000 system. The system had an SD card installed which enabled the collection of flight data that would otherwise be lost. The aircraft was also fitted with a Recoverable Data Module (RDM), which would not download. The data from the display system was analysed and is shown in Figure 1.

At 0942 hrs the aircraft was at 2,000 ft amsl flying to Gloucestershire airport from the east on a heading of 269°M, with an IAS of 84 kt. The AFCS was engaged and in the GPS roll mode and ALT pitch mode. The AFCS pitch mode was changed to vs as the aircraft started to descend. At 0942:57 hrs, the AFCS was manually disconnected as indicated by the recorded AFCS status value of 5, which is linked to a flashing caption on the

display. At 0943:05 hrs the AFCS was recorded as ON again, with the default pitch and roll modes of PITCH HOLD and ROLL HOLD; the aircraft was pitched down 9.4° and had 23.4° of left roll at this time so these values were set by the AFCS as the commanded pitch and roll values.

At 0943:23 the AFCS was manually disconnected again and levelled at approximately 1,400 ft amsl with a relatively stable speed, neutral pitch but not a stable roll or heading. At 0943:40 hrs a right roll was initiated that reached 81.9°, with a commensurate rapid descent and speed increase, until the aircraft levelled at 1,000 ft amsl, heading for the airfield. The aircraft then climbed at a rate that peaked at 2,988 ft/min until it reached 1,771 ft amsl with a speed that had reduced to 54.6 kt. At this point the aircraft rapidly rolled left and the nose dropped. The descent stopped at 880 ft amsl, with an IAS of 144 kt after having exceeded 10,000 ft/min. The cycle of a high pitch climb, reduction in airspeed and accelerating descent was then repeated until the recording stopped in the descent as a result of the BRS being deployed.

Data recovered from the display
