**INCIDENT**

**Aircraft Type and Registration:** American Blimp Corporation A60 Plus Airship, N2017A

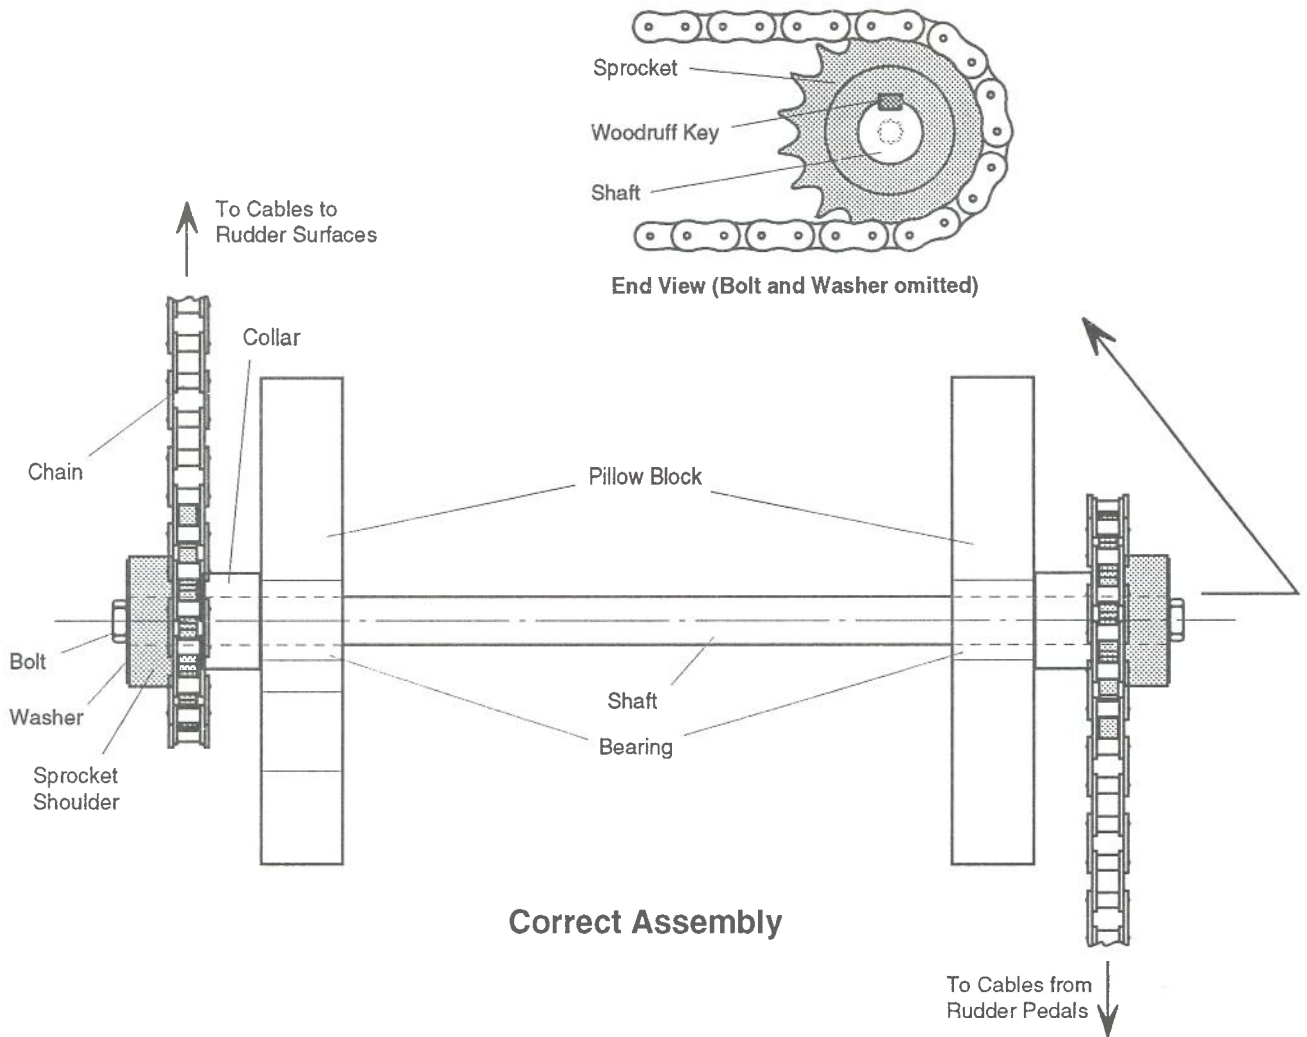
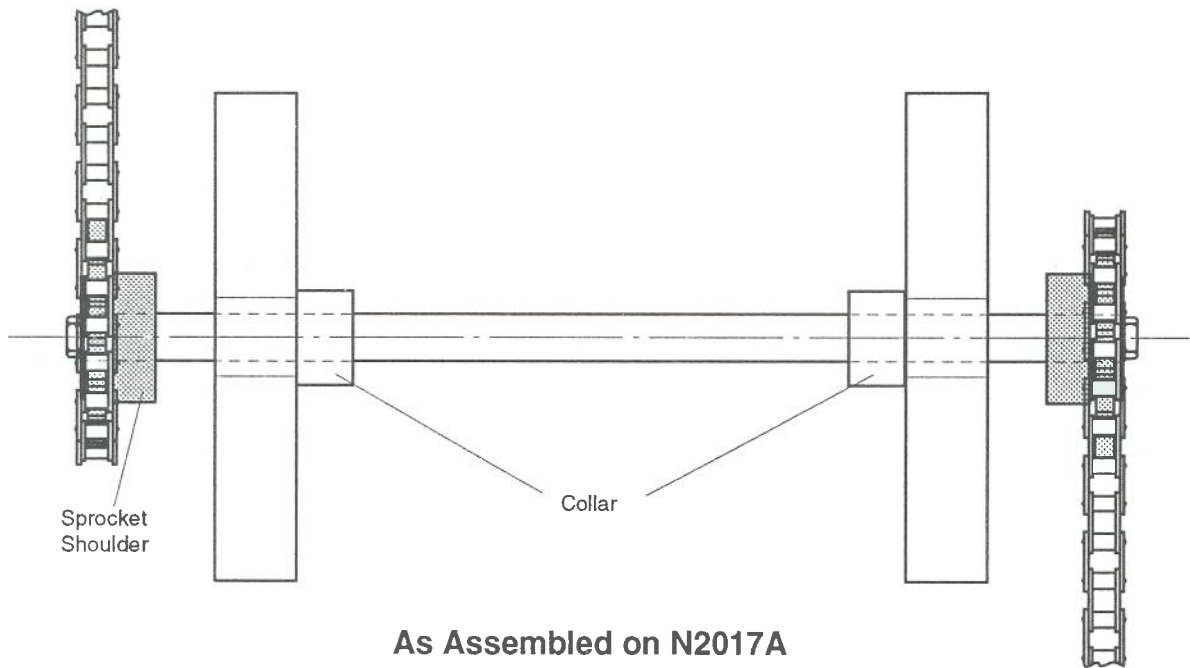
**Fig 1**

The rudder system is manually operated by a cable/pulley system. This incorporates a chain/sprocket link below the floor in the rear part of the gondola to transfer the drive from the rudder pedal mechanism laterally across to close to the aircraft's centre line (Fig 1). A rotatable shaft located in two pillow block mounted bearings carries a shouldered sprocket on each end, locked to the shaft rotationally by a Woodruff key. Axial movement of the Woodruff key is prevented by a washer on the outboard side and by a collar on the inner side and the assembly is held together by a bolt screwed into the shaft at either end. The design requires the collar to be installed between the sprocket and the bearing and the sprockets to be installed with the shoulder outwards. However, investigation found that the rudder system on N2017A had been assembled with both collars inside the bearings and both sprockets reversed, with the shoulders inwards, and this had allowed the Woodruff key of the outboard sprocket to migrate axially and disconnect the drive from the sprocket to the shaft. The assembly had been stripped and reassembled a few flying hours before the incident during maintenance. It was noted that the sprocket orientation found, with shoulders inwards, corresponded to that for an almost identical linkage in the elevator system but for both elevator and rudder systems the collars were required to be fitted outside of the bearings.

Following the incident, the airship manufacturer issued three Memoranda requiring an inspection of the flight control system, with particular attention to the orientation of the rudder and elevator sprockets, requesting a report on the installation found and including drawings of the rudder and elevator linkages for inclusion in the Maintenance Manual.
