Aircraft type and registration: Cessna 310K G-AXLG (light twin engined fixed wing aircraft)

Date and time (GMT): 21 February 1986 at 1130 hrs

Location: Coventry Airport

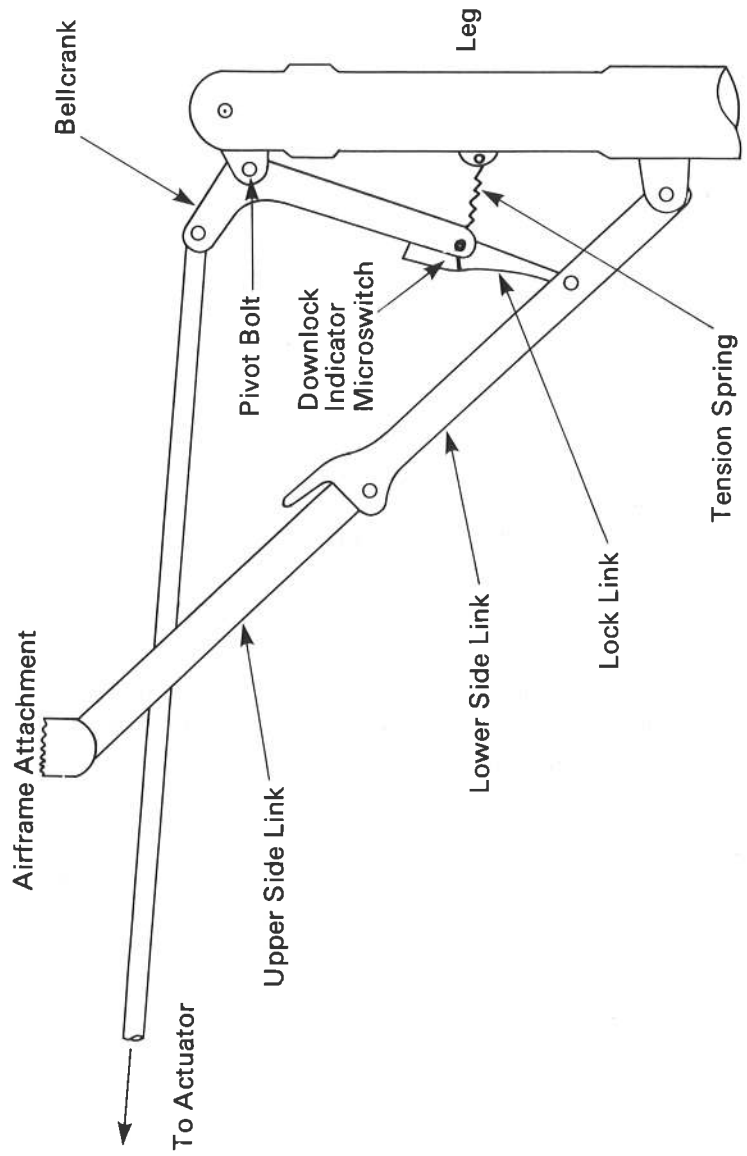
Main Landing Gear Schematic

Subsequent examination of the undercarriage operating system revealed that as a result of the collapse a compression instability failure had occurred to the push/pull operating tube positioned above the left wheel well, this being the only failure in the system.

Closer inspection of the left undercarriage mechanism revealed that the attachment pivot of the sidestay to the undercarriage leg was very stiff and as a result the leg would not freely lock into the down position. It was apparent that a degree of wear was present in the centre joint of the sidestay lock, and that in order to lock the leg down a large side force needed to be applied to the lock. (See figure). The Cessna maintenance manual for the aircraft recommends that every 100 hours the gear down-lock mechanism be checked for positive lock and excessive wear. After the stiff pivot had been freed, the left undercarriage freely locked down with no change required to the rigging of the mechanism.

It was also determined that the down-lock microswitches for the left and right undercarriages

were actuating before the sidestay lock mechanisms were in their overcentre lock positions. Part of the rigging instructions in the Cessna maintenance manual state that these switches should be adjusted so they are not actuated until the landing gear is down and locked by the overcentre linkage.
