No: 9/92

Ref: EW/G92/05/34

Aircraft Type and Registration: Rotorway Executive, G-BPNC
No & Type of Engines: 1 Rotorway RW 152 piston engine
Year of Manufacture: 1990
Date & Time (UTC): 16 May 1992 at 1040 hrs
Location: Quernmore, near Lancaster
Type of Flight: Private
Persons on Board: Crew - 1 Passengers - 1
Injuries: Crew - None Passengers - None
Nature of Damage: Landing gear skids distorted, tail boom fractured
Commander's Licence: Private Pilot's Licence
Commander's Age: 30 years
Commander's Flying Experience: 180 hours (of which 91 were on type)
Last 90 days - 15 hours
Last 28 days - 5 hours
Information Source: Aircraft Accident Report Form submitted by the pilot
and AAIB examination of helicopter

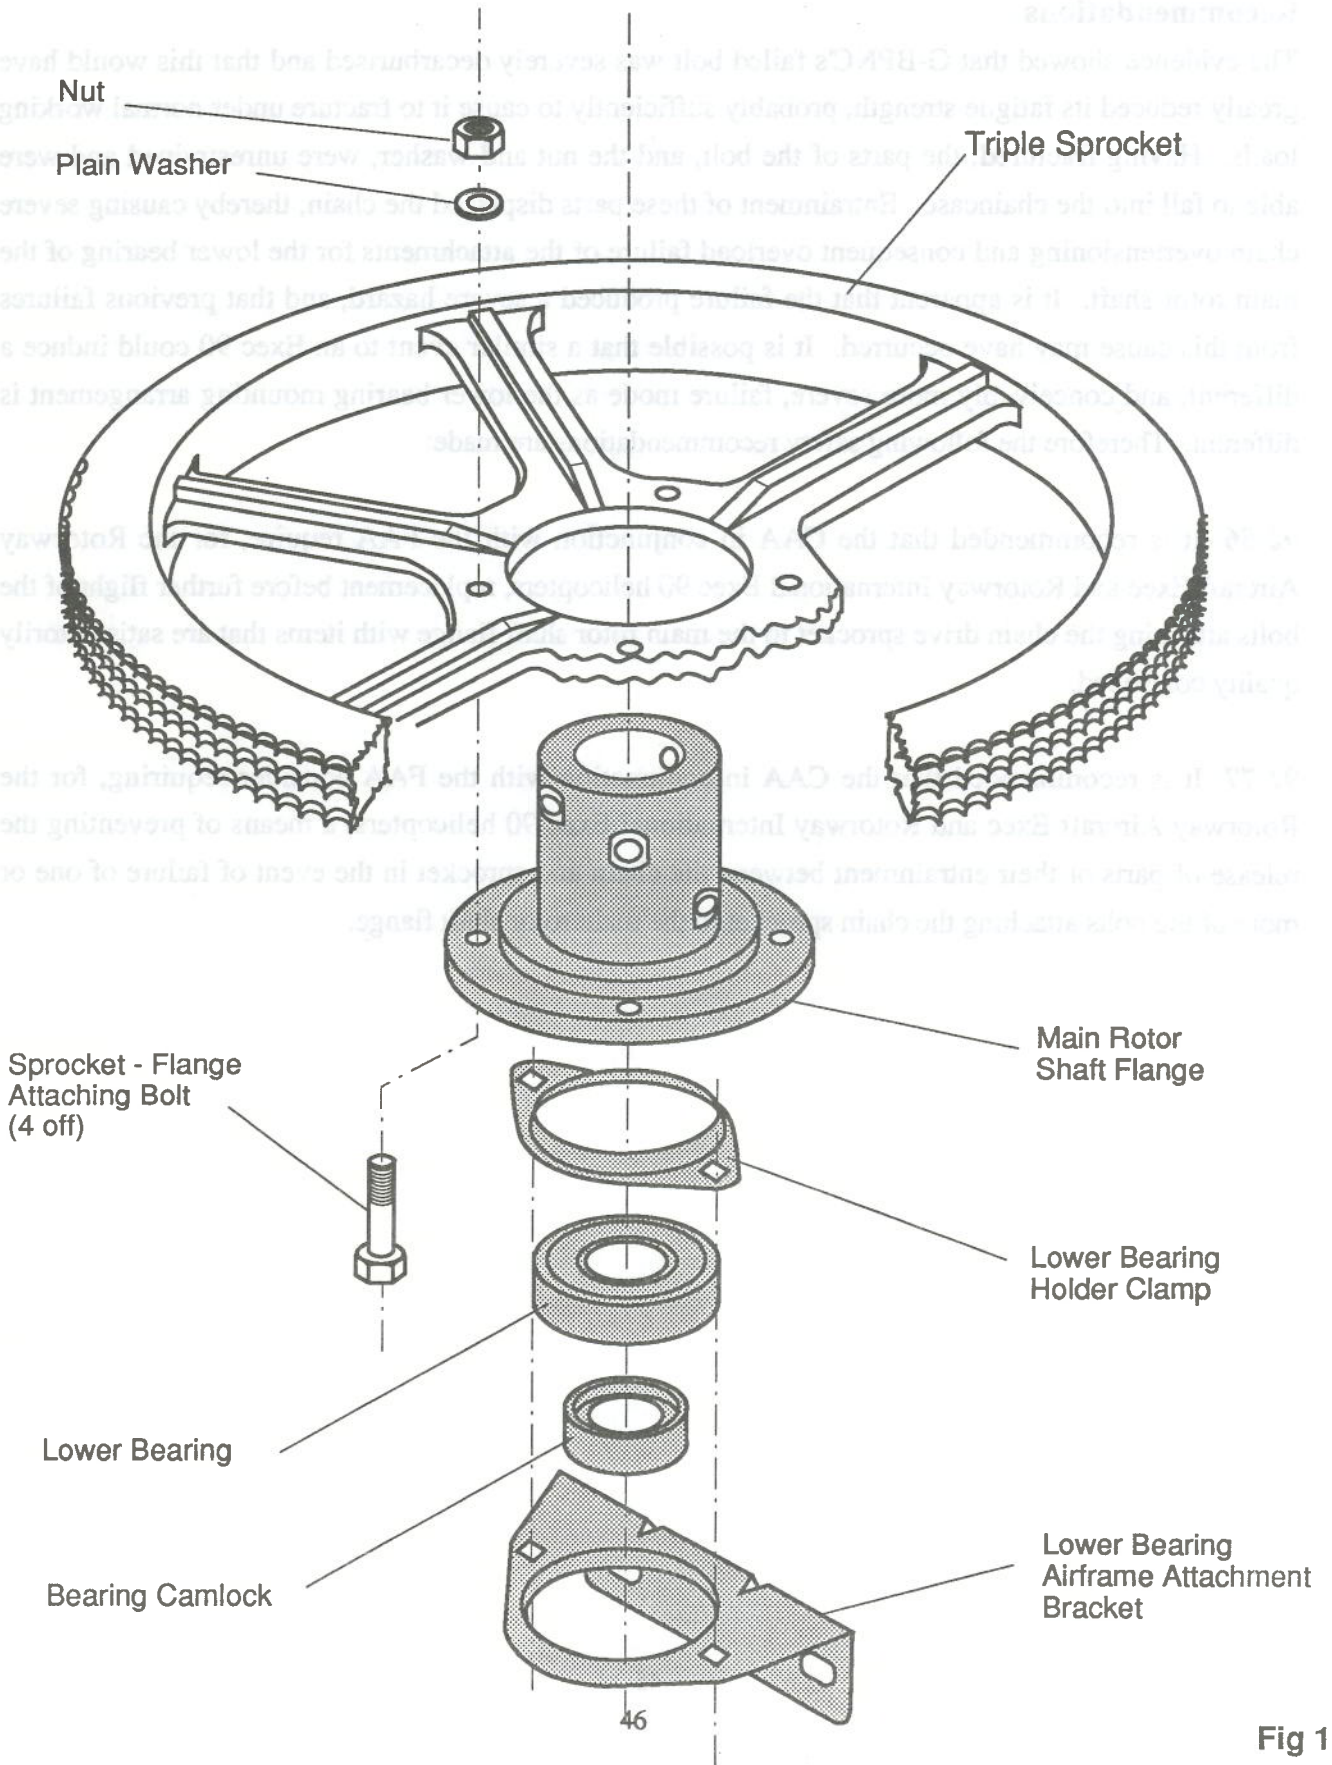
Fig 1

AAIB investigation showed that the drive had been running for a period with the chain displaced downwards on the large sprocket (*ie* in the axial direction of the sprocket) approximately half a tooth. In this condition the chain plates rode on the peaks of the sprocket teeth, thereby considerably increasing the radius of the arc travelled by the chain around the sprocket. Additionally, the holder clamp for the lower bearing of the main rotor drive shaft had torn away from the bracket mounting it to the airframe structure. The lower end of the main rotor shaft had moved aft before being restrained, while rotating, by contact of the shaft with the bracket. The failures in the lower bearing support all exhibited evidence of overload and were fully consistent with the effects of excessive tension in the chain resulting from the chain having ridden on the peaks of the large sprocket teeth.
