Avid Speed Wing MK4, G-BUIR

AAIB Bulletin No: 5/97 Ref: EW/G97/01/14 Category: 1.3

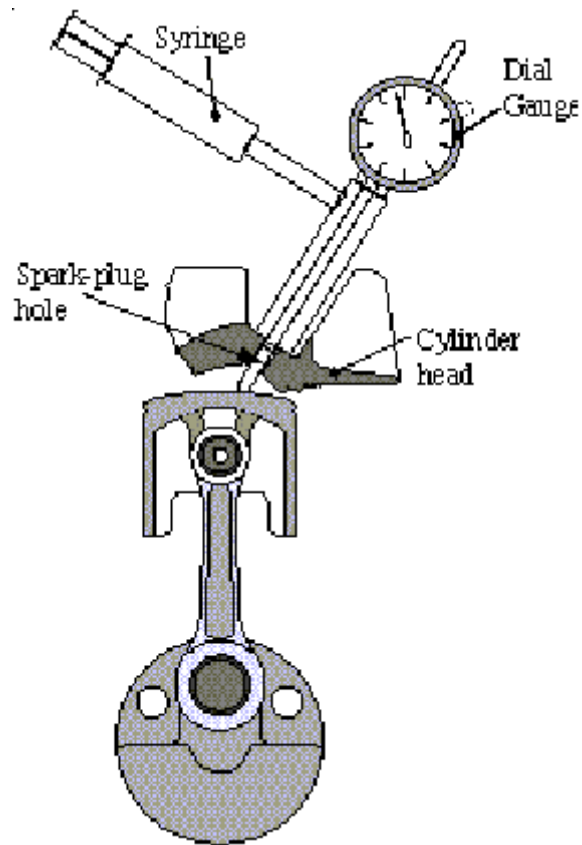
The largest service centre for Rotax engines in the UK has devised an instrument, the 'Cyclone Conrod Bearing Clearance Tester' (illustrated at Figure 1), for testing the combined big/little-end bearing clearances, which has apparently proved extremely effective in preventing such failures.

The Bearing Clearance Tester is essentially a dial gauge mounted on an extension tube which screws into the spark-plug holes and bears on the piston crown when at top dead centre. A syringe is used to suck/blow the piston up and down and the difference in gauge readings is converted into combined bearing clearance. The instructions recommend that this check be performed every 12.5 flight hours when the spark-plugs are removed for inspection in accordance with the Rotax service schedule. Maximum wear figures are provided with the instrument, but records should also be kept so that any trend can be detected in advance. It is understood that the Popular Flying Association acknowledges that this device has been effective in preventing failures of this nature and has published an article entitled 'KNOW YOUR BIG END WEAR' in the December 95/January 96 edition of its magazine, *Popular Flying*.

Figure 1 The Cyclone Conrod Bearing Clearance Tester for Rotax Engines
