ACCIDENT

Aircraft Type and Registration:	Cessna T303 Crusader, N289CW	
No & Type of Engines:	2 Continental Motors Corp IO-520-AE piston engines	
Year of Manufacture:	1982 (Serial no: T30300032)	
Date & Time (UTC):	4 September 2013 at 0913 hrs	
Location:	Approximately 5 nm from Jersey Airport, Channel Islands	
Type of Flight:	Private	
Persons on Board:	Crew - 1	Passengers - 1
Injuries:	Crew - 1 (Fatal)	Passengers - 1 (Fatal)
Nature of Damage:	Aircraft destroyed	
Commander's Licence:	FAA Private Pilot's Licence	
Commander's Age:	56	
Commander's Flying Experience:	524 hours (of which 319 were on type) ¹ Last 90 days - Not known Last 28 days - Not known	
Information Source:	AAIB Field Investigation

Synopsis

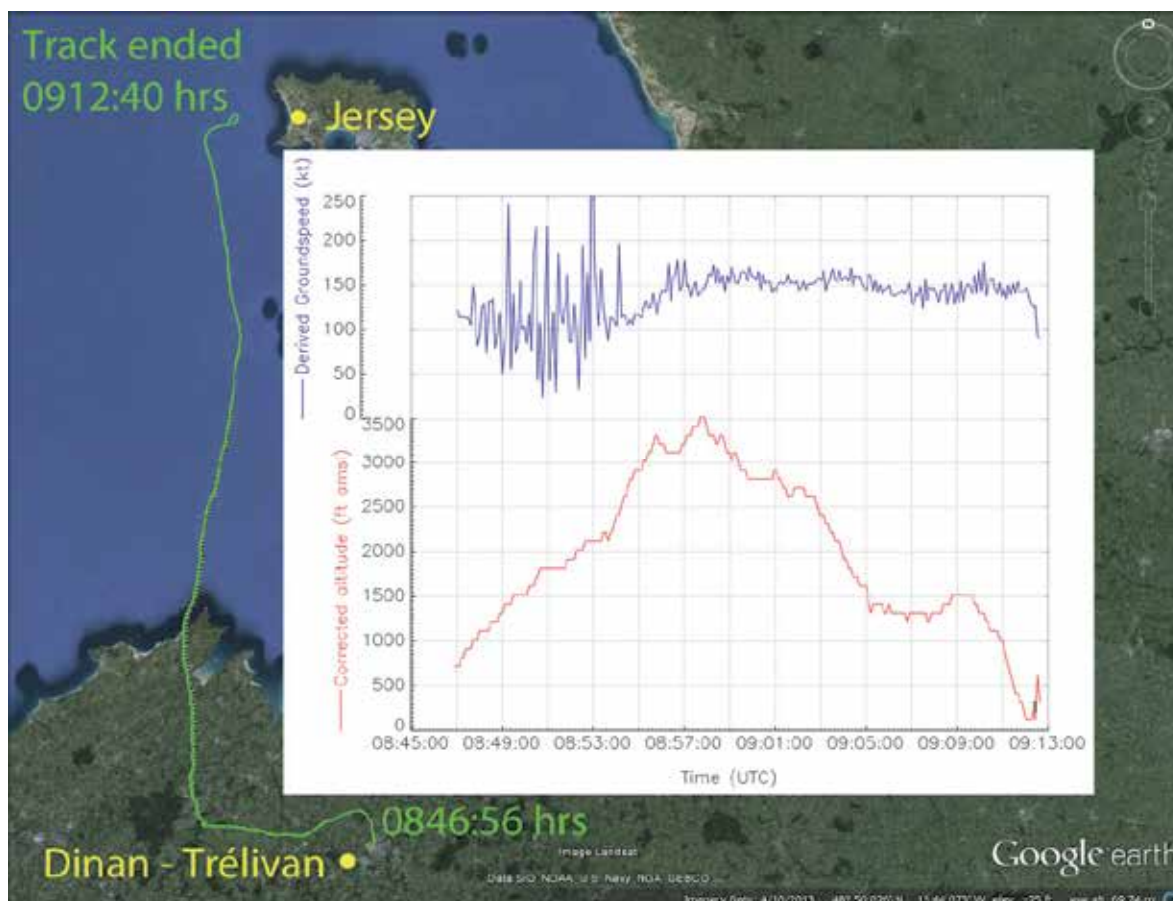
Figure 1
Recorded flight

The radar recordings commence at 0846:56 hrs shortly after departure from Dinan and continue until the aircraft descended below the coverage of the radar at 0912:40 hrs. The recorded radar track is shown in Figures 1 and 2.

The speed is the radar ground speed derived from the point-to-point distance between radar returns. The initial erratic behaviour of the ground speed was due to the position inaccuracy of the radar before the aircraft had gained altitude, whilst it was over France. This also occurred at the end of the track, as the aircraft was at the limit of radar coverage and because of terrain obscuration, therefore the speed calculations are indicative of aircraft speed trends rather than absolute speed values.

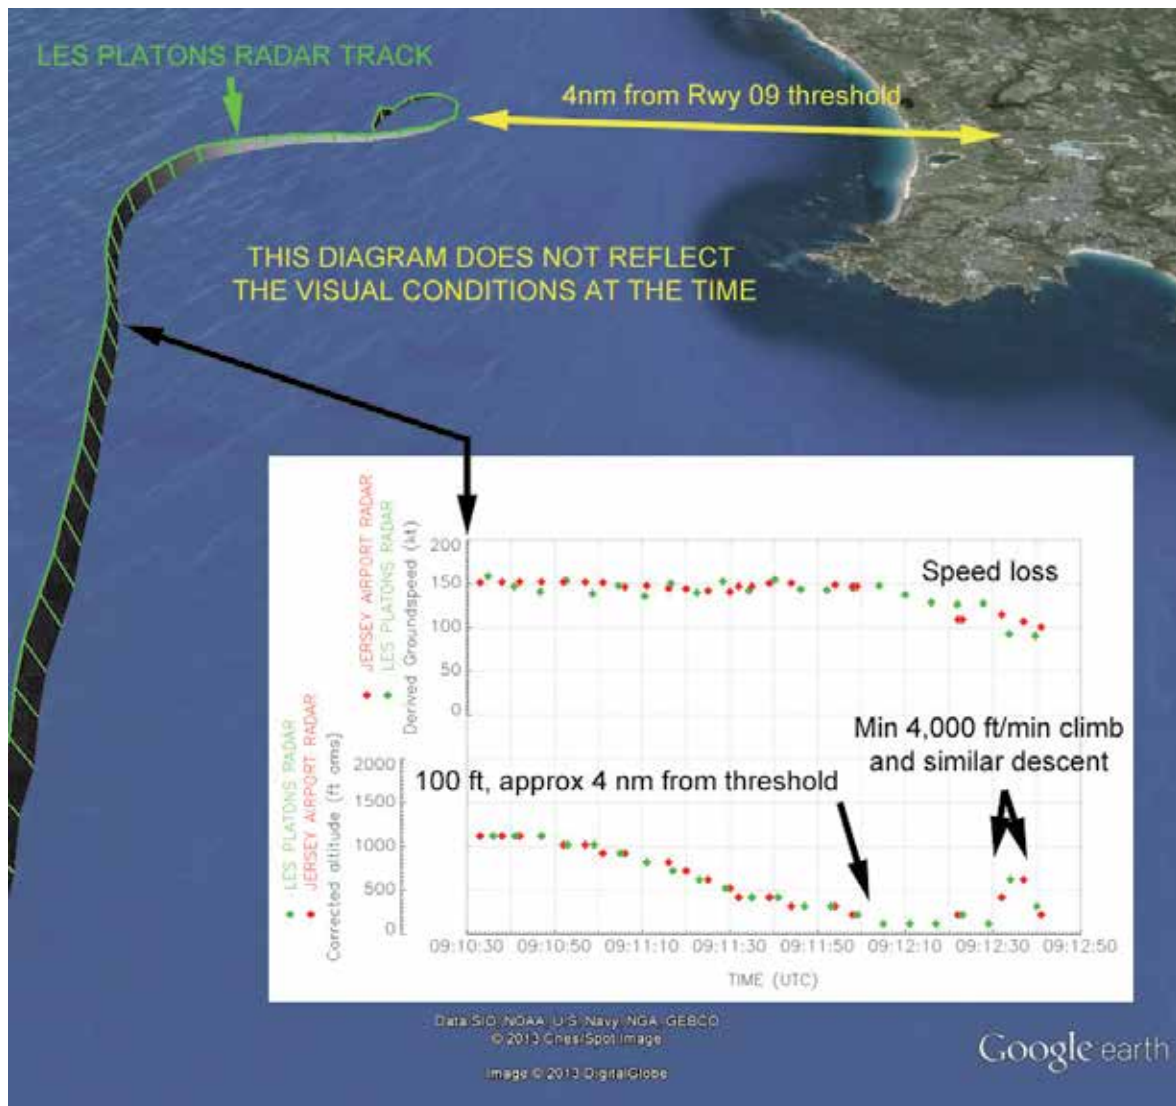
Figure 2
End of radar track

The aircraft passed through the extended centreline of Runway 09 at 0911 hrs at an altitude of 600 ft and continued to descend to 100 ft. At this point the aircraft was about 4 nm from the runway threshold and slightly left of the centreline. The aircraft then commenced a left turn during which the pilot transmitted to Jersey tower "ERM SORRY MAAM CAN YOU GIVE ME THE FREQUEN ... SORRY I'VE DONE ... COMPLETELY GONE WRONG WAY ROUND THERE JUST EH ... ONE MOMENT." The aircraft continued in the turn at 100 ft and the groundspeed decayed from 150 kt to 100 kt. After turning through 180°, the aircraft entered a rapid climb to 600 ft at a minimum rate of climb of 4,000 fpm. It then descended, at a similar rate of 4,000 fpm, to below the coverage of the radar.

The altitude values are encoded by the aircraft systems with a 100 ft resolution, and have been corrected for the ambient air pressure at the time.
