# AAIB Bulletin S1/2006

## *SPECIAL*

<b>Aircraft Type and Registration:</b>	Bell 206B, G-WLLY
<b>No &amp; Type of Engines:</b>	1 Allison 250-C20 turboshaft engine
<b>Year of Manufacture:</b>	1969
<b>Date &amp; Time (UTC):</b>	21 December 2005 at 1015 hrs
<b>Location:</b>	3 nm north east of Coupar Angus, Perthshire
<b>Type of Flight:</b>	Aerial work
<b>Persons on Board:</b>	Crew - 1                      Passengers - 1
<b>Injuries:</b>	Crew - 1 (Fatal)              Passengers - 1 (Fatal)
<b>Nature of Damage:</b>	Aircraft destroyed
<b>Commander's Licence:</b>	Airline Transport Pilot's Licence
<b>Commander's Age:</b>	48 years
<b>Commander's Flying Experience:</b>	15,000 hours approximately Last 90 days - 102 hours Last 28 days - 28 hours
<b>Information Source:</b>	AAIB Field Investigation

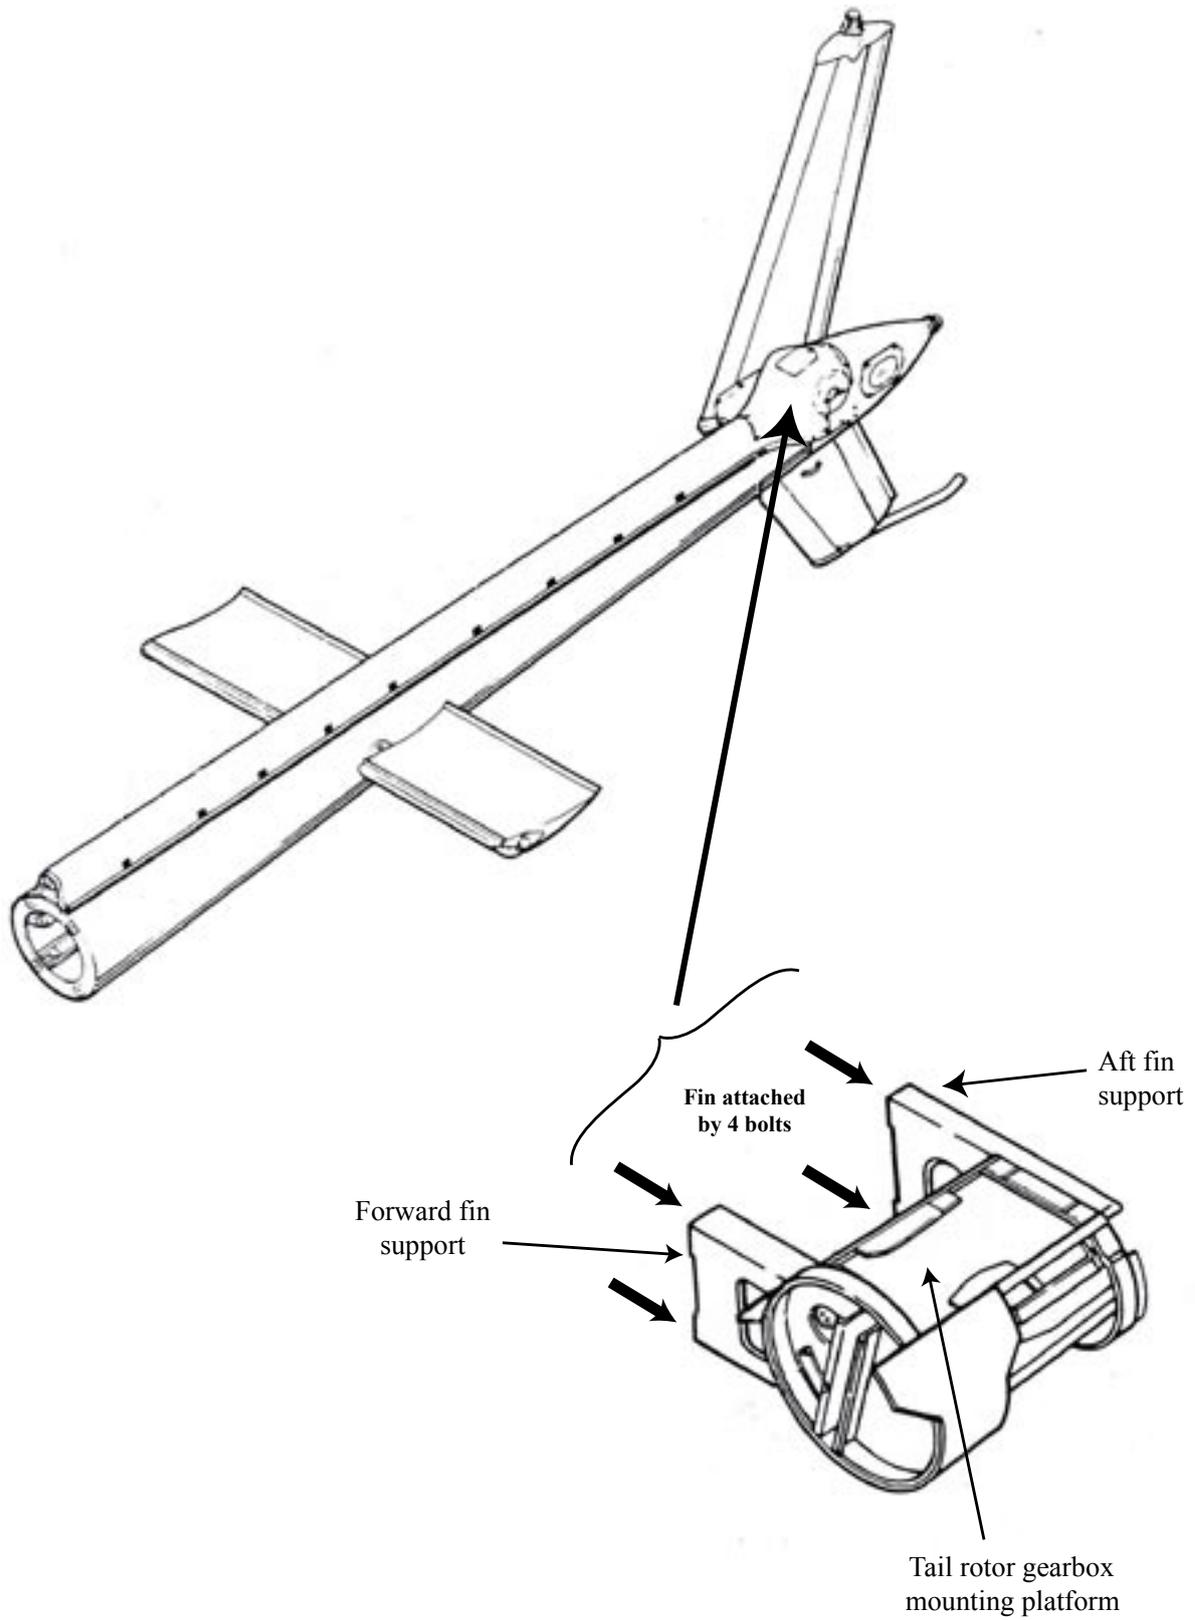
**Figure 1**  
Tail boom and fin supports

The fin is attached to the tail boom by four bolts, which locate into holes in two fin supports positioned at the front and rear of the tail rotor gearbox platform. (See Figure 1). On G-WLLY this platform is of a fabricated sheet metal construction. The fin supports are machined forgings; the rear support is riveted in position such that it effectively forms the rearmost frame of the tail boom. The front support is bolted to the structure. There is a later design in which the platform and fin supports are an integral, one-piece forging.

A metallurgical examination of the fin supports revealed evidence of fatigue in the fractures that had occurred through and around all four bolt holes. The fatigue was the most extensive in the upper rear support, and corrosion was evident on many of the fracture faces, indicating that the fatigue cracks had been growing over a period of time, although the duration could not be quantified.

It is unclear whether the fatigue damage to G-WLLY is related exclusively to this helicopter or whether it could affect other helicopters of this type. In order to gather information to assist this investigation and to protect the fleet, the AAIB proposes a once-off inspection of the affected areas with the fin removed in order to obtain adequate access to the supports and the bores of the bolt holes. Reassembly should be conducted paying particular attention to the torque requirements specified in the Aircraft Maintenance Manual.

It is recommended that the United Kingdom Civil Aviation Authority require a one-off inspection, within a reasonable timescale, of the vertical fin supports of all Bell and Agusta-Bell 206 series helicopters on the UK register. The inspection should be conducted with the fin removed in order to obtain adequate access.
