AAIB Interim Report 2

Accident to Boeing 777-236ER, G-YMMM at London Heathrow Airport on 17 January 2008

ACCIDENT

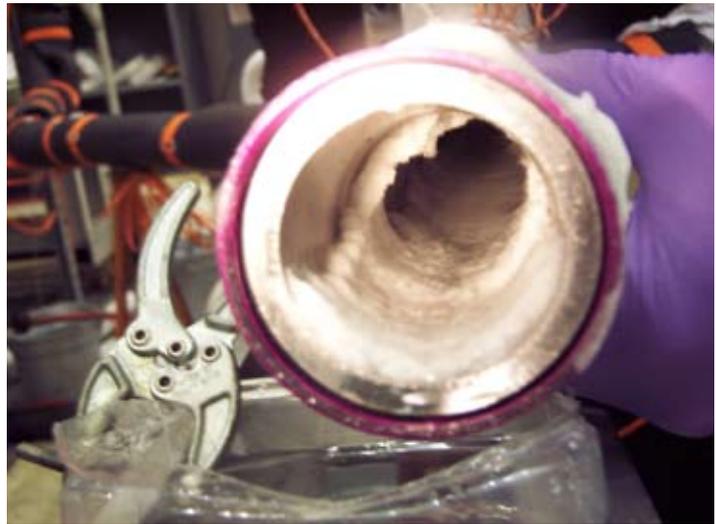
Figure 1

of fuel, at a fuel temperature of -20°C (-4°F) with quite different results. The amount of ice within the system ranged from very little ice to a build up of approximately 6 mm along the bottom of the pipe and 1 to 2 mm around the circumference of the pipe (Figure 1). However, it is possible that on some of the runs, ice might have been released before the end of the test.

Ice in the flexible hose located at the rear of the strut
