INCIDENT

Aircraft Type and Registration:	Enstrom F-28A, G-KOLY	
No & Type of Engines:	1 Lycoming HIO-360-C1A piston engine	
Year of Manufacture:	1973	
Date & Time (UTC):	31 October 1992 at 1330 hrs	
Location:	Monmouth, Gwent	
Type of Flight:	Private (pleasure)	
Persons on Board:	Crew - 1	Passengers - 1
Injuries:	Crew - None	Passengers - None
Nature of Damage:	Severe mechanical damage to engine, minor engine bay fire damage	
Commander's Licence:	Private Pilot's Licence with Night rating	
Commander's Age:	53 years	
Commander's Flying Experience:	787 hours (of which 17 were on type) Last 90 days - 5 hours Last 28 days - 4 hours	
Information Source:	Aircraft Accident Report Form submitted by the pilot and AAIB examination of aircraft and engine

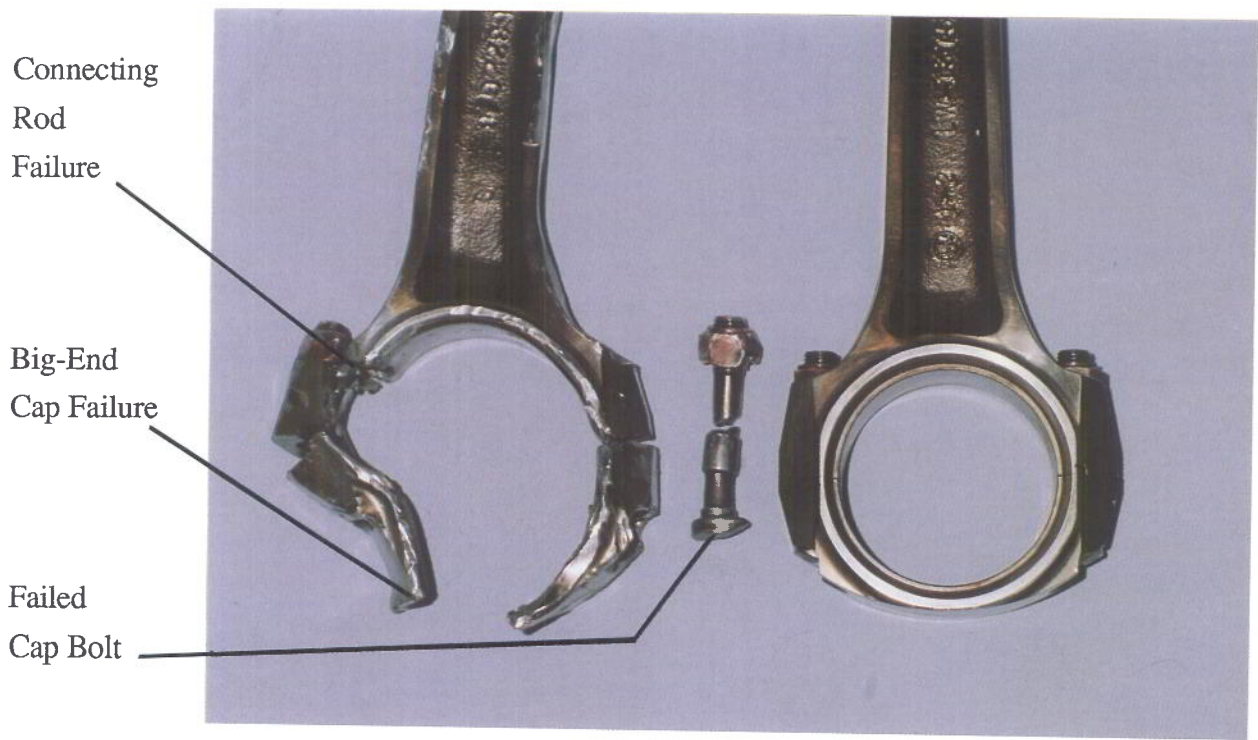
Fig 1 No. 2 Connecting Rod Big-End and Intact Example

Detailed inspection showed that one big-end lug of the No. 2 connecting rod, providing the location for one of the big-end cap bolts, had fractured on two roughly transverse planes at the position of the seating face for the nut. The opposite cap bolt and the cap had distorted and fractured (Fig 1). Specialist materials examination concluded that the cap bolt and cap failures were the result of overload. One of the connecting rod lug fractures had resulted from a high stress low endurance fatigue mechanism and was consistent with secondary failure resulting just prior to the final big-end failure. The other fracture had resulted from a low stress high endurance fatigue mechanism consistent with progression over millions of load cycles (Fig 2). Examination of the microstructure and hardness measurement did not suggest that a material defect had adversely affected the fatigue strength. In both planes of separation the fatigue initiation region was at the bore of the big-end, *ie* at the surface of the big-end journal in contact with the outer surface of the white metal bearing shell. This surface had considerable galling damage, as did the big-end bearing journals of the other connecting rods, and expert evidence indicated that this would be likely to act as a fatigue initiator.

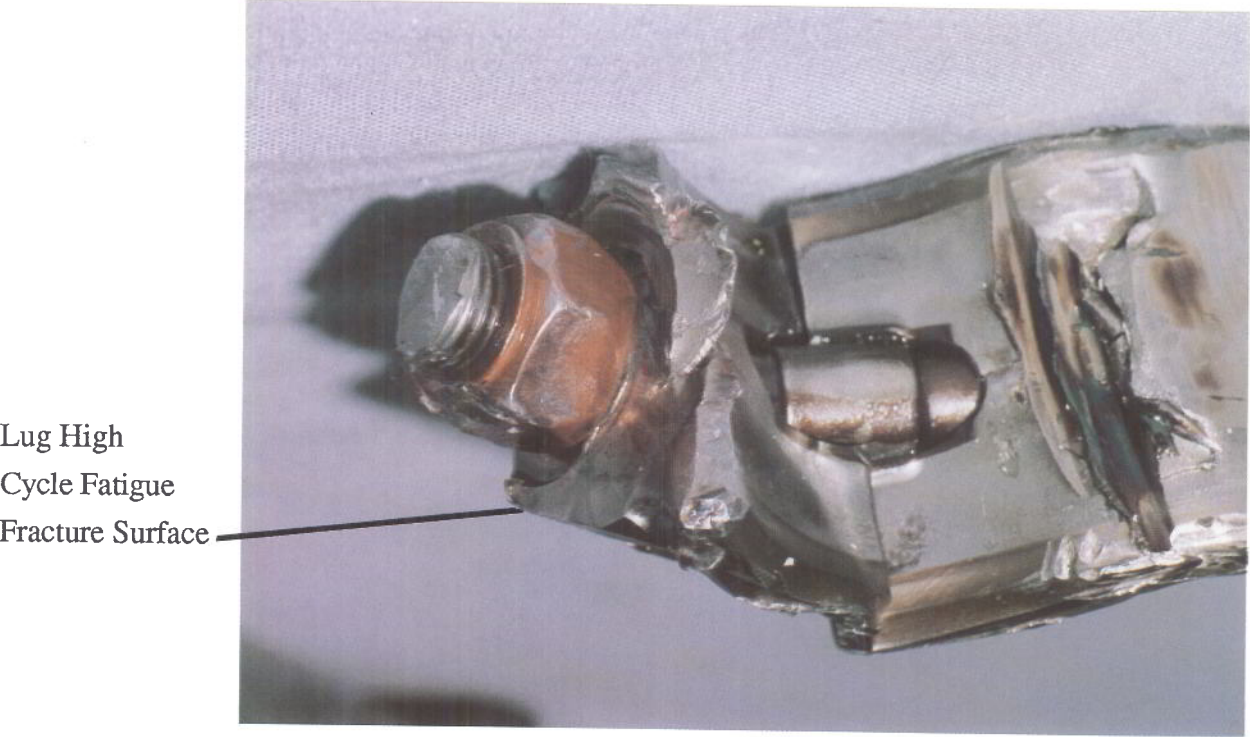
Fig 2 No. 2 Connecting Rod Failure

Engine inspection revealed major failure of the No. 2 connecting rod big-end. The rod had been released from the crankshaft and had holed the crankcase and fractured the camshaft. Reports indicated that the fire had probably resulted from auto-ignition on the exhaust pipes of oil that had been released from the engine. Only very minor fire damage had occurred.
