ACCIDENT

Aircraft Type and Registration:	Mooney M20J, N12ZX	
No & Type of Engines:	1 Lycoming IO-360-B1E engine	
Year of Manufacture:	1991 (Serial no: 24-3227)	
Date & Time (UTC):	8 September 2012 at 1115 hrs	
Location:	Oxford Airport, Kidlington	
Type of Flight:	Private	
Persons on Board:	Crew - 1	Passengers - None
Injuries:	Crew - None	Passengers - N/A
Nature of Damage:	Propeller and engine unserviceable; abrasions to aircraft lower skin, collapsed landing gear	
Commander's Licence:	Private Pilot's Licence	
Commander's Age:	67 years	
Commander's Flying Experience:	5,088 hours (of which 4,958 were on type) Last 90 days - 67 hours Last 28 days - 24 hours	
Information Source:	Aircraft Accident Report Form submitted by the pilot and further information on aircraft damage

Synopsis

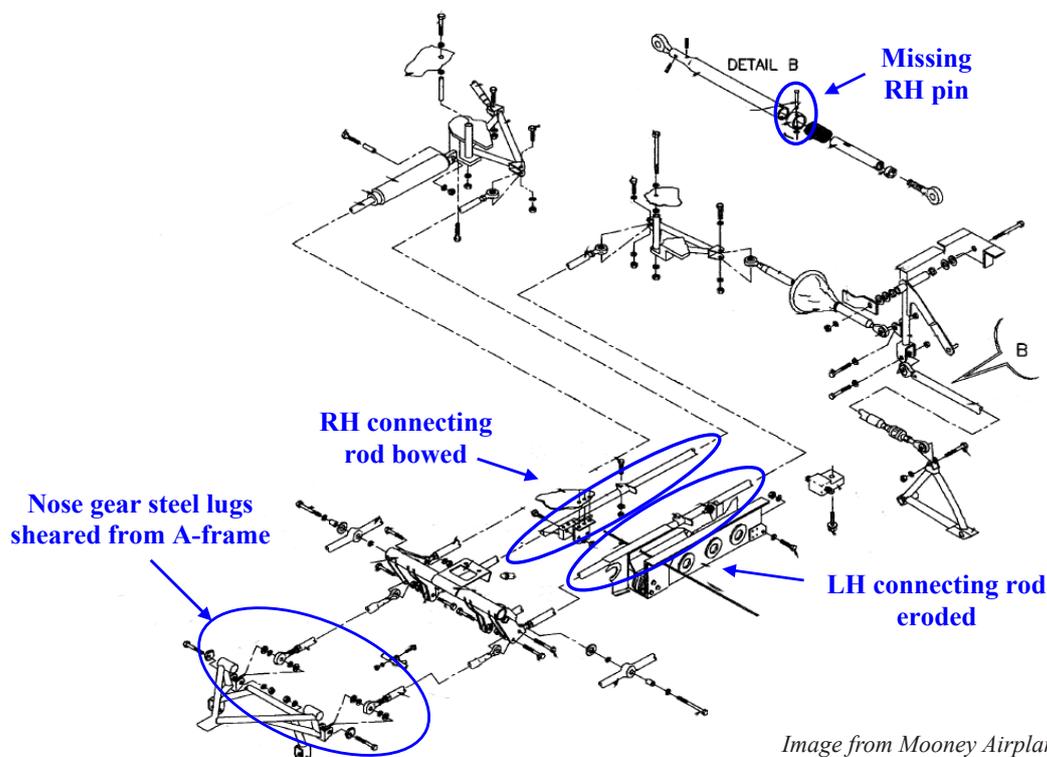
Figure 1

A recovery team removed the aircraft from the runway shortly after the incident and it was stored in a hangar at Oxford Airport. It was reported that initially the salvage crew were not able to extend the right main gear and had found a broken connecting rod in the mechanical linkage (Figure 1). Once this was removed they were able to extend the gear. The condition of the linkage prior to the accident is unknown and it is possible this damage was caused during the landing.

Mooney M20J Landing Gear Retraction System
