AAIB Bulletin No: 3/94

Aircraft Type and Registration: Mooney M20J, G-BSKJ

Date & Time (UTC): 8 January 1994 at 1549 hrs

Location: 'Needle's Eye', The Wrekin, Shropshire

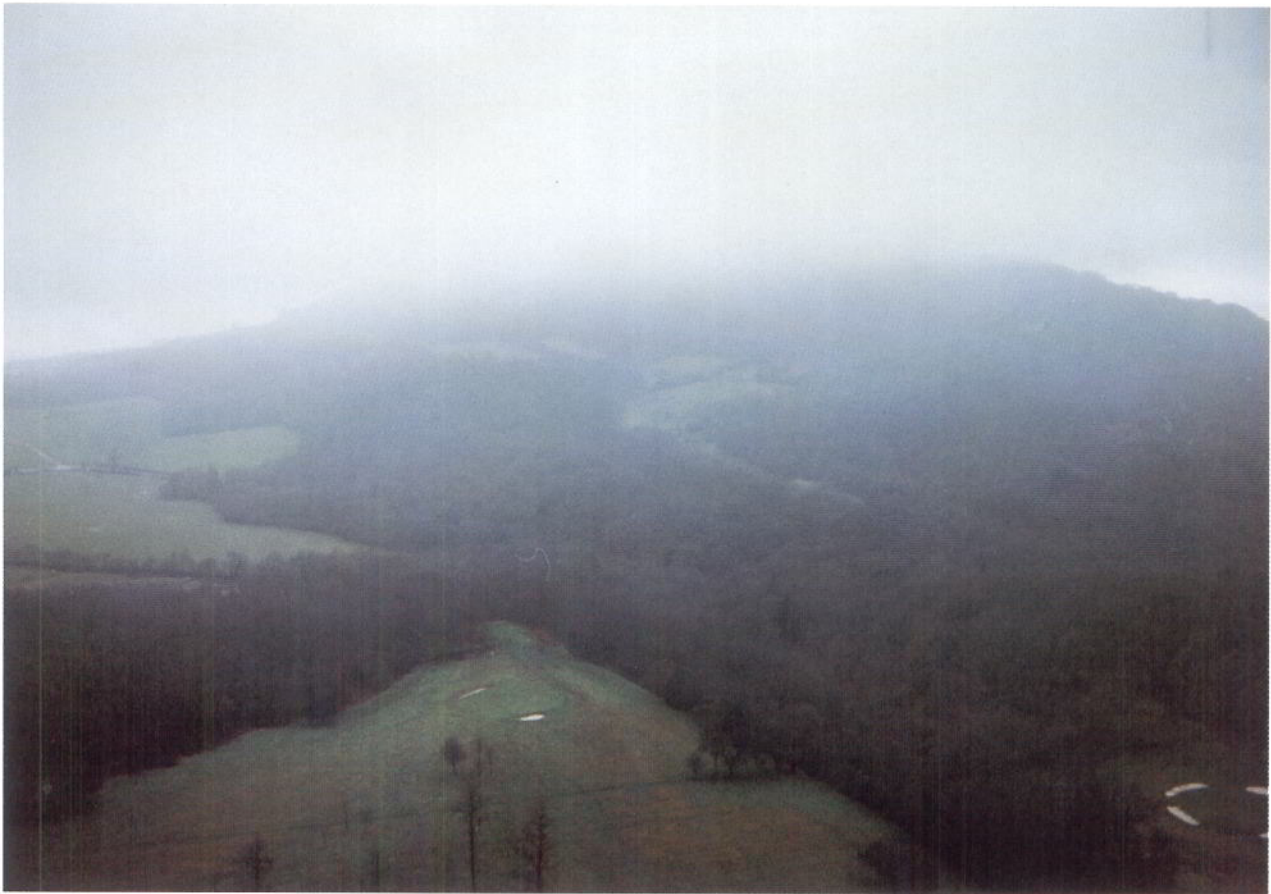
Witnesses later reported having seen the accident aircraft flying level in and out of the low cloudbase and having heard its engine running smoothly. One witness saw it flying directly toward The Wrekin and disappear into the cloud covering its top. At Figure 1 is a photograph of The Wrekin taken from just below cloudbase under similar weather conditions to those pertaining at the time of the accident. It illustrates the potential for mis-identifying ground which is rising into cloud as more level ground which is fading into the distance. Figure 2 shows the aircraft's track (in red), derived from radar recordings as it approached The Wrekin, superimposed on a section the 1:500,000 topographical chart. The isolated nature of The Wrekin and the prominent identification of some power station cooling towers (882 amsl) on the aircraft's track a short distance to the south east may be seen clearly. The impact occurred near the spot height of 1,334 feet.

Figure 1: View of The Wrekin taken from just below cloudbase under similar weather conditions to those on the day of the accident flight.
