ACCIDENT

Aircraft Type and Registration:	Cessna T303, Crusader, D-IAFC
No & Type of Engines:	2 Continental Motors Corporation IO-520-AE piston engines
Year of Manufacture:	1983
Date & Time (UTC):	19 September 2006 at 1228 hrs
Location:	North Sea, approximately 9.5 nm south-east of Aldeburgh, Suffolk
Type of Flight:	Commercial Air Transport (Cargo)
Persons on Board:	Crew - 1 Passengers - None
Injuries:	Crew - 1 (Serious) Passengers - N/A
Nature of Damage:	Destroyed
Commander's Licence:	Commercial Pilot's Licence
Commander's Age:	67 years
Commander's Flying Experience:	24,000 hours (of which 6,000 were on type) Last 90 days - 65 hours Last 28 days - 35 hours
Information Source:	AAIB Field Investigation

Synopsis

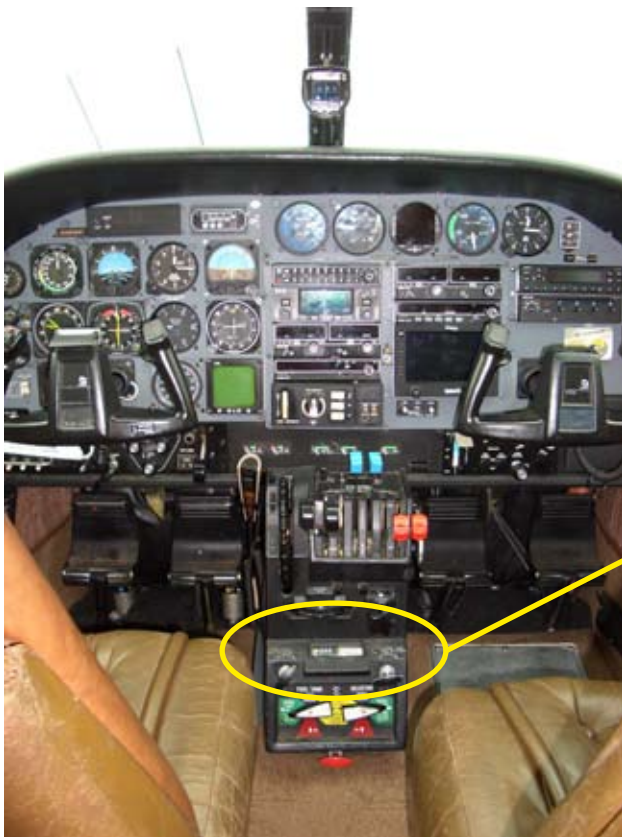
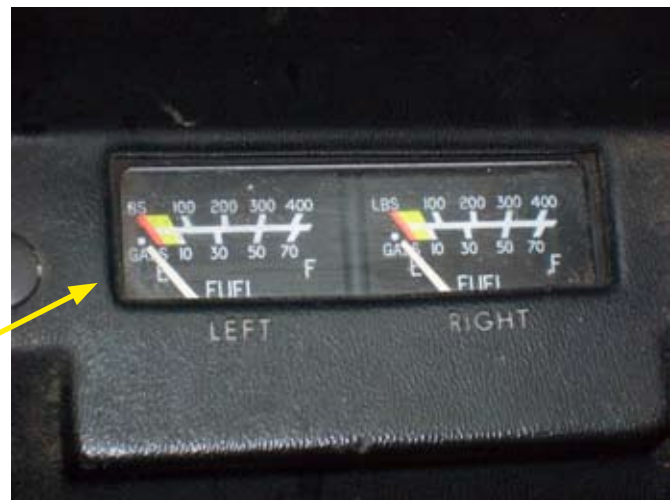
Figure 1

that he had not checked these during the cruise until the right engine started to run roughly, as they were difficult to see as well as being inaccurate⁶.

The Cessna T303 has one fuel tank in each wing, with a total useable fuel capacity of 579 litres (918 lb). There are two fuel gauges, one for each tank, marked left and

right, located at the rear of the centre console just above floor level, Figure 1.

The lower sector of the fuel level scale is marked in red, to indicate when only unusable fuel is remaining in each tank; unusable fuel is quoted in the manual as 12 lb.
