ACCIDENT

Aircraft Type and Registration:	Swift S-1, G-IZII	
No & Type of Engines:	N/A	
Year of Manufacture:	1993	
Date & Time (UTC):	22 August 2010 at 1022 hrs	
Location:	Shoreham Airfield, West Sussex	
Type of Flight:	Aerial work	
Persons on Board:	Crew - 1	Passengers - None
Injuries:	Crew - 1 (Serious)	Passengers - N/A
Nature of Damage:	Substantial	
Commander's Licence:	Glider Pilot's Licence	
Commander's Age:	35 years	
Commander's Flying Experience:	473 hours (of which 57 were on type) Last 90 days - 20 hours Last 28 days - 2 hours	
Information Source:	AAIB Field Investigation

The glider was in a low level final turn to land when it stalled, departed controlled flight and crashed onto the runway. One Safety Recommendation was made.

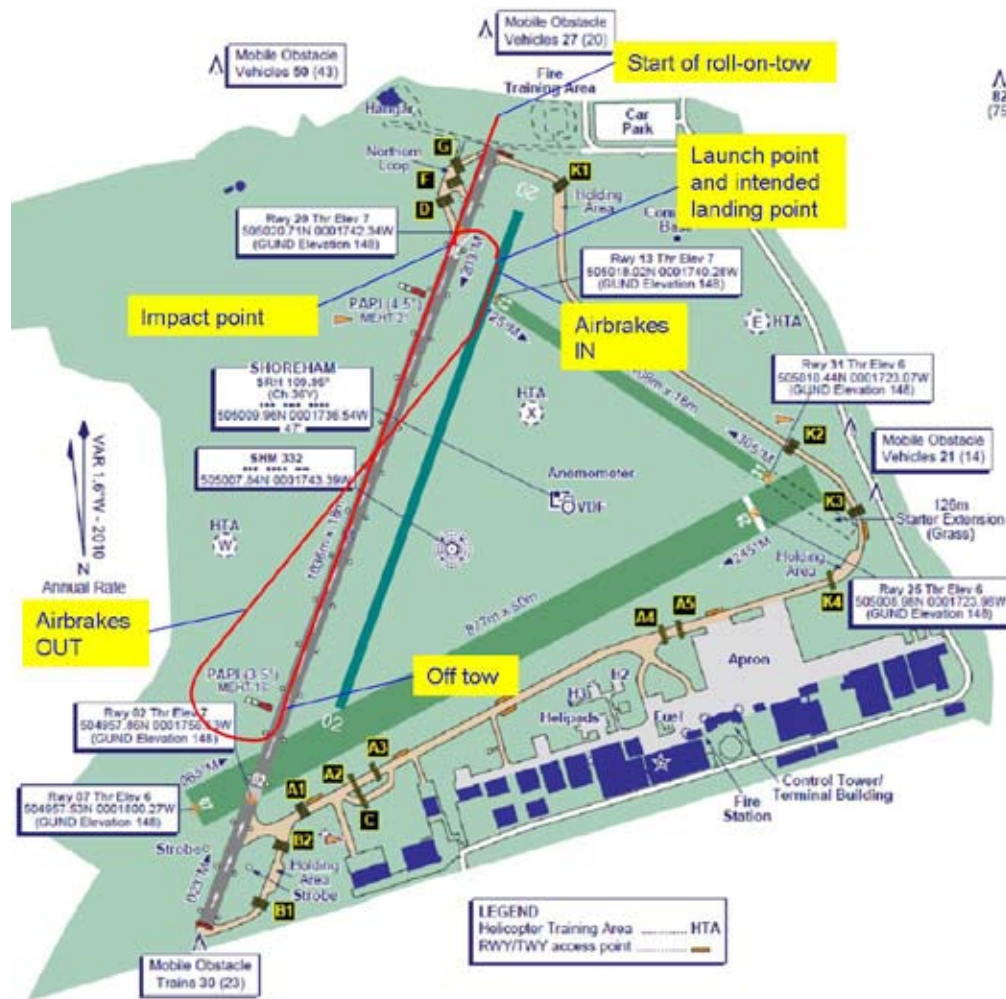
the asphalt Runway 20. He retracted the airbrakes and began a left turn. Figure 1 shows the ground track of the glider.

Ground track flown by G-IZII
