ACCIDENT

Aircraft Type and Registration:	Swift S-1, G-IZII	
No & Type of Engines:	N/A	
Year of Manufacture:	1993	
Date & Time (UTC):	22 August 2010 at 1022 hrs	
Location:	Shoreham Airfield, West Sussex	
Type of Flight:	Aerial work	
Persons on Board:	Crew - 1	Passengers - None
Injuries:	Crew - 1 (Serious)	Passengers - N/A
Nature of Damage:	Substantial	
Commander's Licence:	Glider Pilot's Licence	
Commander's Age:	35 years	
Commander's Flying Experience:	473 hours (of which 57 were on type) Last 90 days - 20 hours Last 28 days - 2 hours	
Information Source:	AAIB Field Investigation

Synopsis

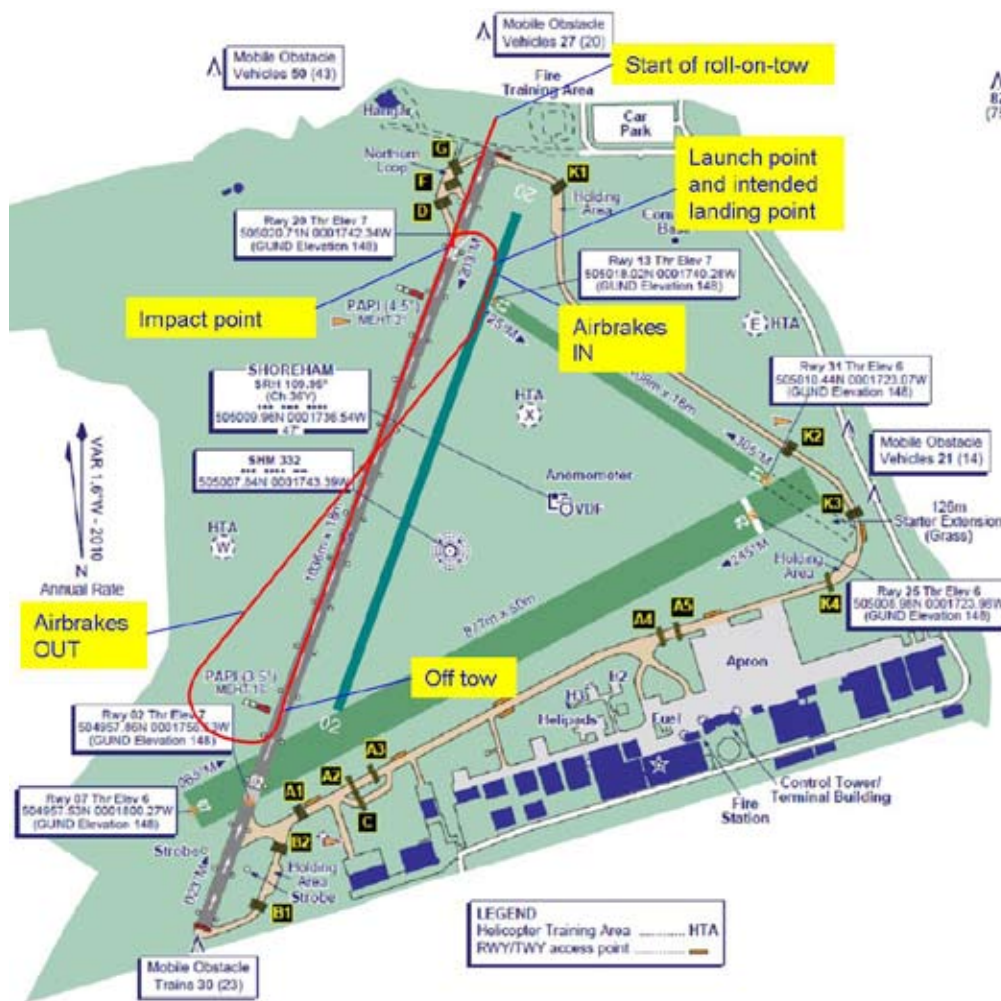
the asphalt Runway 20. He retracted the airbrakes and began a left turn. Figure 1 shows the ground track of the glider.

Ground track flown by G-IZII
