AAIB Bulletin No: 6/94

Ref: EW/G93/10/09

Aircraft Type and Registration: Piper PA-28-161 Cherokee Warrior II, G-BRDF

G-BRDF CRANKSHAFT FAILURE

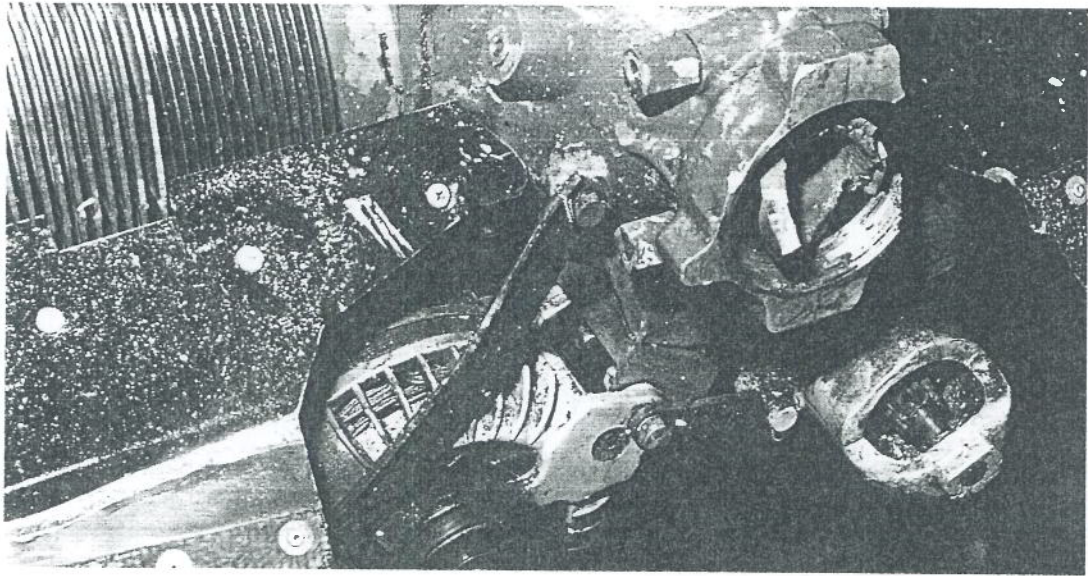
Fig 1

The propeller was recovered and examination showed that the engine crankshaft had fractured just behind the integral propeller mounting flange, near the position of the forward oil seal (Figs 1 and 2).

The engine was bulk stripped and the components examined, with no abnormalities found except for those concerning the crankshaft, described below. Detailed specialist examination of the crankshaft fracture showed that the fracture surfaces had been damaged by rubbing and corrosion but concluded that the separation had resulted from a high cycle reverse torsional fatigue mechanism that had initiated from a number of corrosion pits in the crankshaft bore. After the cracks had progressed through a substantial proportion of the crankshaft section the rate of advance had increased until the remaining unseparated portion had failed as a result of overload. It was clear that much of the cracking had occurred in high cycle fatigue and that it had progressed over an extended period of service.

Fractured Crankshaft

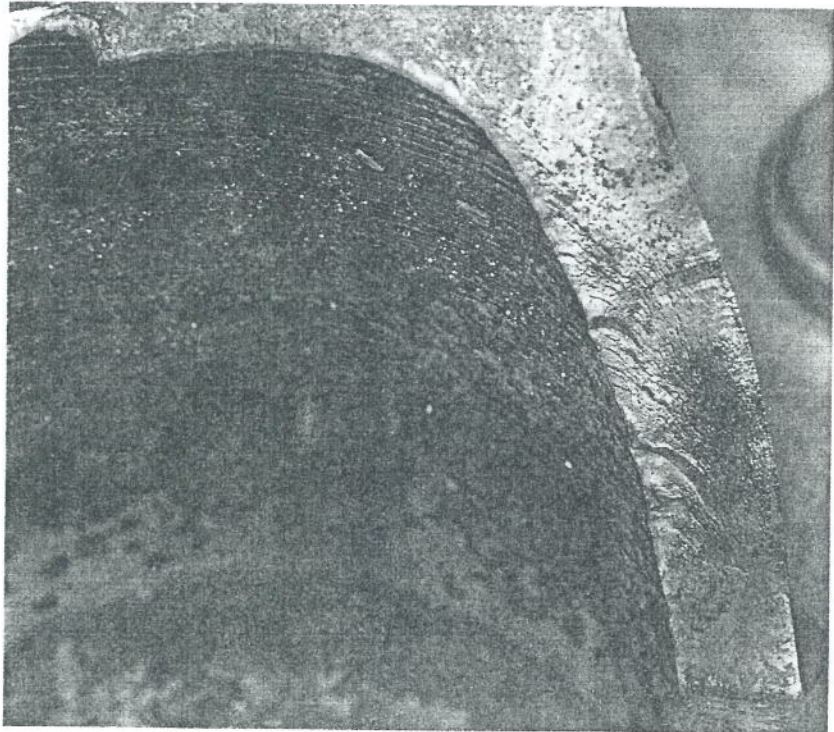
Fig 3

The bore through the forward section of the crankshaft was found to be coated in a thick layer of solid oil sludge-like deposit, in the order of $\frac{1}{4}$ inch thick, consistent with the centrifuging effect that would be present in this area with the crankshaft turning. In an area immediately behind the plug, heavy corrosion was present on the surface of the crankshaft bore (Fig 3). It was noted that the reduced diameter portion of the bore effectively constituted a weir, making the larger diameter forward part of the bore a sump into which debris or water entering the bore would be centrifugally separated from the oil while the engine was operating and where it would remain trapped when the engine stopped. It also appeared possible that the forward portion of the crankshaft could be a relatively cool area with the engine running and thereby particularly conducive to condensation. The bore also exhibited heavy machining scores and extensive brittle cracking across these scores. Microsection examination and hardness measurements showed that the bore had a hardened layer, typical of that produced by carbo-nitriding, with deep corrosion pitting and cracking present, and parts of the outer surface of the forward portion of the crankshaft had a less complete hardened layer.

problems. Corrosion was clearly the cause in the case of G-BRDF's failure. The Service Bulletin described, issued 34 years ago, applied to the engine of a different manufacturer but concerned an apparently similar type of crankshaft and indicates that the potential hazard from cracking as a result of corrosion is not a new problem. In view of the evidence and the potentially catastrophic consequences of failure, the following safety recommendation has been made.

Corrosion in Crankshaft Bore

It is recommended that the CAA liaise with the FAA and require procedures to be issued, for UK registered aircraft powered by the Avco Lycoming O-320-D3G and for other engines with similar crankshaft design features, for the mandatory inspection of the forward portion of the crankshaft bore aimed at detecting existing significant corrosion and/or cracking before any such effects progress to the point of crankshaft fracture. In parallel, mandatory procedures should be developed aimed at preventing subsequent corrosion.
