Transport Category (Passenger). It was sponsored by an international company and was being used on the day of the accident to provide pleasure flights for the prize winners and runners up in two national competitions, one of which was organised by the sponsors. The helicopter was maintained by a CAA approved helicopter charter company, holders of an Air Operator's Certificate. The pilot of the accident aircraft was employed by the helicopter charter company and they had agreed to make his services available to the owners of the helicopter on the day of the accident.

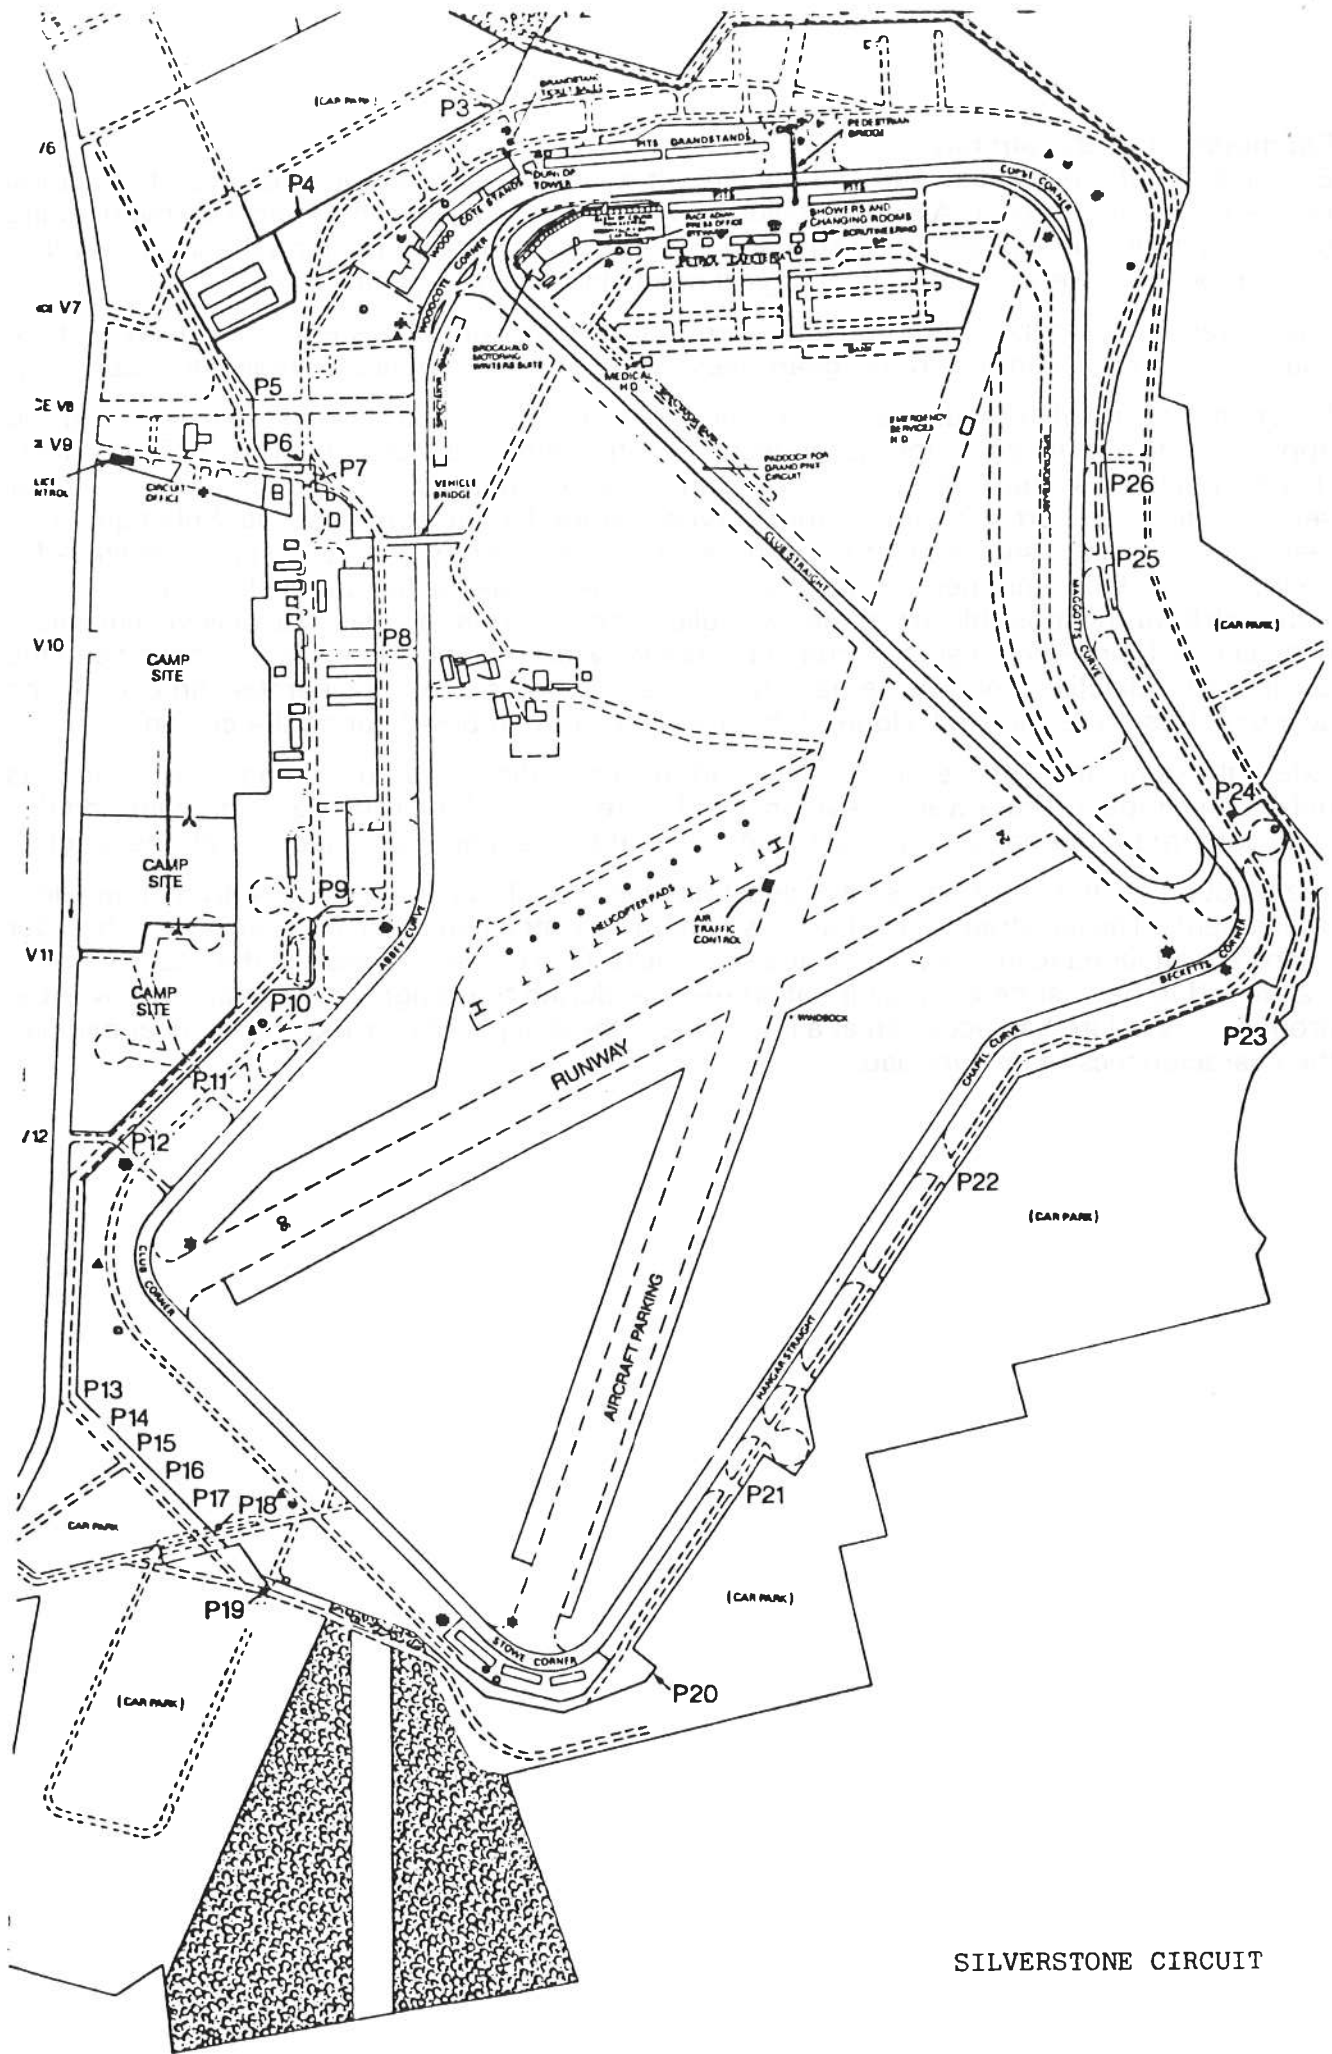
SILVERSTONE CIRCUIT

One of the rear seat passengers was taking photographs during the flight. An analysis of the sequence of shots indicates a steeply banked turn to the right just north of the Club Corner followed by a dive towards Abbey Curve. The aircraft then levelled out and flew in a right hand turn behind the Grandstand Pits complex. Witnesses next saw the aircraft flying in a south easterly direction parallel to the Club straight. Positioned south east of the Chapel Curve it reversed its course through 180° and headed back towards the centre of the circuit at an estimated height of 50 feet. The aircraft then pitched down as if to make a low pass across the airfield in a north westerly direction.

Passengers in the helicopter state that they felt that recovery from the dive was unlikely and at the last moment the pilot banked the helicopter steeply to the right. The aircraft struck the ground just inside the Armco safety barrier. The tail rotor tips contacted the top of the barrier and the aircraft crashed through several strands of galvanised wire fencing which had been erected some 2 metres inside the Armco barrier. Evidence from the impact marks indicates that the helicopter was banked at 45 degrees to the right, in a steep nose up attitude and with a ground speed of approximately 125 knots.
