ACCIDENT

Aircraft Type and Registration:	Piper PA-34-200T Seneca II, N43GG	
No & Type of Engines:	2 Continental TSIO-360-EB piston engines	
Year of Manufacture:	1976	
Date & Time (UTC):	27 September 2005 at 1438 hrs	
Location:	Humberside Airport, Ulceby, South Humberside	
Type of Flight:	Private	
Persons on Board:	Crew - 1	Passengers - 1
Injuries:	Crew - None	Passengers - None
Nature of Damage:	Both propellers bent, engines shock loaded, nose cone and nose landing gear doors damaged	
Commander's Licence:	UK Private Pilot's Licence (A)	
Commander's Age:	43 years	
Commander's Flying Experience:	470 hours (of which 119 were on type) Last 90 days - 36 hours Last 28 days - 9 hours	
Information Source:	Aircraft Accident Report Form submitted by the pilot and subsequent AAIB Engineering examination

Synopsis

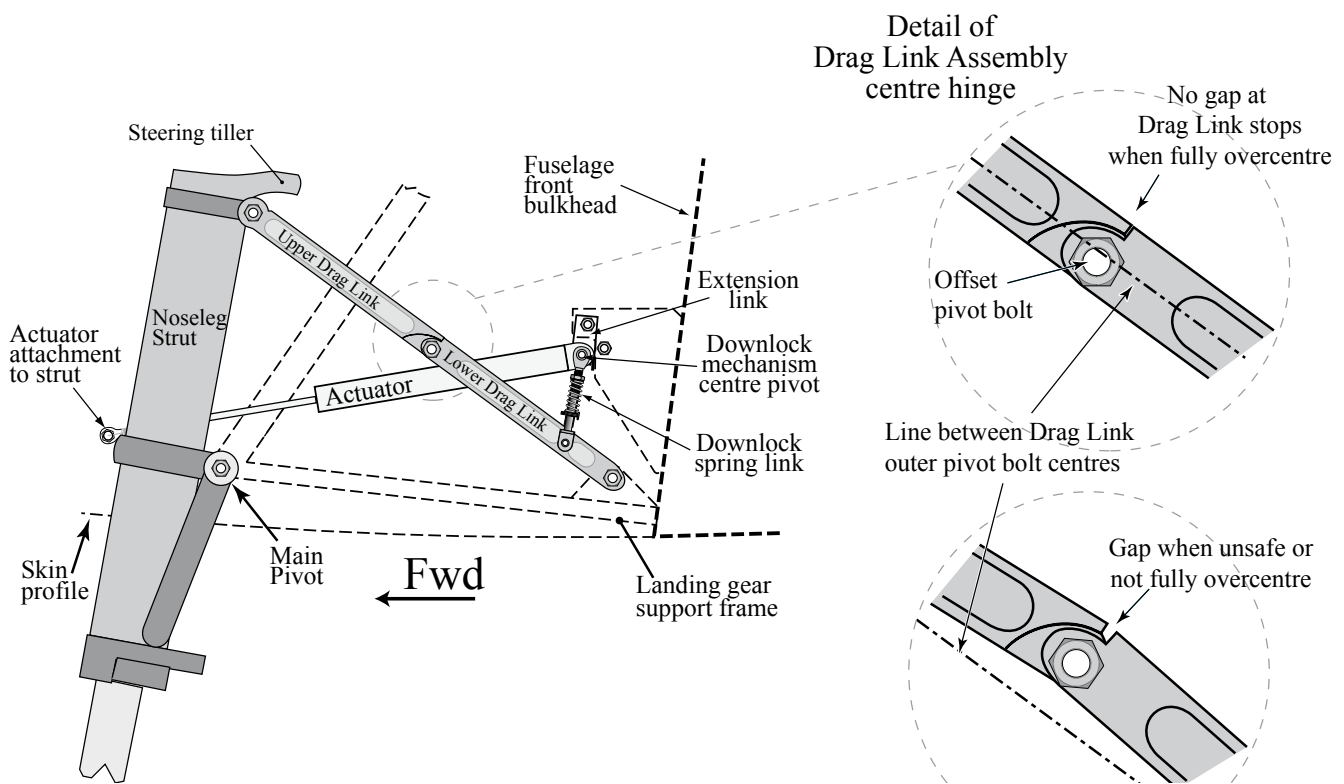
Figure 1

PA-34 nose landing gear side view showing main components in extended position
(Steering mechanism & downlock spring omitted for clarity)

During NLG extension, as the actuator extends, the extension link (see Figures 1 & 2) is rotated to make contact with the microswitch, providing an indication that the actuator has reached the limit of its extension and that the NLG is 'down and locked'. If the compressed downlock spring link remains of sufficient length, the NLG drag link assembly will be forced into the over centre position, locking the NLG in position. In a situation where the compressed downlock spring link is shorter than required, the NLG microswitch will still be activated by the extension of the NLG actuator; but the downlock spring link will not be of sufficient length to drive the drag link assembly into the 'safe' over centre position. It is probable that the combination of the distortion to the downlock mechanism centre pivot pin and the ovality of the pin slot, which introduced increased play in the downlock spring link, allowed the drag link assembly to remain in, or move to, an under centre and 'unlocked' position whilst indications showed that it was 'down and locked'.
