ACCIDENT

Aircraft Type and Registration:	Piper PA-34-200T Seneca II, N43GG	
No & Type of Engines:	2 Continental TSIO-360-EB piston engines	
Year of Manufacture:	1976	
Date & Time (UTC):	27 September 2005 at 1438 hrs	
Location:	Humberside Airport, Ulceby, South Humberside	
Type of Flight:	Private	
Persons on Board:	Crew - 1	Passengers - 1
Injuries:	Crew - None	Passengers - None
Nature of Damage:	Both propellers bent, engines shock loaded, nose cone and nose landing gear doors damaged	
Commander's Licence:	UK Private Pilot's Licence (A)	
Commander's Age:	43 years	
Commander's Flying Experience:	470 hours (of which 119 were on type) Last 90 days - 36 hours Last 28 days - 9 hours	
Information Source:	Aircraft Accident Report Form submitted by the pilot and subsequent AAIB Engineering examination

Synopsis

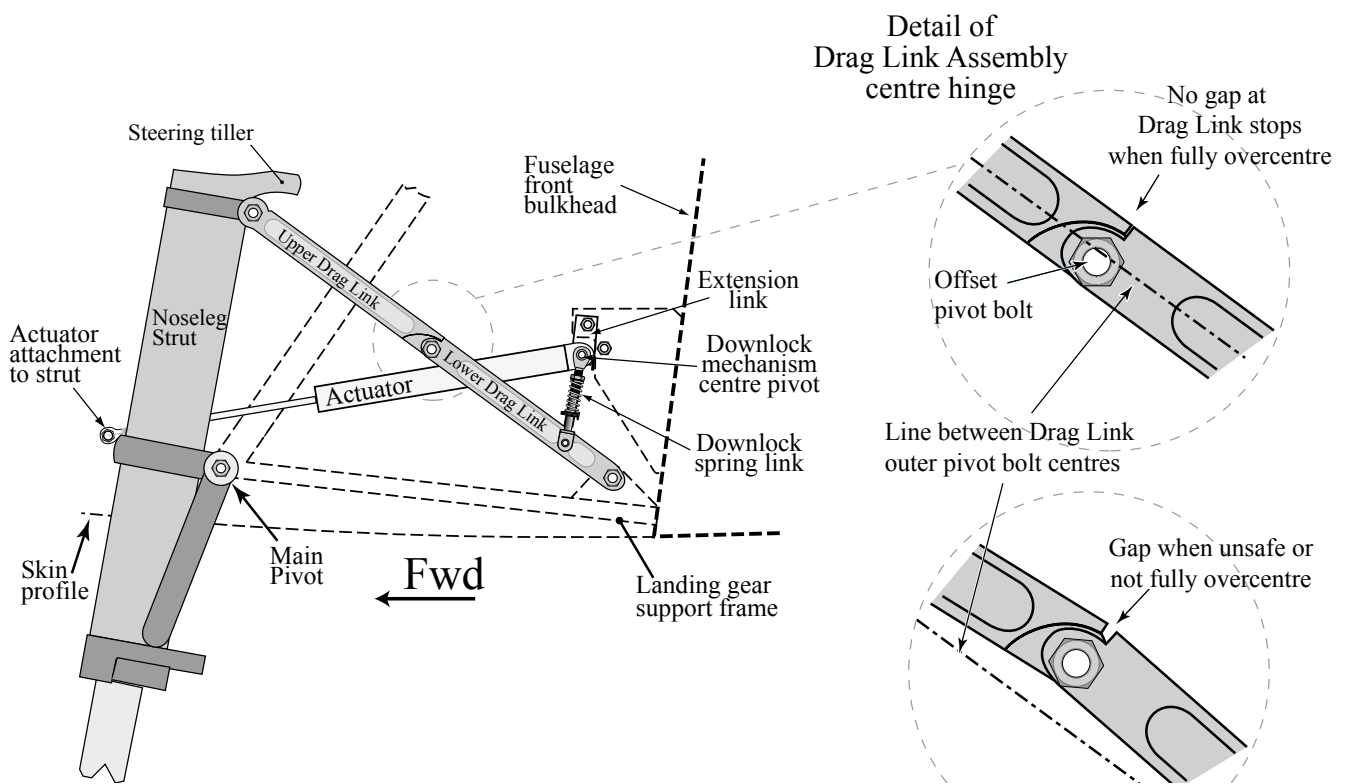
Figure 1

PA-34 nose landing gear side view showing main components in extended position
(Steering mechanism & downlock spring omitted for clarity)

During NLG extension, as the actuator extends, the extension link (see Figures 1 & 2) is rotated to make contact with the microswitch, providing an indication that the actuator has reached the limit of its extension and that the NLG is 'down and locked'. If the compressed downlock spring link remains of sufficient length, the NLG drag link assembly will be forced into the over centre position, locking the NLG in position. In a situation where the compressed downlock spring link is shorter than required, the NLG microswitch will still be activated by the extension of the NLG actuator; but the downlock spring link will not be of sufficient length to drive the drag link assembly into the 'safe' over centre position. It is probable that the combination of the distortion to the downlock mechanism centre pivot pin and the ovality of the pin slot, which introduced increased play in the downlock spring link, allowed the drag link assembly to remain in, or move to, an under centre and 'unlocked' position whilst indications showed that it was 'down and locked'.

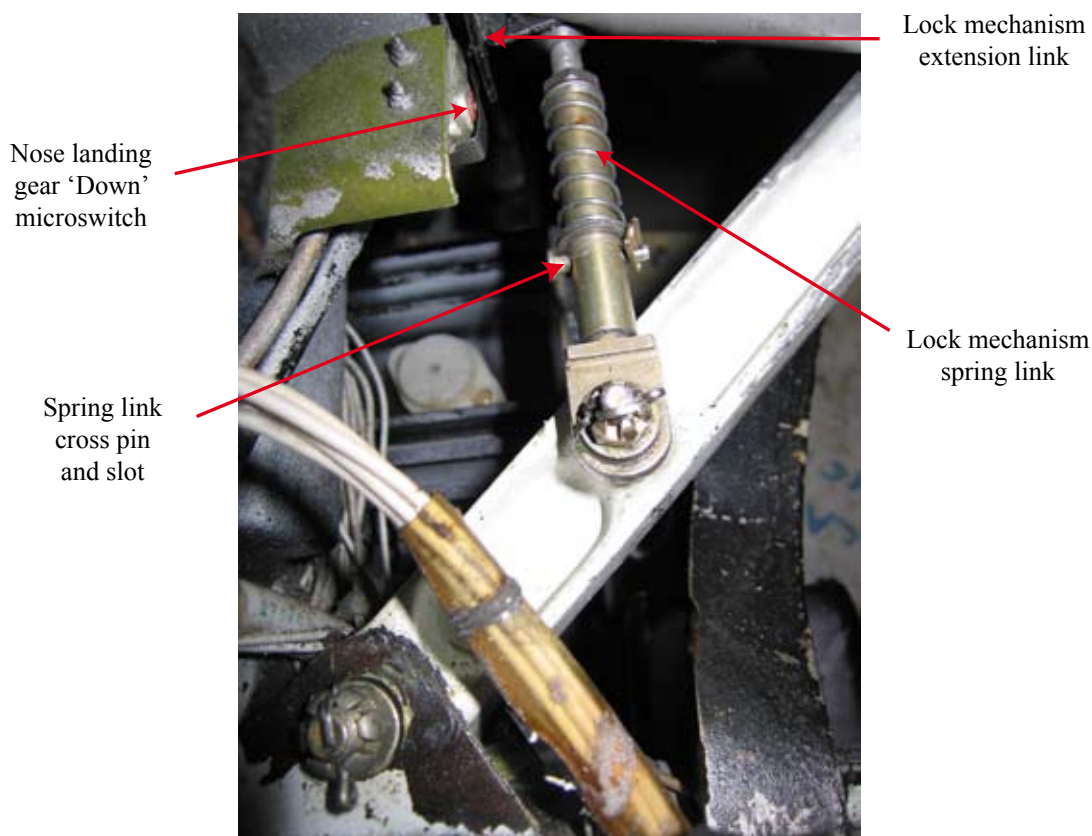
Figure 2

The aircraft was examined at Humberside Airport with the NLG secured in the down position by strops. Facilities were not available to carry out a functional test of the landing gear. The NLG extension link (see Figure 2) was found in a position corresponding to the down and locked position and the NLG micro switch had been activated, producing a 'down and locked' indication in the cockpit. The drag link assembly however was in an unlocked, under centre, condition. The downlock spring link showed some ovality in the pin slot, it was not possible to determine if this was the result of in service wear or as a result of an overload event. The central pivot pin, which secures the spring lock to the extension link and acts as the retraction jack input point, was severely distorted (see Figure 3). The retraction jack appeared to be in good condition with no evidence of external leaks or damage.

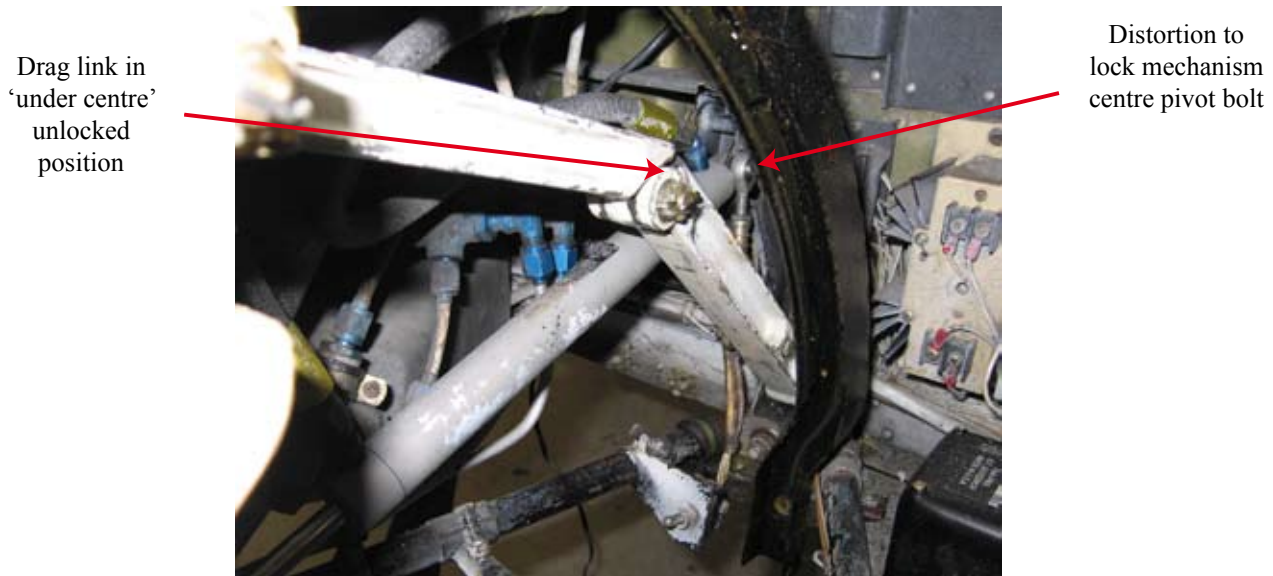
Figure 3

Based on the results of previous investigations and the ductility of the material involved, it is probable that the distortion of the downlock mechanism centre pivot pin was produced as a result of an overload event such as a nose wheel landing, or rough surface takeoff. A review of the aircraft records and discussions with the aircraft's owner and maintenance organisation did not reveal any events which might have resulted in an overload of the link mounting pin.
