AAIB Bulletin No: 2/2001

Ref: EW/C2000/6/1

Aircraft Type and Registration:	Piper PA-34-220T, G-BMNT	
No & Type of Engines:	2 Continental Motors LTSIO-360-KB piston engines	
Year of Manufacture:	1981	
Date & Time (UTC):	1 June 2000 at 1132 hours	
Location:	Rowley Mile Course, Newmarket, Suffolk	
Type of Flight:	Private	
Persons on Board:	Crew - 1	Passengers - 2
Injuries:	Crew - 1 (Fatal)	Passengers - 2 (Serious injury)
Nature of Damage:	Aircraft destroyed	
Commander's Licence:	Commercial Pilot's Licence (Frozen ATPL)	
Commander's Age:	52 years	
Commander's Flying Experience:	1,525 hours (of which 60 were on type) Last 90 days – 44 hours Last 28 days – 28 hours	
Information Source:	AAIB Field Investigation

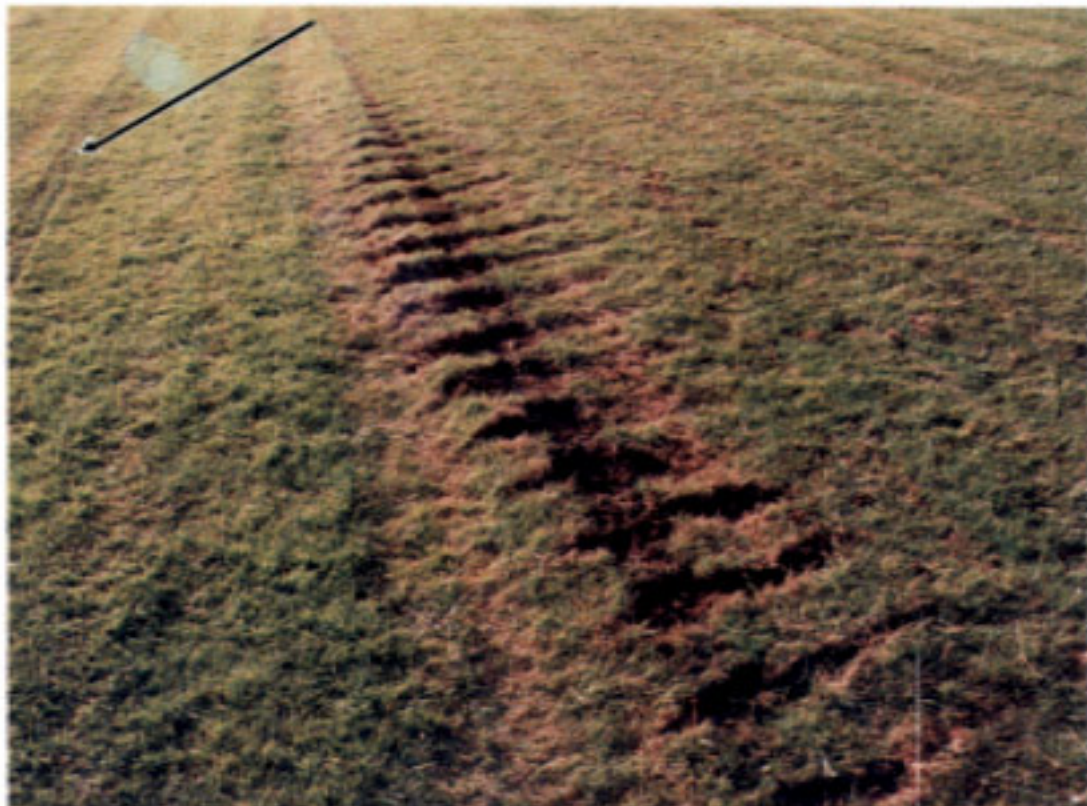
At the extreme top of the embankment, a relatively light scar in the earth was found to contain pieces of fibreglass wingtip and the green navigation and white strobe light glasses. On the runway itself, about 20 propeller slashes were clearly visible with an associated mainwheel tyre impression running through the middle of them. The mainwheel mark commenced at the start of the slashes and finished as they stopped. A distinct, but slightly fainter, impression obviously from the nosewheel tyre, could be discerned 1.7 metres to the left, again commencing and finishing almost precisely at the same time as the right mainwheel mark (see Figure 1, Appendix 1). There was no clear impression of the left mainwheel. All the latter marks started 300 metres from the runway threshold markings and were slightly to the right of the centreline.

The ground marks and wreckage distribution suggest that the take-off run had been ostensibly normal until the right main and nose wheels and propeller struck the ground. The aircraft was travelling straight along, and effectively on, the centreline. The propeller slashes were clearly made by an engine under high power and when measured their pitch corresponded to a groundspeed of 79 kt assuming take-off propeller RPM of 2,800. The tyre marks suggested a firm-to-heavy touchdown almost simultaneously on the right mainwheel and nosewheel.

Figure 1 - Photograph of wheel marks and propeller slashes looking in the take-off direction. Note impression of nosewheel tyre (arrowed)

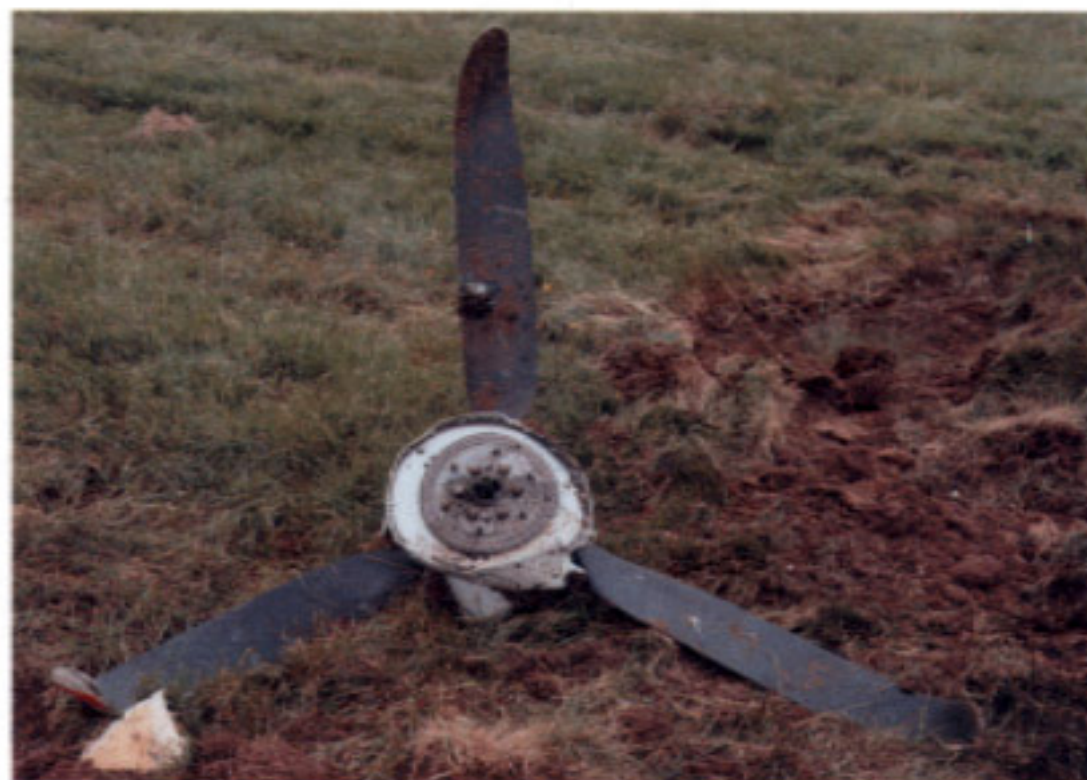
The investigation tried to establish whether the propeller strikes on the runway had resulted in any damage to the right engine or propeller which may have contributed to a possible loss of directional control and/or loss of climb performance. Accordingly, both propellers and the right engine were strip-inspected at a major overhaul agency under AAIB supervision. Externally, both propellers seemed remarkably little damaged by the main impact, which comprised a heavy blow to the front of the pitch-change cylinder in both cases. Hence all six blades were essentially straight apart from the three from the right propeller which had the tips curled back over about 15 cm in each case (see Figure 2, Appendix 1). When strip-inspected however, both propellers had suffered damage to the pitch change mechanism. Two of the links had become completely detached from their blade actuating pins in the case of the left propeller and one from the right. All the associated phenolic bushes had suffered damage to a greater or lesser extent. The blade retaining circlips of all six blades had jumped-out of their grooves.

The strip inspection revealed similar damage to both the pitch links and circlips on both propellers but it was impossible to distinguish between damage caused during the major ground impact and the tip strikes on the right propeller. However, the propeller manufacturer has advised that they would expect pitch mechanism damage to occur with a high-power tip strike and thus it is likely that one blade from the right propeller became free of the pitch change link after the tip strikes on the runway. In these circumstances, the blade counterweights should ensure that it rotates to the fully-feathered position. Under these conditions, a severe loss of thrust will occur due to the drag of the feathered blade and fining-off of the other two in an attempt to retain the selected RPM.

Figure 2 - Photograph of right propeller as-found. Note curled tips to blades.

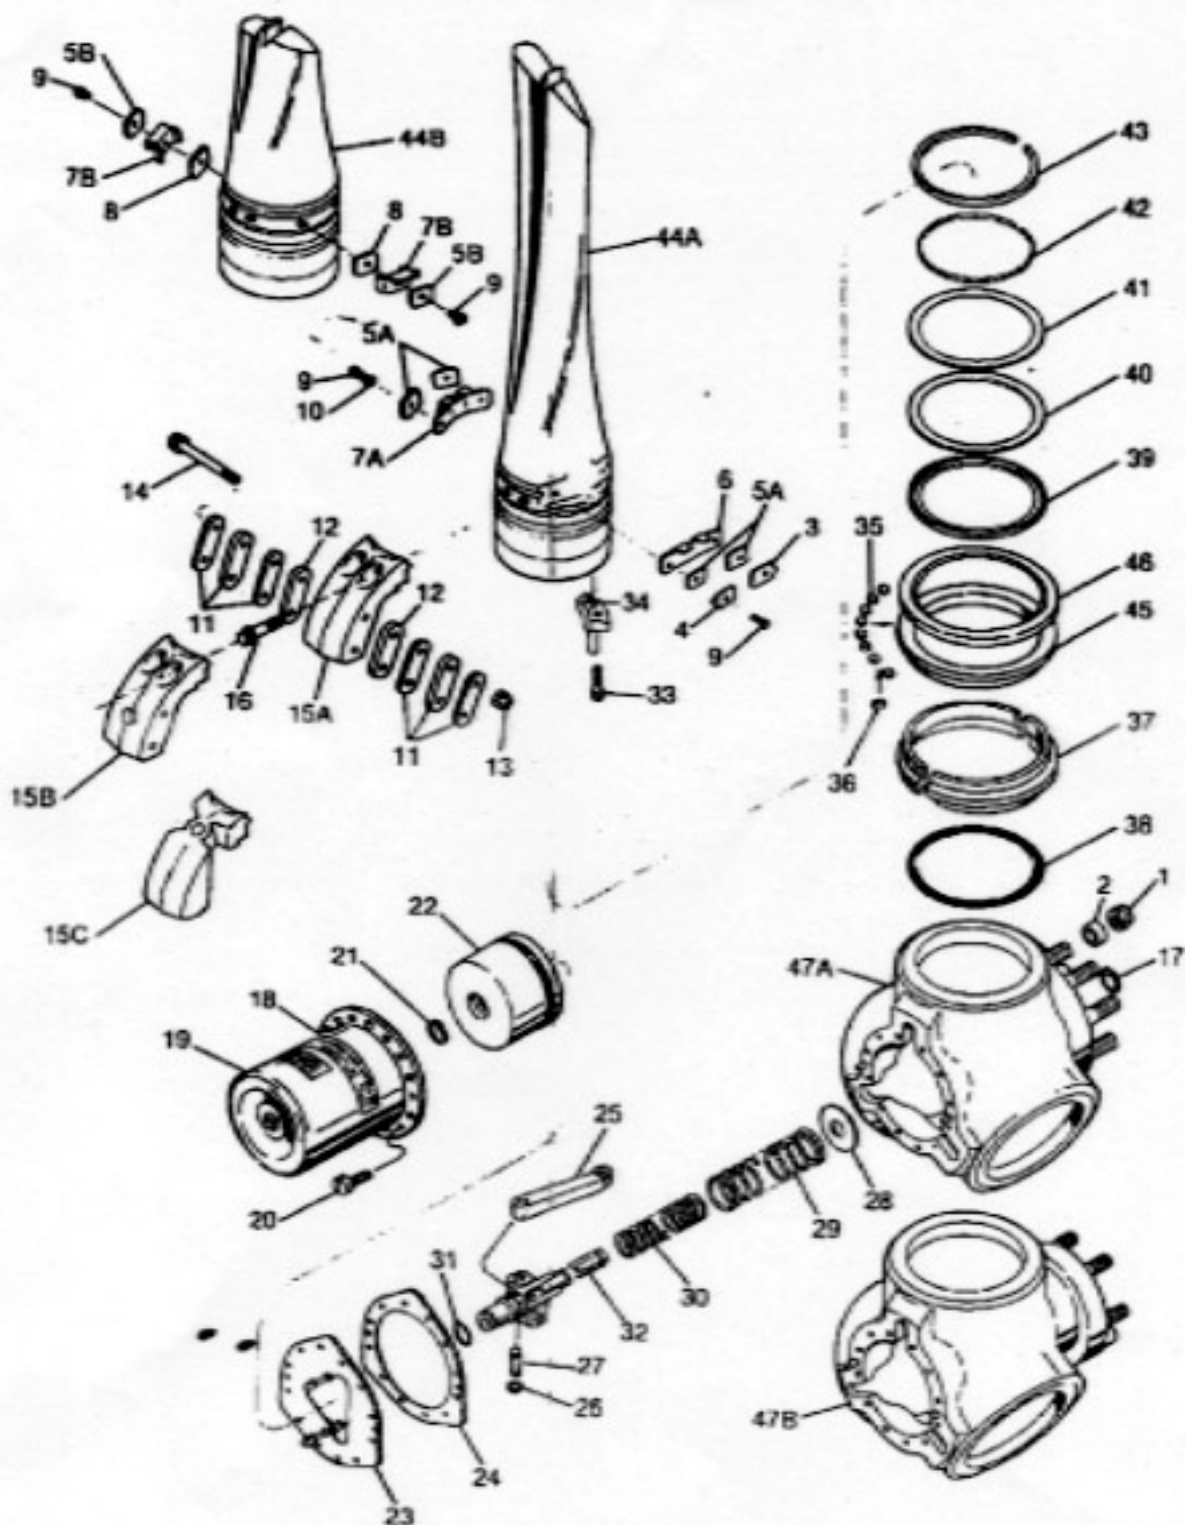
Referring to the diagram at Appendix 2, longitudinal motion of the piston and piston rod (items 22 and 32) is translated into rotational movement of the blades by three light alloy linkages (item 25) which connect the piston rod, immediately behind the piston, to the blade actuating pin bolted to the blade root

(item 34). At the piston end, the link is attached by a small gudgeon pin, itself retained by a circlip (items 26 and 27), whilst at the blade end the link slides onto the blade actuating pin without any form of retention. Phenolic bushes are used at both ends of the links.

G-BMNT - Exploded view of propeller pitch-change mechanism, showing pitch change links (3 off) as item 25
