Air Accidents Investigation Branch

**Report on the accident to
Cessna Citation 500
registration VP-BGE
2nm NNE of Biggin Hill Airport
30 March 2008**

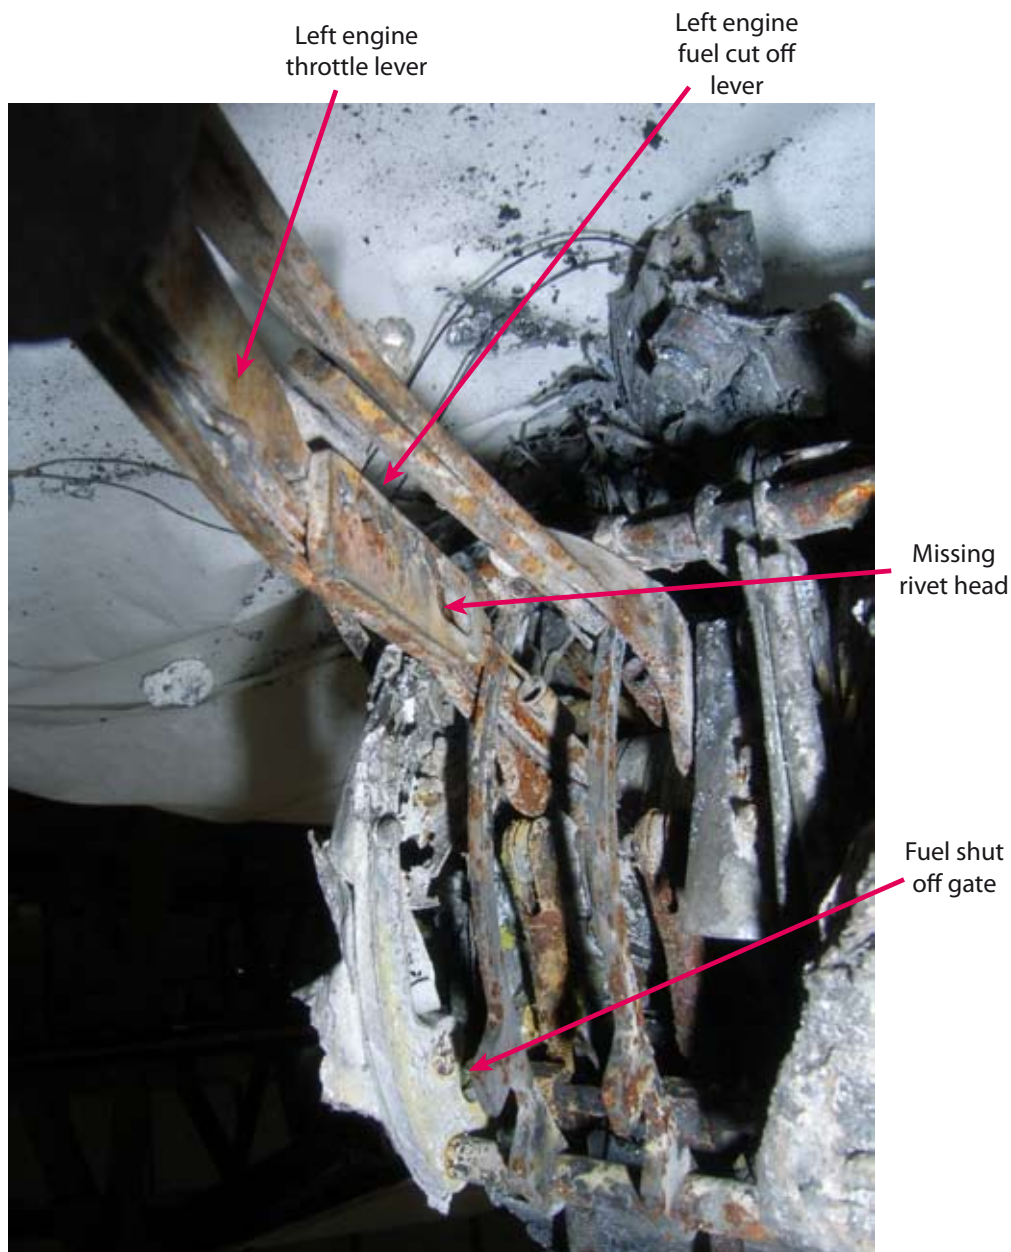
Figure 7

The continuity of the engine throttle cables was confirmed from the cockpit to each engine prior to wreckage recovery. Due to the break in the fuselage immediately behind the cockpit, both throttle cables, which ran adjacent to one another under the cabin floor, had been bent through approximately 25°. At the location of the bend, the outer section of the cable had been destroyed and the elements of the inner cable had opened out preventing movement of the cable. Both the left and right engine throttle levers were found in the forward (full thrust) position. Examination of the throttle levers showed that the head of the rivet used to retain the left engine fuel cut-off lever was missing (Figure 7).

Measurements taken from the throttles of another aircraft of the same type indicated that, with the rivet head missing, it is possible for the left engine fuel cut-off lever to pass across the inboard side of the fuel shut-off gate. The fracture surface of the remaining rivet shank had corroded as a result of its exposure to the fire fighting foam. This surface did, however exhibit characteristics of a failure in overload.

Inspection of the inner face (closest to the throttle lever) of the fuel cut-off lever showed the presence of corrosion products together with light scoring on the lower section of the inner face. The scoring was shallow, predominantly parallel to the movement path of the throttle and most pronounced on the lower rear section of the inner face of the cut-off lever. The scoring did not extend beyond the height of the fuel cut-off gate from the bottom of the lever. The scoring was inconsistent with the normal, vertical movement of the inner face of the cut-off lever against its associated throttle lever. In addition, an area of damage was identified on the rear inner corner of the cut-off lever which was consistent with the rear inner edge of the cut-off lever striking a fat-faced object which then passed across the inner face of the lever in an aft-to-forward direction. A similar, much smaller area of damage was found on the lower inner corner of the lever, consistent with the corner striking a fat face which then passed across the inner face of the lever in a forward-to-aft direction. No such damage was found on the right engine fuel cut-off lever. Examination of the left throttle cut-off gate identified an area of mechanical

Throttle quadrant post-impact on VP-BGE

damage and a faint witness mark, running parallel to the direction of throttle movement, on the forward corner and outer face of the gate (furthest from the throttle lever). These were consistent with an object striking the corner which then passed across the outer face of the gate. No such damage was identified on the right throttle gate.

A review of the Approved Maintenance Schedule for the aircraft confirmed that there is no specific routine inspection of the condition of the fuel cut-off levers or their attachment to the engine throttles. The manufacturer confirmed that there had been no incidents of missing or failed fuel cut-off lever locating rivets reported to them since the Citation I had entered service.

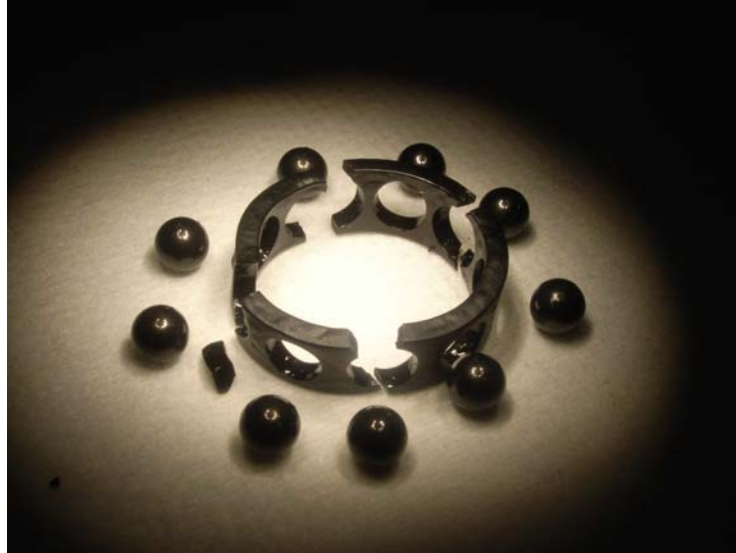
Figure 8

The ACM (air cycle machine) had been partially destroyed, but it was possible, after the removal of the remains of the compressor casing, to rotate the ACM compressor/turbine assembly. During rotation a small degree of roughness was felt through the shaft, which was initially believed to have been due to fire damage to the bearings.

The remains of the ACM were then disassembled and the bearings removed. There was evidence of light scoring and rubbing of the ACM compressor shroud. The compressor/turbine bearing was in good condition with all the balls and bearing cage intact. The ACM shaft was found to be blued in the region of the second bearing, indicating that it had been subject to elevated temperatures in operation. When the bearing was removed, the cage was found to have broken into five pieces, see Figure 8, with a small segment of it missing. The surface of the cage (a synthetic material) had also become distorted and blistered. Laboratory examination of the remains of the ACM revealed evidence of false brinelling on both sets of bearing raceways. False brinelling is a condition produced by subjecting bearings to vibration in a non-rotating condition. The false brinelling observed on the compressor/turbine bearing was evenly spaced at the pitch of the ball bearings, whereas the fan bearing exhibited both even and unevenly spaced false brinelling. Examination of the remains of the fan bearing cage showed evidence of uneven wear on the edges of the ball bearing pockets which was characteristic of the ACM having operated after the failure of the fan bearing cage. There was evidence of the initiation of spalling on several of the ball bearings and in some of the false brinelling marks on the raceways. There was no evidence to indicate that either bearing had been exposed to a lack of lubrication in operation.

Air cycle machine inlet fan bearing cage and rollers

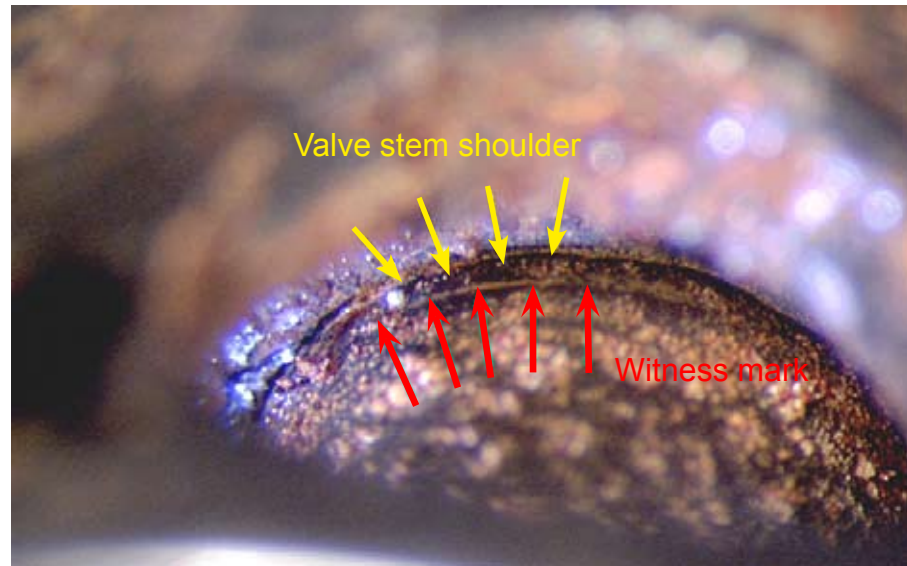
Figure 10

The FCU body had been damaged by fire which had destroyed the throttle input mechanism and exposed the remains of the fly weight governor, the torque tube, bellows ratio lever and the FCU bellows. The FCU drive coupling was intact. Examination of the FCU bellows confirmed that, although distorted, the bellows had retained their vacuum. All the rubber components and seals within the FCU had been destroyed and the fuel metering valve stem was seized within the valve sleeve. Section imaging of the fuel metering valve and valve sleeve was carried out to determine the position of the valve. The body of the metering valve was then cut using electro discharge machining (to minimise vibration of the valve) and the valve stem removed. Microscopic examination of the valve stem identified an impact mark on the conical portion of the valve which matched the profile of the corresponding metering orifice of the valve sleeve, (Figure 10).

Image of the metering section of the left FCU valve stem

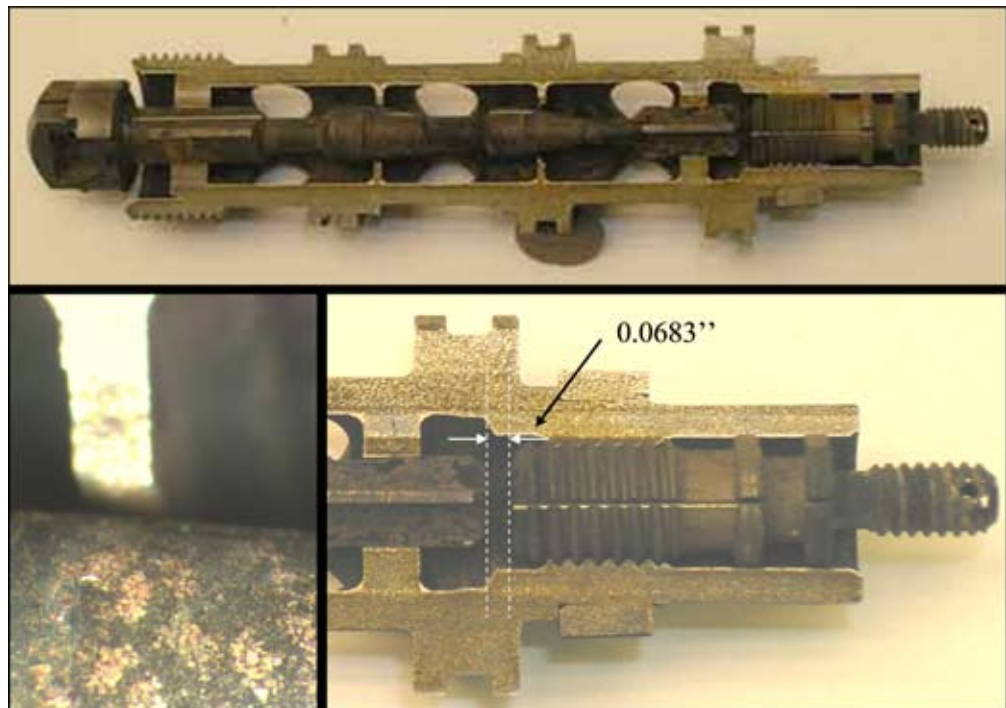
Figure 11

Alignment of the mark with the metering orifice indicated that in this position the valve was 0.0683 inches away from the minimum flow stop, (Figure 11). Data provided by the manufacturer confirmed that in this position the FCU would deliver a fuel flow of approximately 890 pph.

Sectioned left engine FCU metering valve

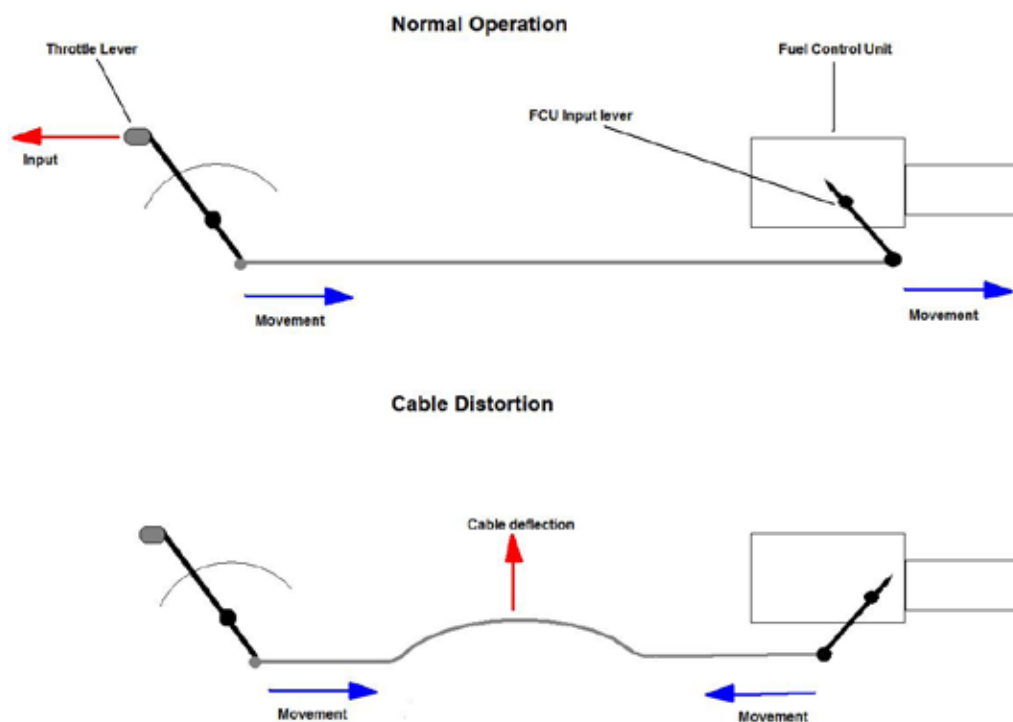
**Figure 16**

The layout of the engine controls within the aircraft is such that any distortion of the fuselage would tend to pull the ends of the engine control cables together. This load would result in a movement of the throttles towards the full thrust position and conversely a movement of the engine fuel control input levers towards the idle position, (Figure 16). This would explain why the thrust levers were found in the full power position but both engine N_2 speeds were similar and corresponded to a lower thrust lever position.

The effect of engine control cable distortion
