**Air Accidents Investigation Branch**

**Report on the accident to  
Cessna Citation 500  
registration VP-BGE  
2nm NNE of Biggin Hill Airport  
30 March 2008**

Published 21 May 2010

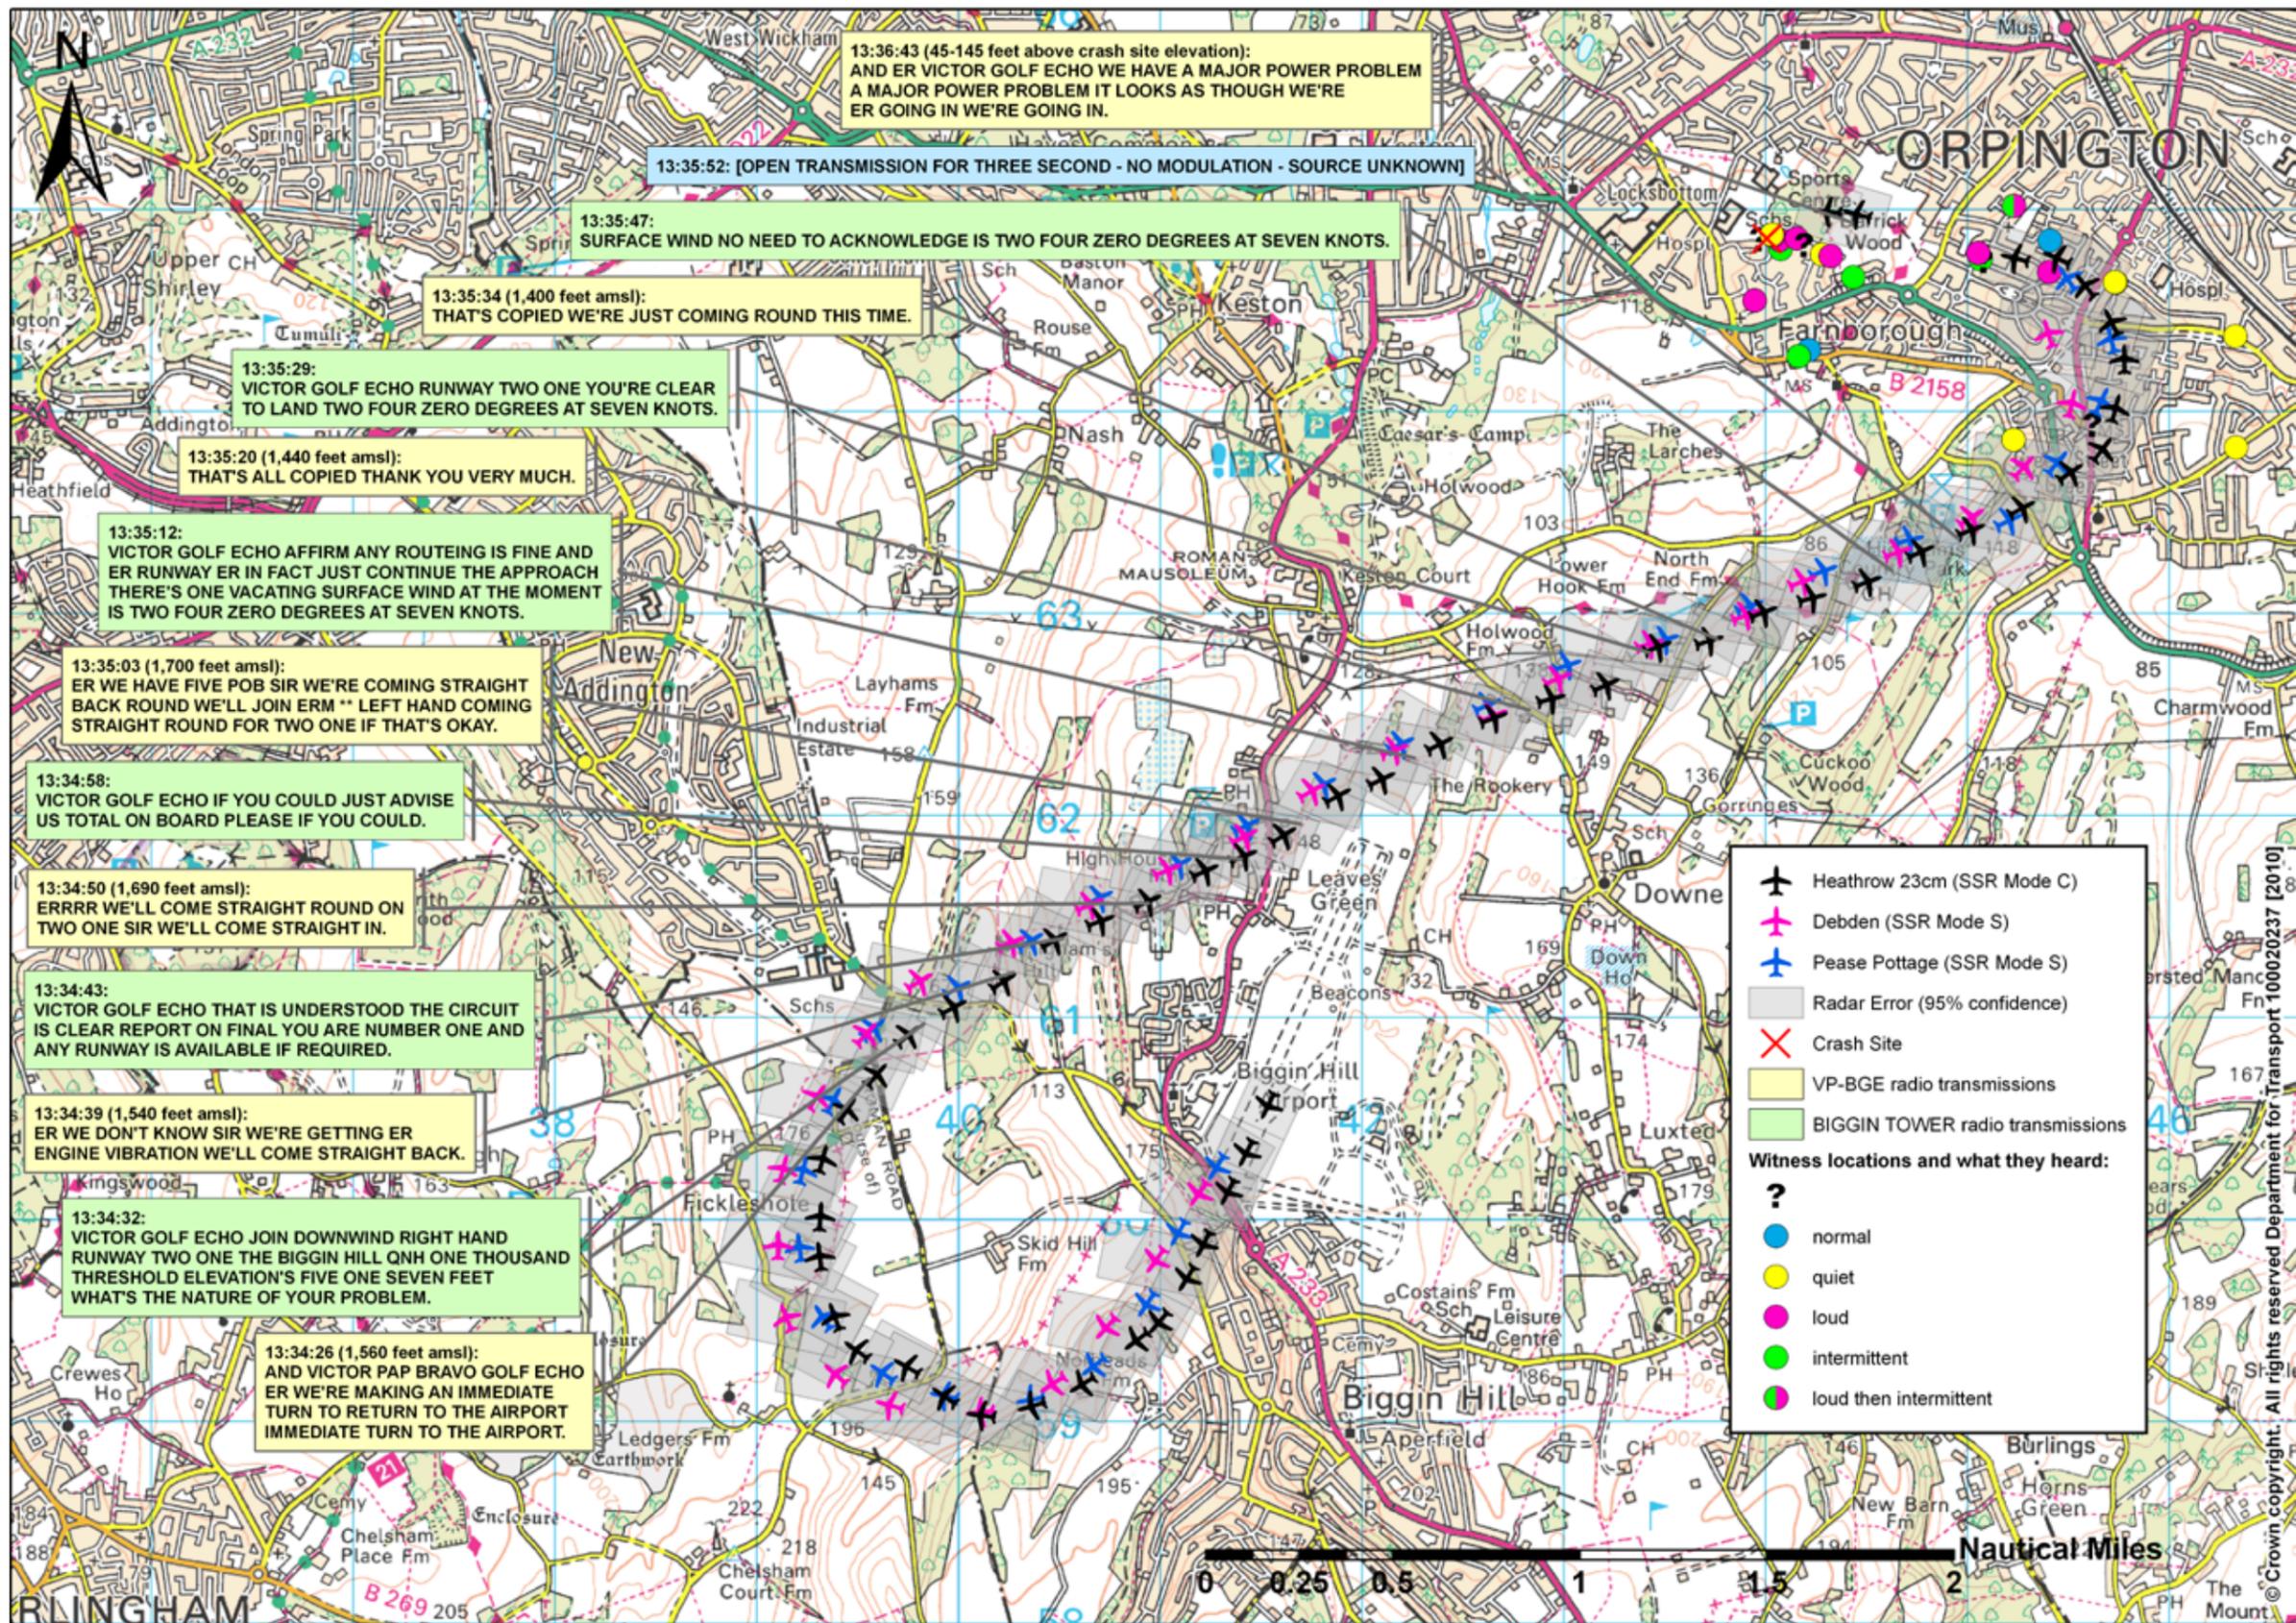
Figure 1  
Aircraft recorded flight path, transmissions and witness locations

Having flown over several houses at an extremely low height the aircraft’s left wing clipped a house which bordered a small area of woodland. The aircraft then impacted the ground between this and another house and caught fire. There were no injuries to anyone on the ground but all those on board the aircraft were fatally injured.

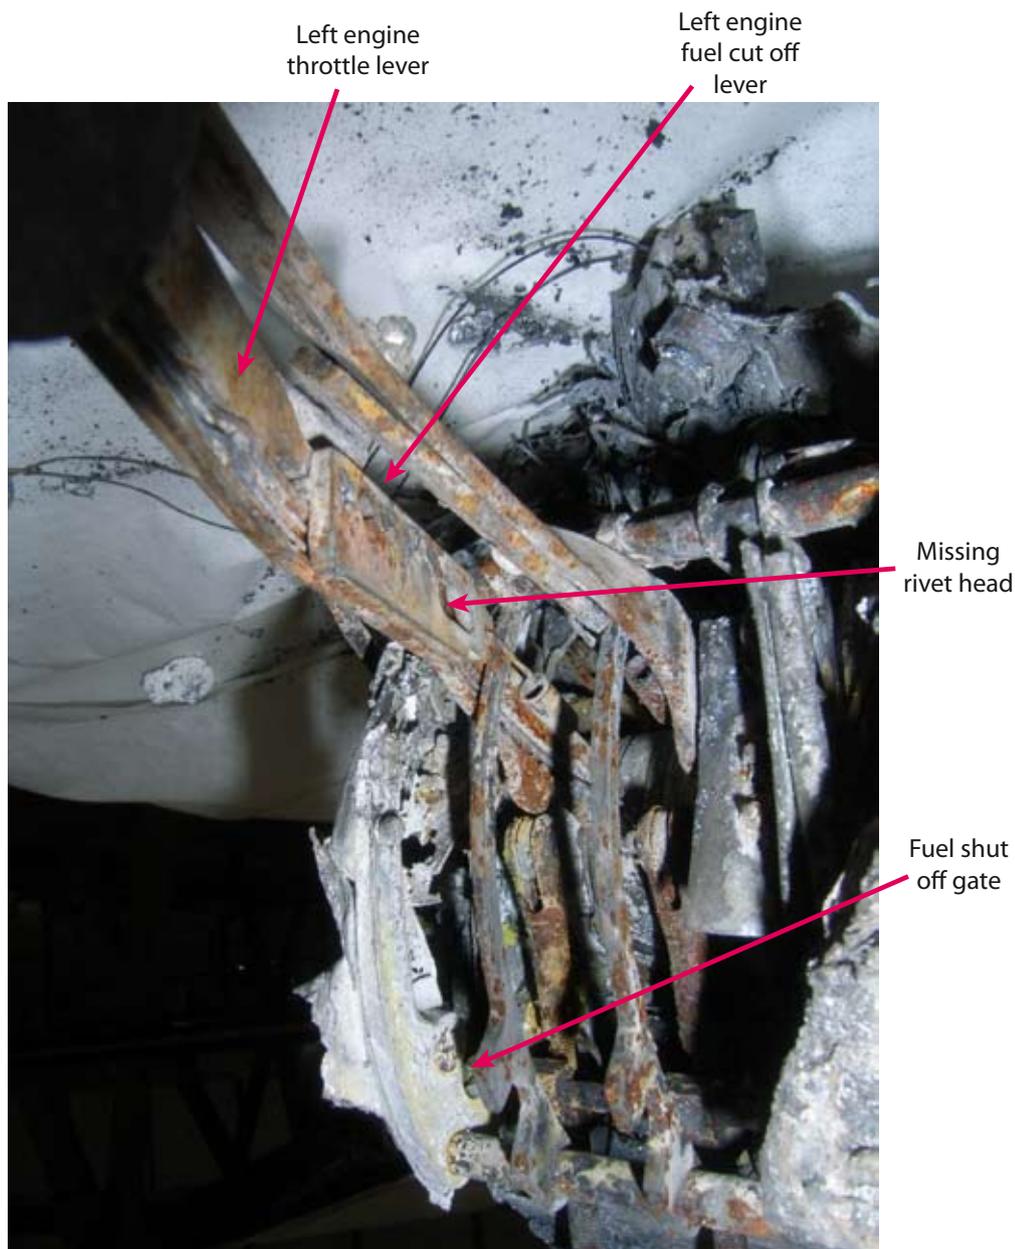
**Figure 7**

The continuity of the engine throttle cables was confirmed from the cockpit to each engine prior to wreckage recovery. Due to the break in the fuselage immediately behind the cockpit, both throttle cables, which ran adjacent to one another under the cabin floor, had been bent through approximately 25°. At the location of the bend, the outer section of the cable had been destroyed and the elements of the inner cable had opened out preventing movement of the cable. Both the left and right engine throttle levers were found in the forward (full thrust) position. Examination of the throttle levers showed that the head of the rivet used to retain the left engine fuel cut-off lever was missing (Figure 7).

Measurements taken from the throttles of another aircraft of the same type indicated that, with the rivet head missing, it is possible for the left engine fuel cut-off lever to pass across the inboard side of the fuel shut-off gate. The fracture surface of the remaining rivet shank had corroded as a result of its exposure to the fire fighting foam. This surface did, however exhibit characteristics of a failure in overload.

Inspection of the inner face (closest to the throttle lever) of the fuel cut-off lever showed the presence of corrosion products together with light scoring on the lower section of the inner face. The scoring was shallow, predominantly parallel to the movement path of the throttle and most pronounced on the lower rear section of the inner face of the cut-off lever. The scoring did not extend beyond the height of the fuel cut-off gate from the bottom of the lever. The scoring was inconsistent with the normal, vertical movement of the inner face of the cut-off lever against its associated throttle lever. In addition, an area of damage was identified on the rear inner corner of the cut-off lever which was consistent with the rear inner edge of the cut-off lever striking a flat-faced object which then passed across the inner face of the lever in an aft-to-forward direction. A similar, much smaller area of damage was found on the lower inner corner of the lever, consistent with the corner striking a flat face which then passed across the inner face of the lever in a forward-to-aft direction. No such damage was found on the right engine fuel cut-off lever. Examination of the left throttle cut-off gate identified an area of mechanical

Throttle quadrant post-impact on VP-BGE

damage and a faint witness mark, running parallel to the direction of throttle movement, on the forward corner and outer face of the gate (furthest from the throttle lever). These were consistent with an object striking the corner which then passed across the outer face of the gate. No such damage was identified on the right throttle gate.

A review of the Approved Maintenance Schedule for the aircraft confirmed that there is no specific routine inspection of the condition of the fuel cut-off levers or their attachment to the engine throttles. The manufacturer confirmed that there had been no incidents of missing or failed fuel cut-off lever locating rivets reported to them since the Citation I had entered service.

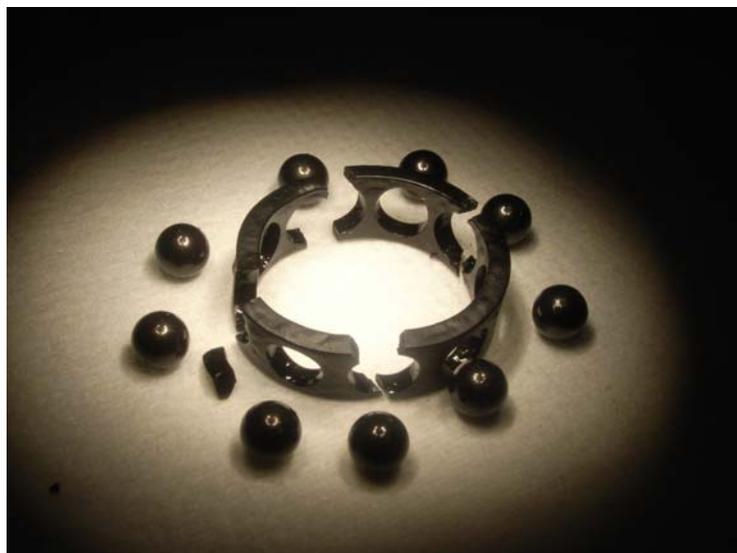
**Figure 8**

The ACM (air cycle machine) had been partially destroyed, but it was possible, after the removal of the remains of the compressor casing, to rotate the ACM compressor/turbine assembly. During rotation a small degree of roughness was felt through the shaft, which was initially believed to have been due to fire damage to the bearings.

The remains of the ACM were then disassembled and the bearings removed. There was evidence of light scoring and rubbing of the ACM compressor shroud. The compressor/turbine bearing was in good condition with all the balls and bearing cage intact. The ACM shaft was found to be blued in the region of the second bearing, indicating that it had been subject to elevated temperatures in operation. When the bearing was removed, the cage was found to have broken into five pieces, see Figure 8, with a small segment of it missing. The surface of the cage (a synthetic material) had also become distorted and blistered. Laboratory examination of the remains of the ACM revealed evidence of false brinelling on both sets of bearing raceways. False brinelling is a condition produced by subjecting bearings to vibration in a non-rotating condition. The false brinelling observed on the compressor/turbine bearing was evenly spaced at the pitch of the ball bearings, whereas the fan bearing exhibited both even and unevenly spaced false brinelling. Examination of the remains of the fan bearing cage showed evidence of uneven wear on the edges of the ball bearing pockets which was characteristic of the ACM having operated after the failure of the fan bearing cage. There was evidence of the initiation of spalling on several of the ball bearings and in some of the false brinelling marks on the raceways. There was no evidence to indicate that either bearing had been exposed to a lack of lubrication in operation.

Air cycle machine inlet fan bearing cage and rollers

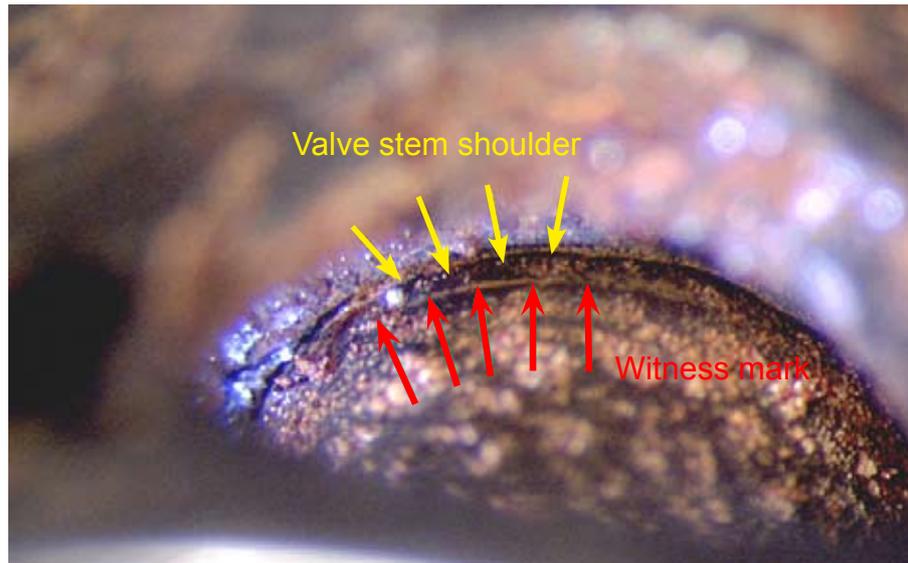
**Figure 10**

The FCU body had been damaged by fire which had destroyed the throttle input mechanism and exposed the remains of the fly weight governor, the torque tube, bellows ratio lever and the FCU bellows. The FCU drive coupling was intact. Examination of the FCU bellows confirmed that, although distorted, the bellows had retained their vacuum. All the rubber components and seals within the FCU had been destroyed and the fuel metering valve stem was seized within the valve sleeve. Section imaging of the fuel metering valve and valve sleeve was carried out to determine the position of the valve. The body of the metering valve was then cut using electro discharge machining (to minimise vibration of the valve) and the valve stem removed. Microscopic examination of the valve stem identified an impact mark on the conical portion of the valve which matched the profile of the corresponding metering orifice of the valve sleeve, (Figure 10).

Image of the metering section of the left FCU valve stem

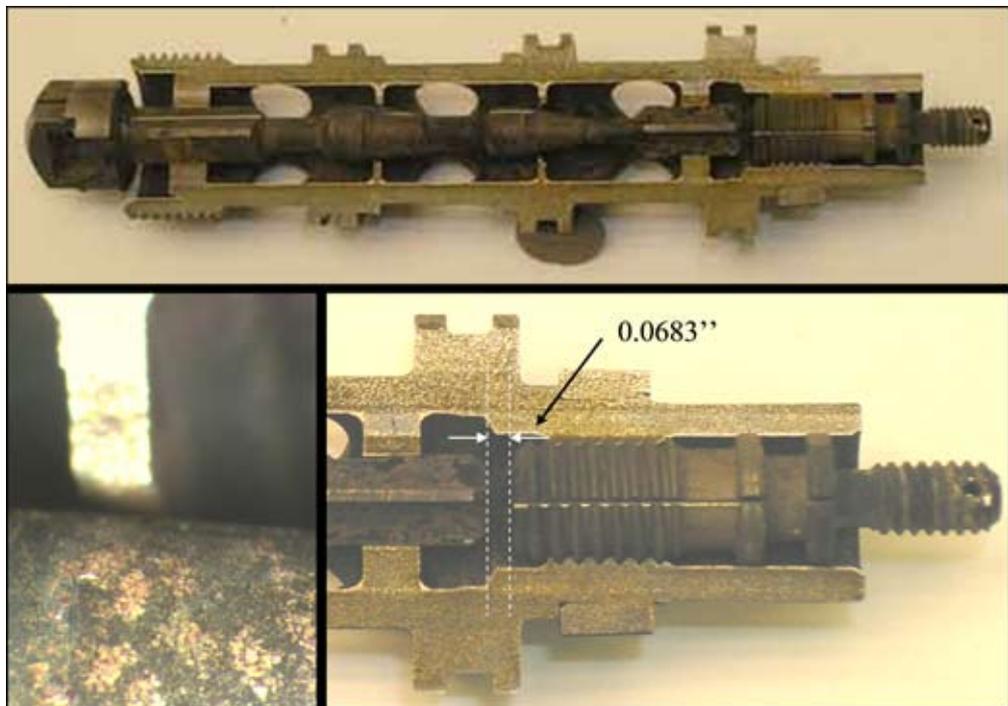
**Figure 11**

Alignment of the mark with the metering orifice indicated that in this position the valve was 0.0683 inches away from the minimum flow stop, (Figure 11). Data provided by the manufacturer confirmed that in this position the FCU would deliver a fuel flow of approximately 890 pph.

Sectioned left engine FCU metering valve

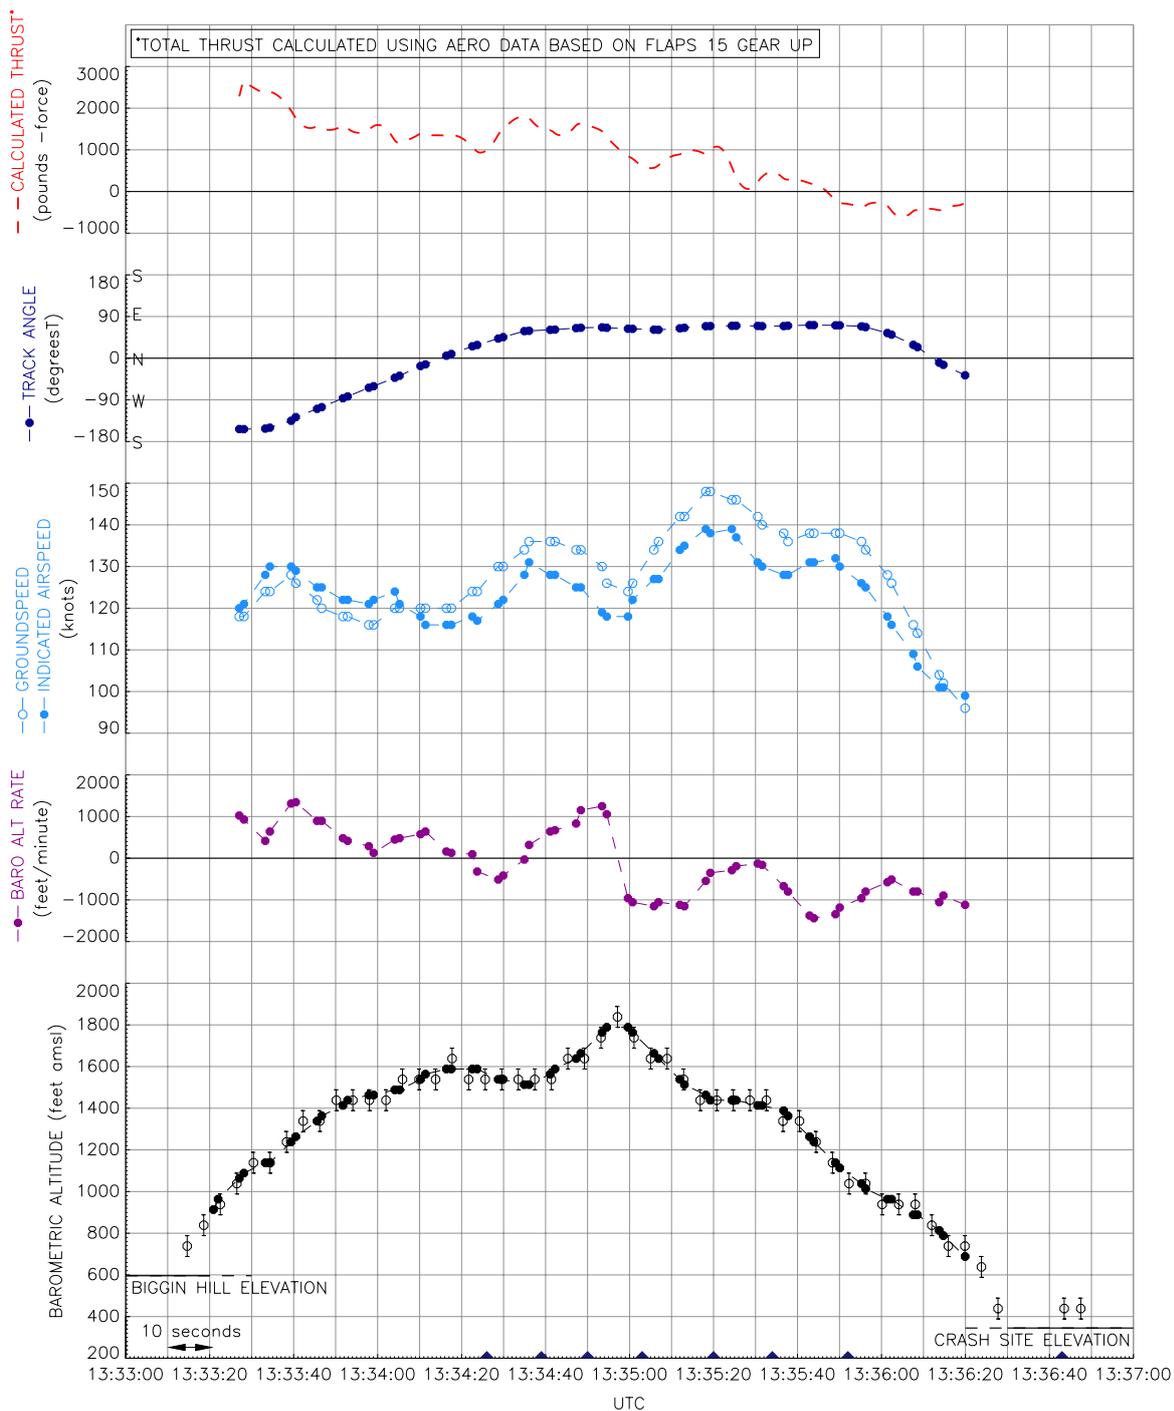
**Figure 13**  
Accident flight thrust prediction

The thrust predictions made using this direct method are plotted in Figure 13 (flaps 15, gear up). The low sample rate (ie two points every six seconds) and the position uncertainty of the Mode S data introduce unrealistic noise and discontinuities in performance calculations based on this data. To reduce these effects, a smooth track was computed by first calculating true airspeed from the recorded Mode S indicated airspeed and weather information, and selecting winds such that the integration of the true airspeed vector plus the wind vector resulted in a track that closely matched the track recorded by the radar.

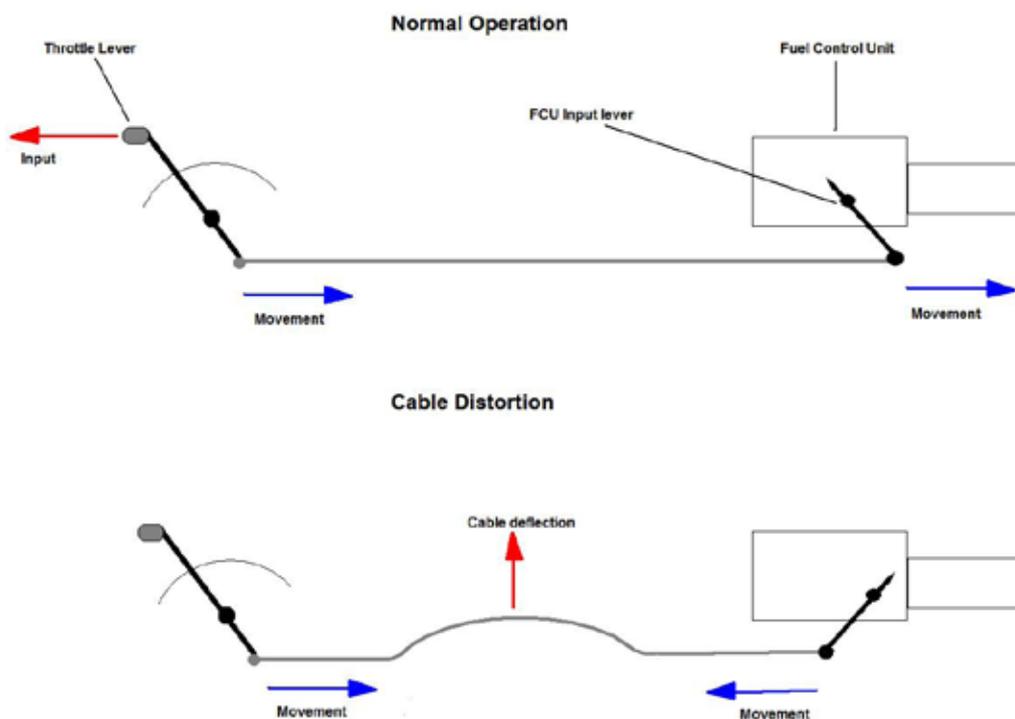
**Figure 16**

The layout of the engine controls within the aircraft is such that any distortion of the fuselage would tend to pull the ends of the engine control cables together. This load would result in a movement of the throttles towards the full thrust position and conversely a movement of the engine fuel control input levers towards the idle position, (Figure 16). This would explain why the thrust levers were found in the full power position but both engine  $N_2$  speeds were similar and corresponded to a lower thrust lever position.

The difference between the recorded left engine  $N_1$  of 44% and the right engine fan speed of 55% is thought to be due to the damage and subsequent rubbing of the left engine fan blades on the fan shroud as a result of the damage sustained when the aircraft's left wing struck the house.

The effect of engine control cable distortion
