**AIRCRAFT ACCIDENT REPORT 2/2007**

**Air Accidents Investigation Branch**

**Report on the serious incident to  
Boeing 777-236, G-YMME  
on departure from London Heathrow Airport  
on 10 June 2004**

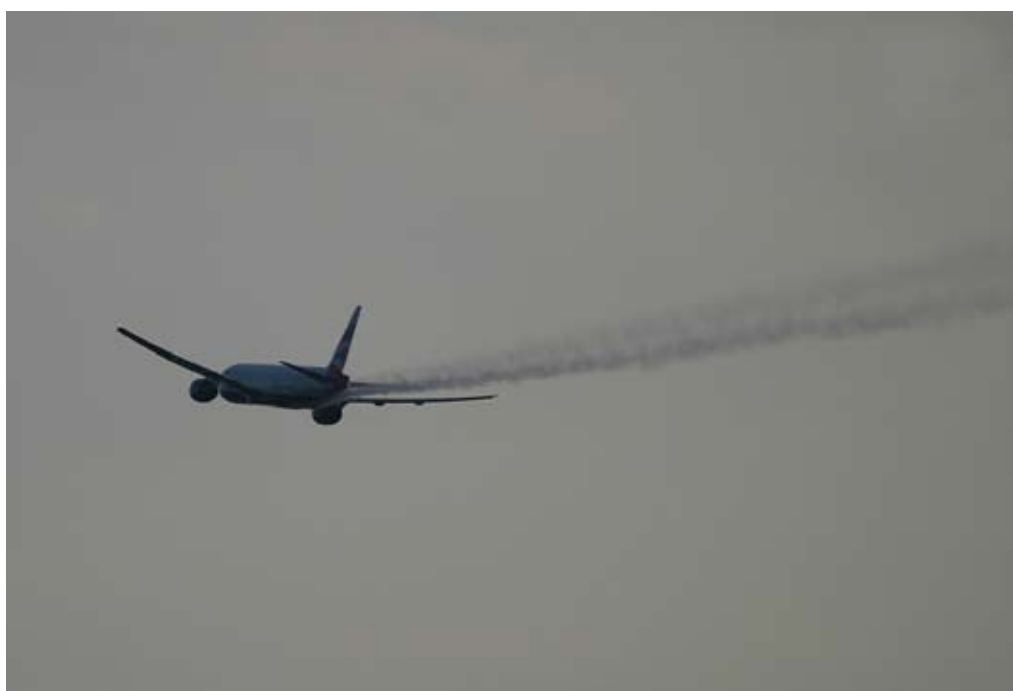
**Figure 1**

Fuel stream visible from G-YMME during departure from Heathrow  
(photo courtesy Steve Flint)

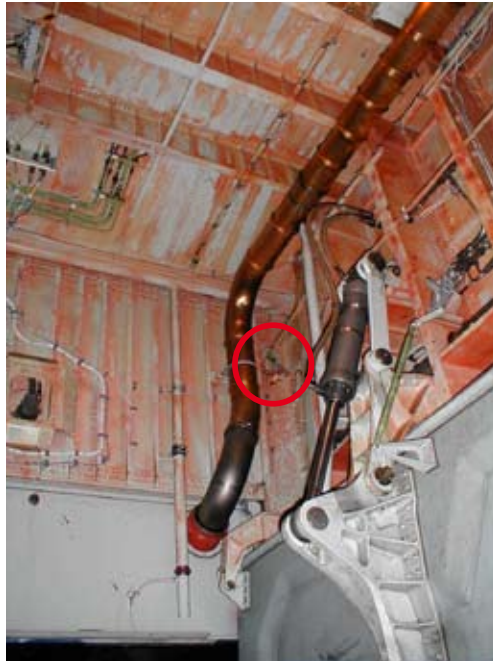
**Figure 2**

The fuel leak was caused by fuel escaping through an open purge door inside the left main landing gear bay, on the rear spar of the centre wing tank. The purge door had been removed during base maintenance at the operator's maintenance organisation in Cardiff, between 2 May and 10 May 2004, and had not been refitted prior to the aircraft's return to service.

View inside left main gear bay looking forward at the rear spar of the centre fuel tank. Purge door opening circled in red.

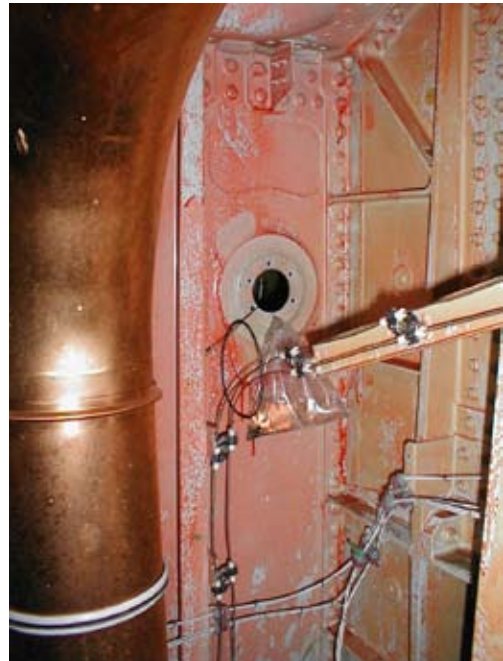
**Figure 3**

Purge door opening. Fuel and retaining bolts inside plastic bag. Purge door is hanging on a lanyard inside fuel tank. Purge door O-ring visible on lanyard.

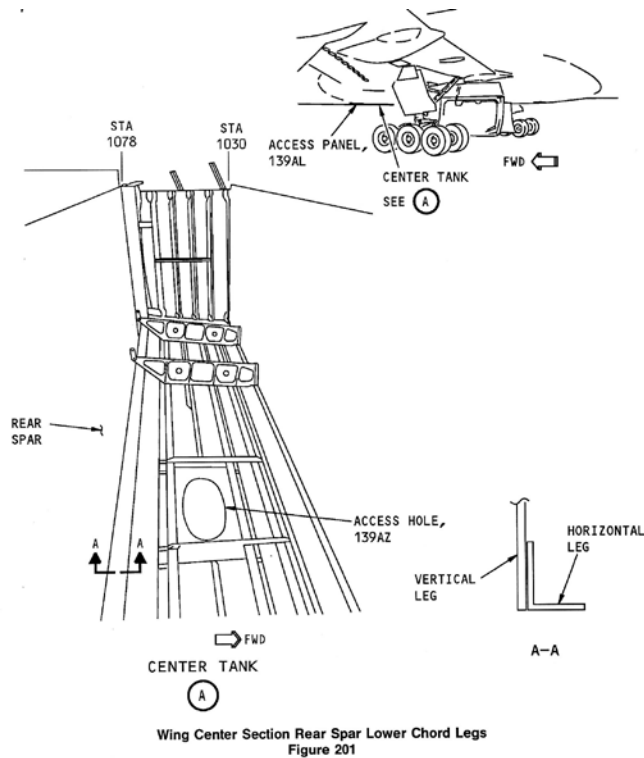
**Figure 10**

The ensuing instructions simply stated ‘*Do the inspection*’ and then the illustration depicted in Figure 10 followed. The AMM (also last revised 5 May 2003) contained the same instructions and the same diagram.

There are a number of errors in Figure 10 and these can best be visualised by comparing it to a corrected diagram in Figure 11. Both figures depict the forward section of the centre section of the CWT, but Figure 10 has the front spar incorrectly labelled as the rear spar, the STA (station) numbers are reversed and the FWD arrow in the lower diagram of Figure 10 points the wrong way. In Figure 10 the area shown to be inspected (A-A) is the lower section of the front spar but it could be interpreted to be the lower section of the forward spanwise beam due to the FWD arrow pointing the wrong way. A new diagram, Figure 12, clearly shows the aft section of the CWT and the area to be inspected on the rear spar.

Rear spar inspection diagram with errors (Rev 5 May 2003)  
(Copied with permission of The Boeing Company)

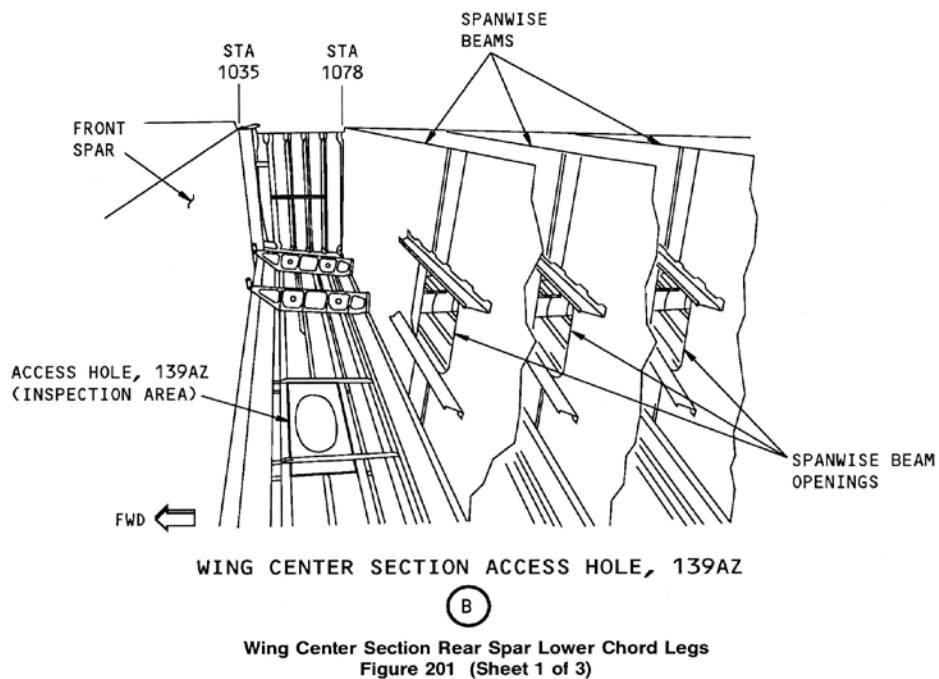
**Figure 11**

Revised diagram for rear spar inspection, part 1 (Rev 5 September 2004)  
(Copied with permission of The Boeing Company)

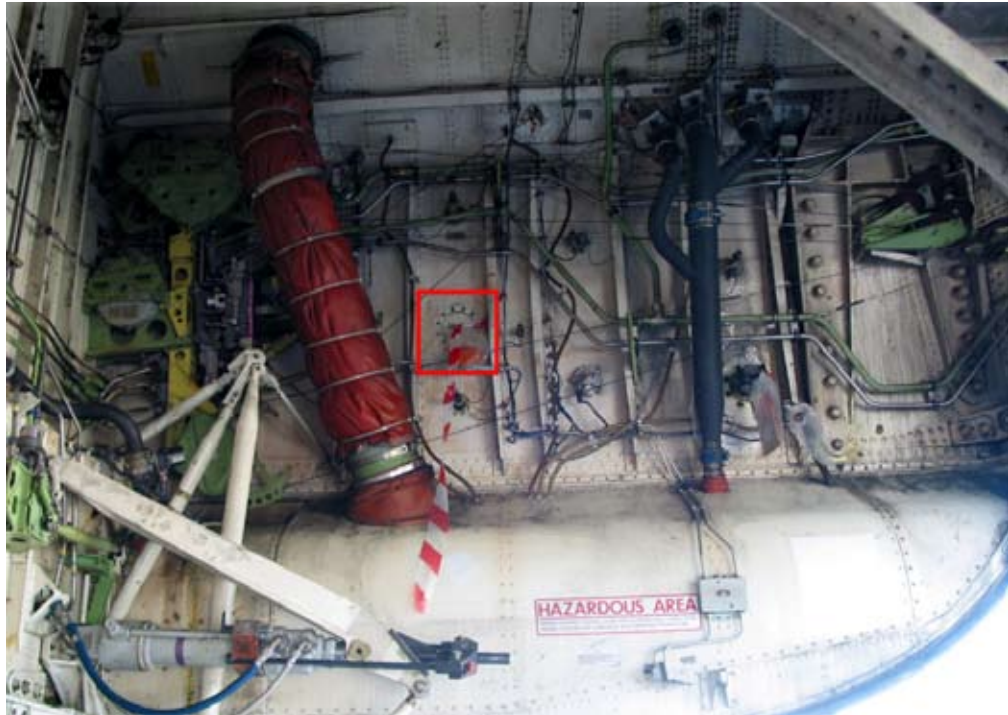
**Figure 14**

Boeing 747-400 purge door (highlighted by red box) with hazard tape
