## ACCIDENT

| <b>Aircraft Type and Registration:</b> | Cyclone AX2000, G-MZJR | |
| <b>Information Source:</b> | AAIB Field Investigation | |

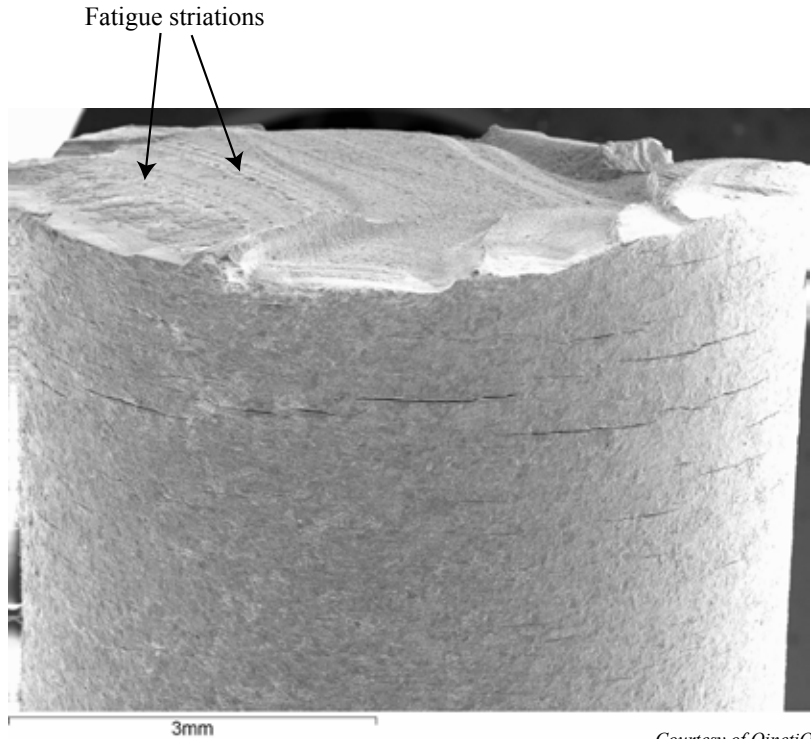
**Figure 1**

Examination of the aircraft at the accident site indicated that the engine had seized due to an internal failure. The engine was taken to the manufacturer’s UK agent’s facility where, under AAIB supervision, a strip examination was carried out. This revealed that the head of one of the two exhaust valves in the No 1 (right) cylinder had separated from its stem and caused severe disruption and break-up of the piston, which had eventually resulted in the seizure of the engine. The cylinder head, complete with three intact valves and the failed valve stem, was submitted for specialist metallurgical examination.

The valves were cleaned using acetic acid in an ultrasonic bath to remove surface deposits prior to examination in a scanning electron microscope. The examination showed that the failure of the exhaust valve was the result of fatigue that had initiated from multiple origins in the valve stem. Examination of the stem in the region of the failure (Figure 1) highlighted thermally-generated corrosion, which provided the stress concentration to initiate fatigue.

It was noted that the microstructure of the valve material at the points of failure had been altered by the effects of temperature to a condition that was more susceptible to corrosion and hence fatigue initiation. The rate of such changes in microstructure is temperature dependent. Therefore, failure could occur prematurely in these valves if the operating temperature is higher than ‘normal’. However, even at ‘normal’ operating temperatures, it is expected that failure would eventually occur after many hours in service.

Failed exhaust valve stem showing secondary fatigue cracks

The engine failure was caused by the fracture of an exhaust valve due to a fatigue failure initiated by thermally-generated corrosion. This could occur if the valve had been operating above the material's maximum operating temperature, or for a time in excess of the valves recommended operating life, or a combination of the two. The engine manufacturer recommended that all valves be replaced at overhaul. This particular engine should have been overhauled every 300 hours or 5 years. However, at the time of the accident the valves in the No 1 (right) cylinder had completed 544 operating hours and 6 years 7 months had elapsed since fitment. The pilot, based on his experience with other, similar engine types, and the improved modification state of the engine, considered that an extension of the service life of this engine was justifiable.

The engine seizure was precipitated by the failure of an exhaust valve due to thermally-generated fatigue cracking in the valve stem. This was caused by operation of the engine beyond the manufacturer's recommended engine overhaul life of 300 hours or 5 years.
