ACCIDENT

Aircraft Type and Registration:	Maule MXT-7-180, G-BZDT	
No & Type of Engines:	1 Lycoming O-360-C1F piston engine	
Category:	1.3	
Year of Manufacture:	2000	
Date & Time (UTC):	25 October 2005 at 1700 hrs	
Location:	Portadown, Northern Ireland	
Type of Flight:	Private	
Persons on Board:	Crew - 1	Passengers - None
Injuries:	Crew - 1 (Minor)	Passengers - N/A
Nature of Damage:	Aircraft damaged beyond economic repair	
Commander's Licence:	Private Pilot's Licence	
Commander's Age:	42 years	
Commander's Flying Experience:	480 hours (of which 290 were on type) Last 90 days - 60 hours Last 28 days - 45 hours	
Information Source:	Aircraft Accident Report Form submitted by the pilot

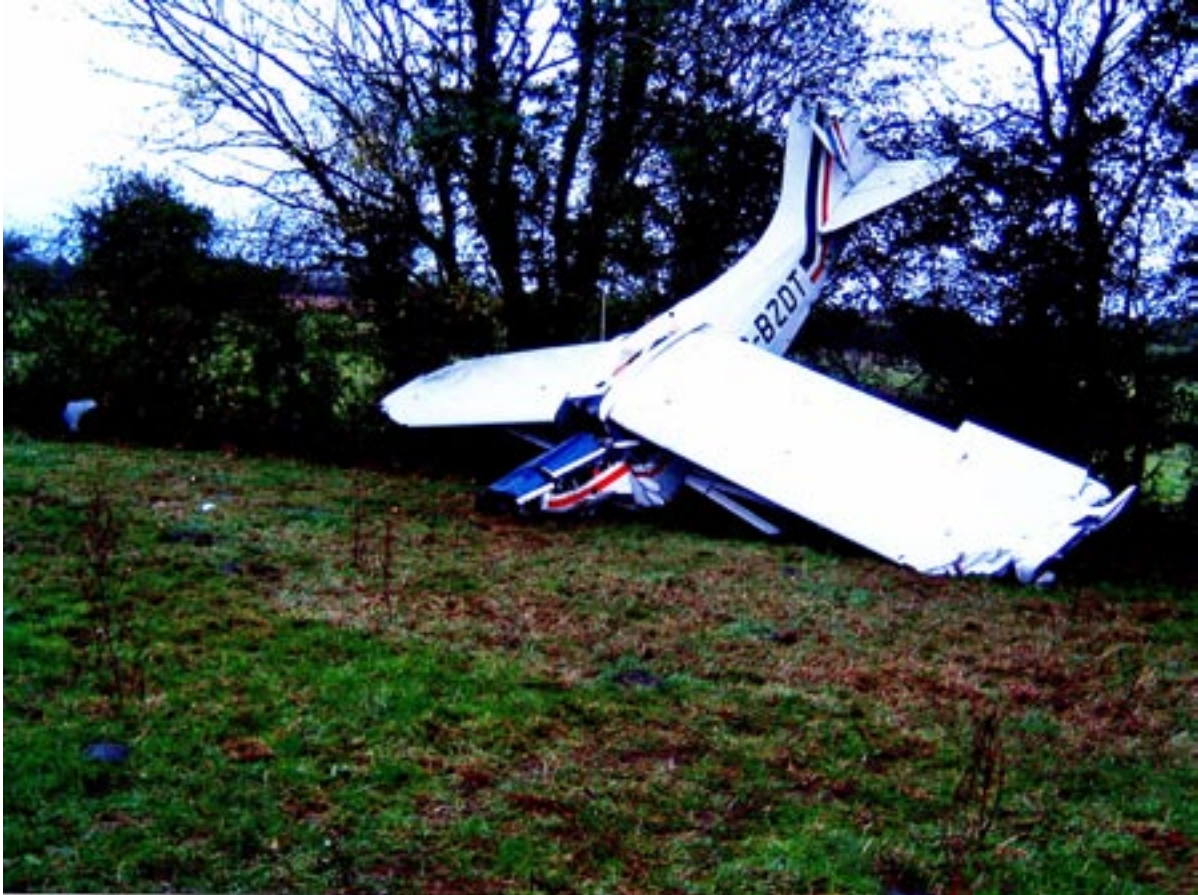
Figure 1

attempt to climb away. However, an uncommanded roll to the left led to a nose low attitude and the left wing and propeller struck the ground before control could be regained. The aircraft then cart wheeled onto its right wing before coming to rest against some trees. The pilot, who was wearing a lap and diagonal harness, was rendered unconscious for a short period before vacating the aircraft without assistance.
