No: 2/92

Ref: EW/C91/10/1

Aircraft Type and Registration:	Boeing 737-230, D-ABHU	
No & Type of Engines:	2 JT8D-15 turbofan engines	
Year of Manufacture:	1981	
Date & Time (UTC):	5 October 1991 at 1013 hrs	
Location:	London Heathrow Airport	
Type of Flight:	Public Transport	
Persons on Board:	Crew - 6	Passengers - 88
Injuries:	Crew - None	Passengers - None
Nature of Damage:	Nose dome detached from No. 2 engine	
Commander's Licence:	German Airline Transport Pilot's Licence	
Commander's Age:	39 years	
Commander's Flying Experience:	6,000 hours (of which 803 were on type)	
Information Source:	AAIB Field Investigation

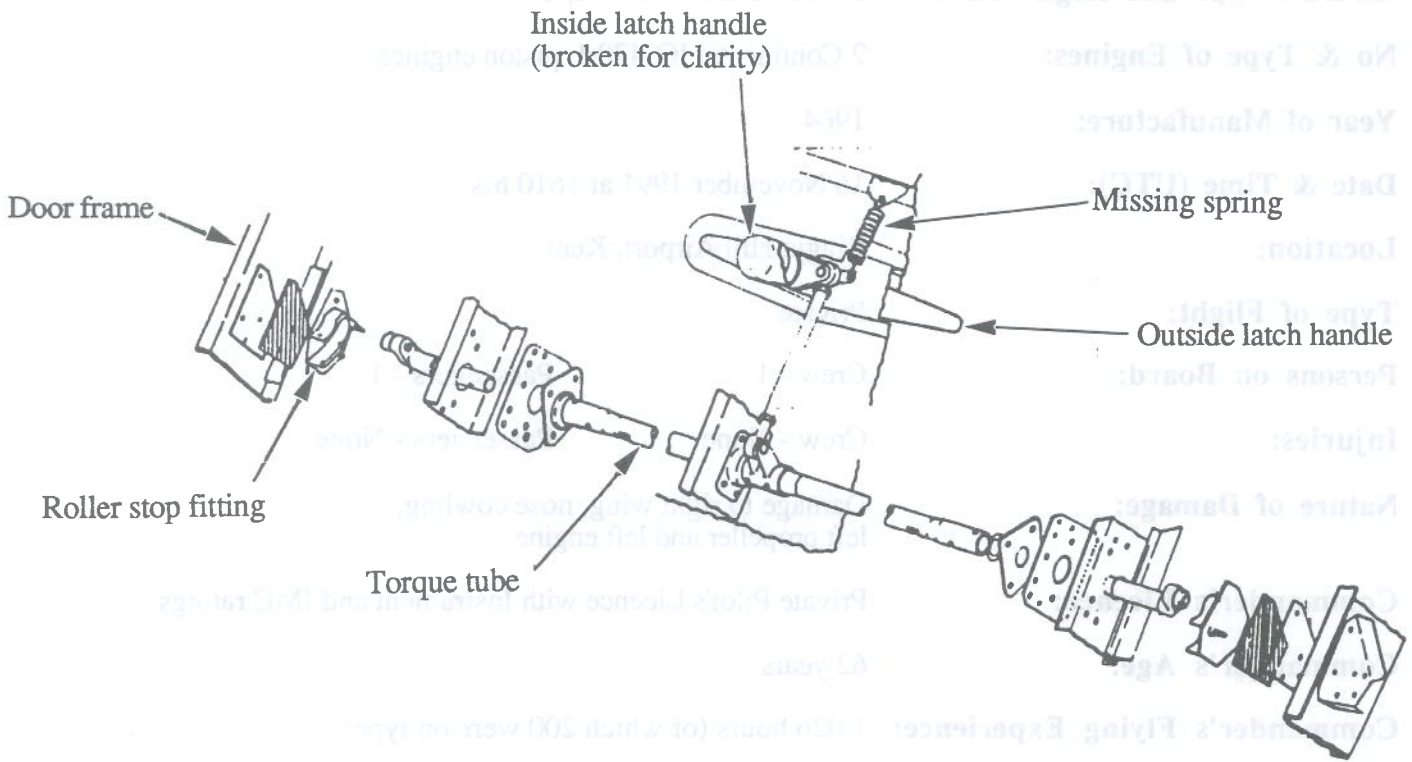
A rigging and door indication check revealed no abnormalities but, when the internal trim was removed, it was found that the spring, whose part number is quoted above, was missing. This meant that the inner handle could be actuated using only very light finger pressure. There was no sign of the spring and it appeared that it had not been fitted. The last time this area had been accessed for maintenance was reported to be January 1991.

Thus it appeared that buffeting of the airframe due to the engine surges had caused the door to become unlocked and gave the crew the warning caption in the cockpit. It was unlikely that the door had actually opened until after the aircraft had landed. The reason why this latent defect in the door mechanism had not manifested itself earlier, perhaps after a firm landing, remains unclear.

D-ABHU forward cargo door latching mechanism showing location of missing spring.
