**ACCIDENT**

<b>Aircraft Type and Registration:</b>	Avions Pierre Robin DR400-180, F-GDYD	
<b>No &amp; Type of Engines:</b>	1 Lycoming O-360-A3A piston engine	
<b>Year of Manufacture:</b>	1984	
<b>Date &amp; Time (UTC):</b>	19 July 2008 at 1337 hrs	
<b>Location:</b>	Llanfihangel Glyn Myfyr, near Corwen, North Wales	
<b>Type of Flight:</b>	Private	
<b>Persons on Board:</b>	Crew - 2	Passengers - None
<b>Injuries:</b>	Crew - 2 (Serious)	Passengers - N/A
<b>Nature of Damage:</b>	Substantial	
<b>Commander's Licence:</b>	Private Pilot's Licence	
<b>Commander's Age:</b>	67 years	
<b>Commander's Flying Experience:</b>	871 hours (of which 440 were on type) Last 90 days - 41 hours Last 28 days - 16 hours	
<b>Information Source:</b>	AAIB Field Investigation

**Synopsis**

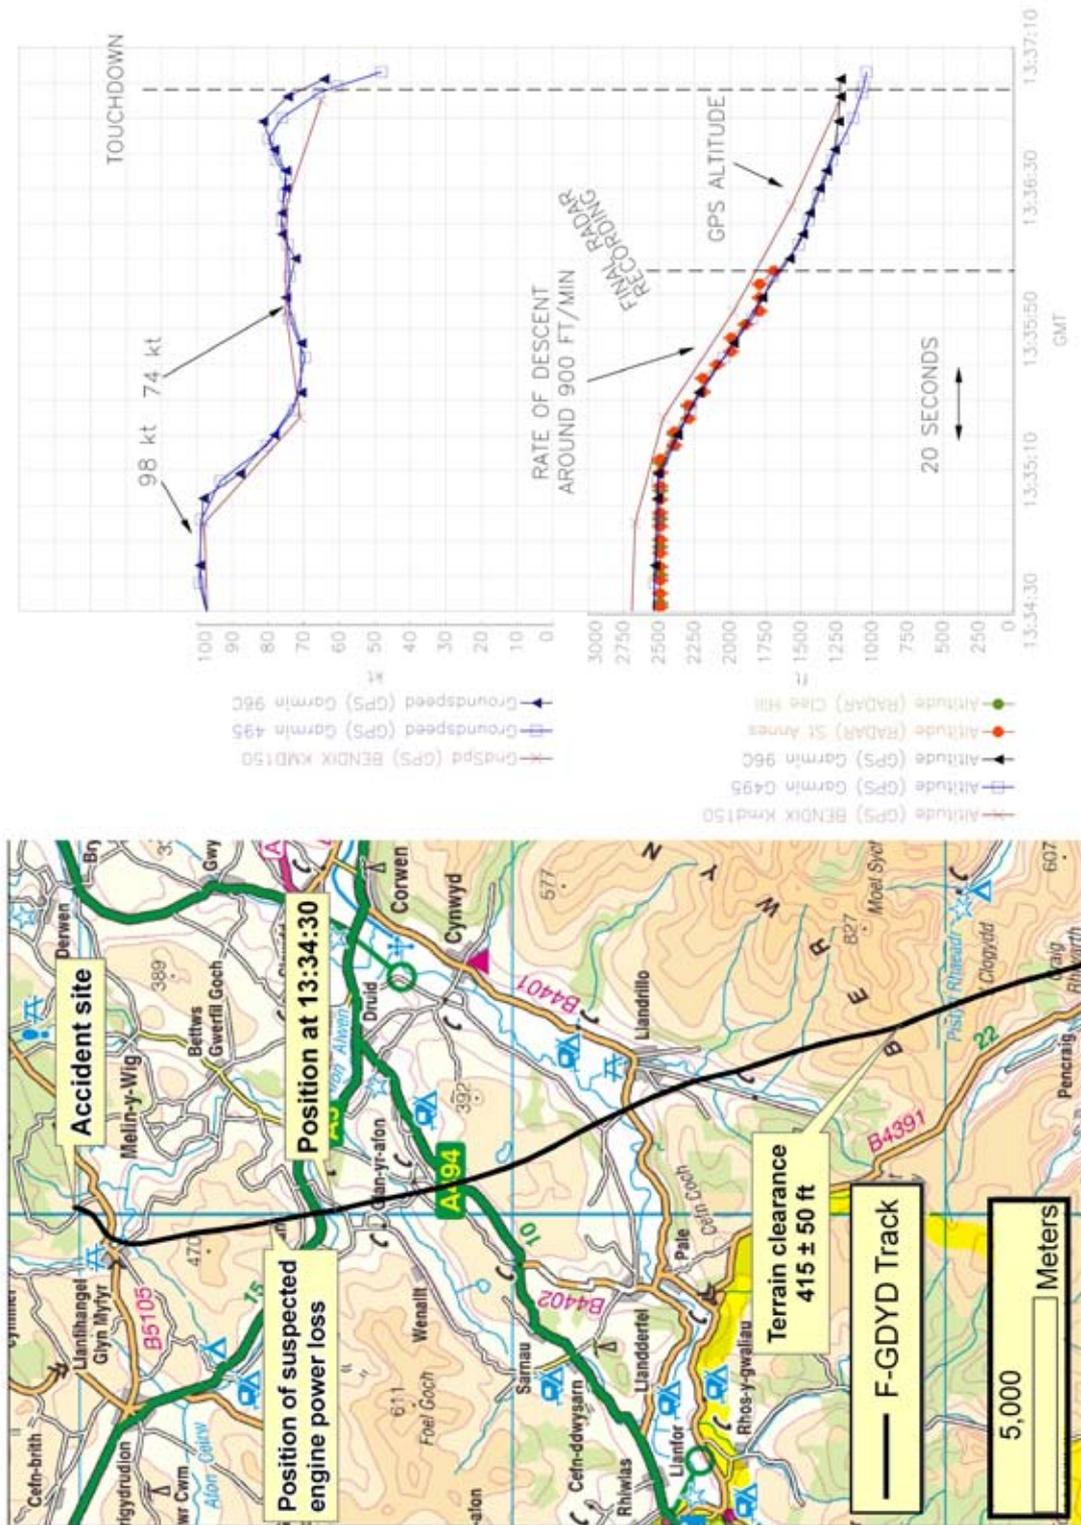
Figure 1  
F-GDYD GPS and radar data<sup>1</sup>

At 13:27:23 hrs, the aircraft was 15 track nm from the accident site at an altitude of 3,300 ft amsl. Over the next eight minutes, the aircraft gradually descended to an altitude of 2,500 ft, passing over an area of rising ground in North Wales. At one stage, over the undulating terrain, the aircraft was  $415 \pm 50$  ft agl.

At 13:35:07 hrs, the GPS derived groundspeed showed the aircraft speed starting to decay from 98 kt. This is the point at which it was suspected that loss of engine power occurred. Nine seconds later, recorded radar data confirmed that the aircraft began to descend from 2,500 ft amsl.

Airspeed and altitude continued to decrease for about 35 seconds following the suspected loss of engine power. The groundspeed then appeared to stabilise at approximately 74 kt, while the recorded radar and GPS altitudes suggested a rate of descent of about 900 ft/min. F-GDYD passed overhead Llanfihangel Glyn Myfyr at 13:36:28 hrs at a GPS altitude of between 1,375 ft and 1,530 ft amsl.

<sup>1</sup> Terrain elevations in this map are relative to the UK Ordnance Survey datum. Vertical clearances were calculated using radar altitudes by adjusting the terrain elevations to the WGS84 datum.
