**AAIB Bulletin No: 4/94**

**Ref: EW/G94/01/09**

**Aircraft Type and Registration:** Grumman AA-5B Tiger, G-PORK

**Nature of Damage:** Aileron outer bearing support brackets failed

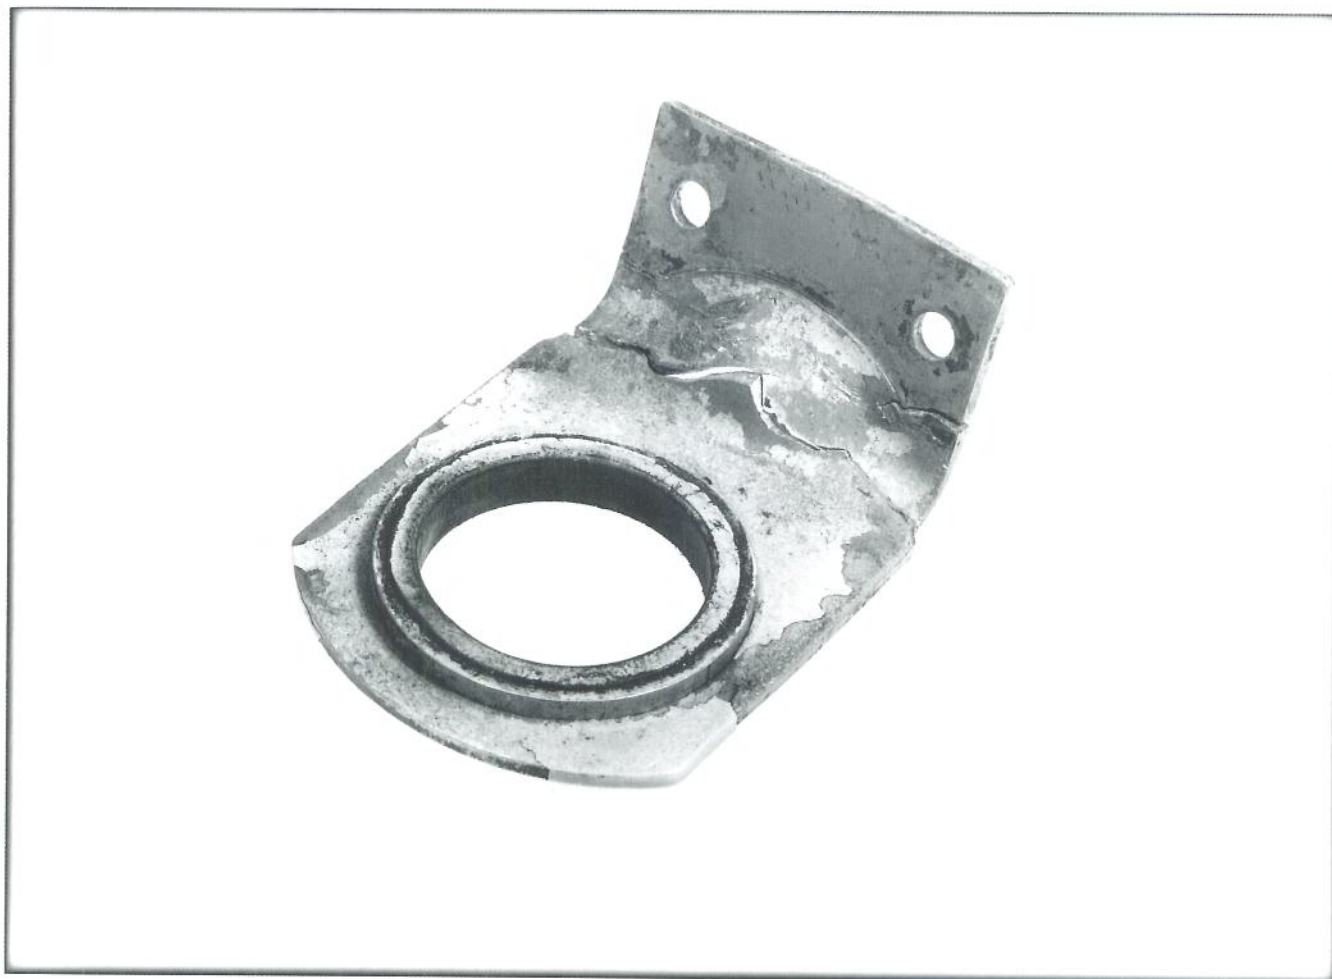
He immediately took control and reduced speed to about 80 kt whence the oscillation stopped. Informing Southampton ATC of their intention to return, an uneventful landing was subsequently achieved with the instructor reporting that the response to control inputs felt normal at all times. Examination showed that both left and right aileron outer bearing support brackets (Part No 902010-501) had failed completely (see photograph).

The owner of the aircraft immediately suspected that the failures were related to the fact that the aircraft had spent some time during the preceding days parked tail-to-wind in gale-force conditions. He reported that the control column gust lock had subsequently been found partially dislodged. Metallurgical examination confirmed that the fractures exhibited a high proportion of low-cycle/high strain fatigue characteristics consistent with a number of excessive load cycles being applied to the brackets.

**G-PORK Photograph of failed aileron outer bearing support bracket**
