| <b>Aircraft Type and Registration:</b> | 1) Robinson R22 Beta, G-LIDS<br>2) Hybred 44XLR, G-MTJP |
| <b>Date &amp; Time (UTC):</b> | 6 July 2004 at 1154 hrs |
| <b>Location:</b> | Overhead Welham Green, Hertfordshire |

### Synopsis

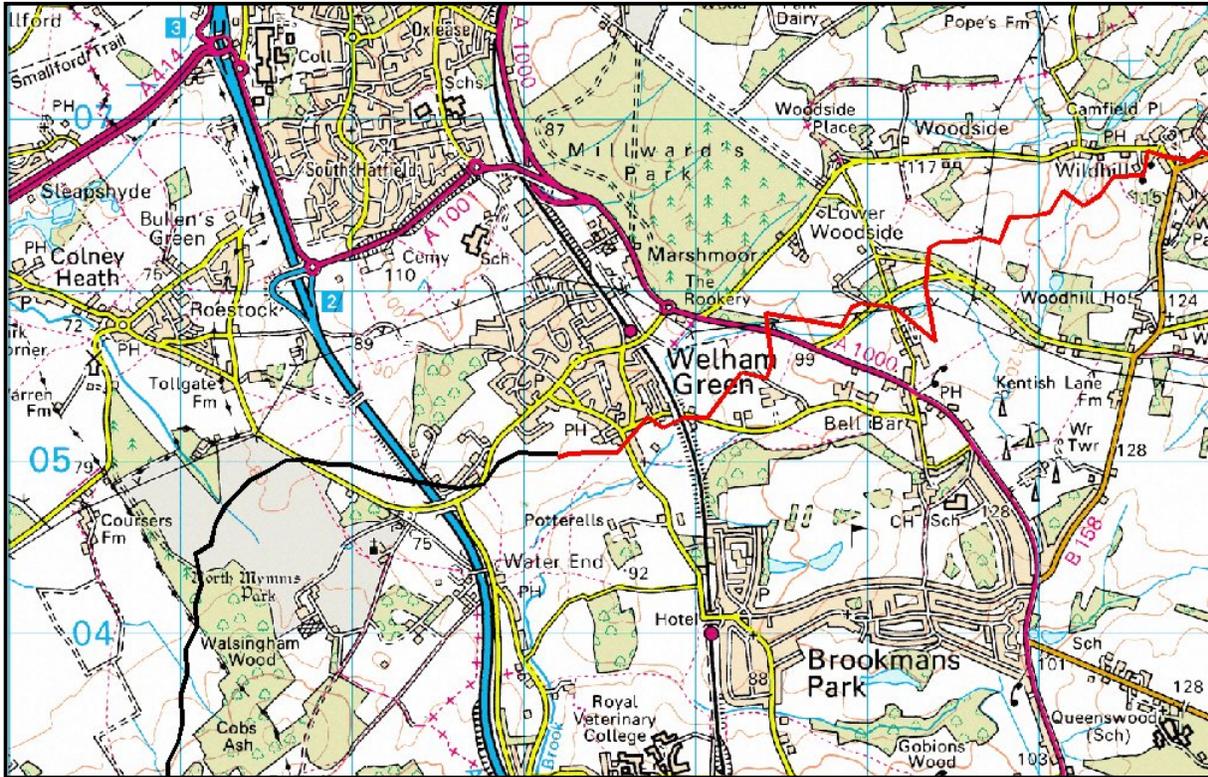
Both aircraft were being operated VFR in good VMC at about 1,200 feet on the QNH. The radar data recorded from the Stansted radar head, showed the microlight was generally tracking 245°T at a ground speed of 65 kt. This was confirmed by a number of witnesses just prior to the collision who saw the aircraft holding a constant heading in a level attitude and maintaining what appeared to be a constant height. The radar tracks are overlaid on the map included at Figure 1. The slightly oscillatory nature of the aircraft tracks, particularly the microlight track, results from the limitations of the radar recording.

When the R22 rolled out of its gentle right turn at about 1,500 feet the aircraft were approximately 1 nm apart and some 30 seconds from the collision. From that moment onwards they were heading towards each other with nearly constant relative bearings of 085°/265° creating virtually a 'head-on' collision. There was no obstruction of any significance between the two aircraft to prevent them seeing each other.

**Figure 1 - Radar tracks of microlight G-MTJP (in red) and helicopter G-LIDS (in black)**

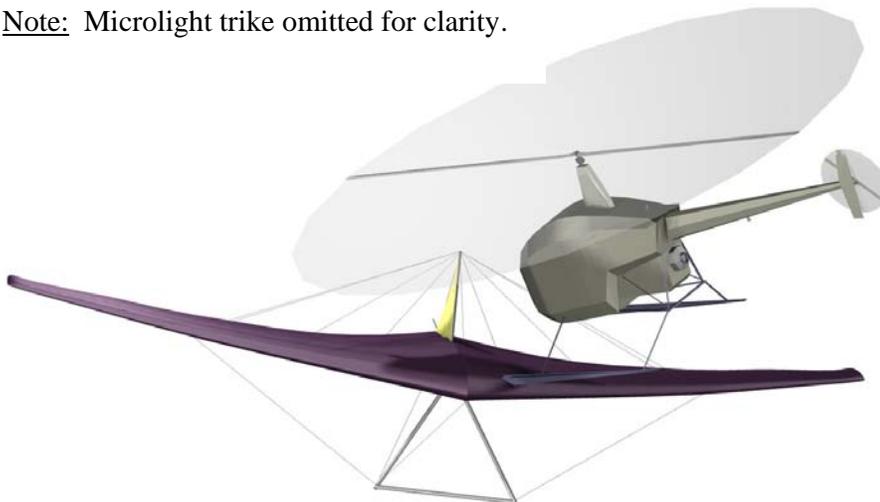
The sum total of the evidence led to a 'best fit' of the parts of each aircraft that came into contact in the air, which in turn suggested that the R22 was banked approximately 30° to the left, relative to the microlight, on a relative heading of around 135°. This is represented graphically in Figure 2 where it can be seen that the helicopter's left skid would contact the left inboard leading edge of the microlight wing, with the right skid remaining clear of the left wing rigging wires. From this position, the helicopter's nose would go on to brush the wing upper surface, with the main rotor cutting into the right tip. It was not clear how all but one of the upper surface wing wires escaped being damaged, although the effect of the impact on the leading edge may have resulted in an instantaneous loss of tension, causing them to droop out of the way.

It must be stressed however that the illustration is a 'best fit' approximation and the relative attitude of the ensemble to the horizon is not known.

Note: Microlight trike omitted for clarity.

**Figure 2 - Representation of the two aircraft immediately prior to impact**
