ACCIDENT

Aircraft Type and Registration:	DHC-8-402 Dash 8, G-ECOZ
No & Type of Engines:	2 Pratt & Whitney Canada PW150A turboprop engines
Year of Manufacture:	2001
Date & Time (UTC):	1 November 2009 at 0949 hrs
Location:	London Gatwick Airport
Type of Flight:	Commercial Air Transport (Passenger)
Persons on Board:	Crew - 4 Passengers - 42
Injuries:	Crew - None Passengers - None
Nature of Damage:	Tailstrike, aircraft skin abraded and fuselage frames deformed. Runway surface damaged
Commander's Licence:	Airline Transport Pilot's Licence
Commander's Age:	47 years
Commander's Flying Experience:	10,260 hours (of which 902 were on type) Last 90 days - 180 hours Last 28 days - 50 hours
Information Source:	AAIB Field Investigation

Synopsis

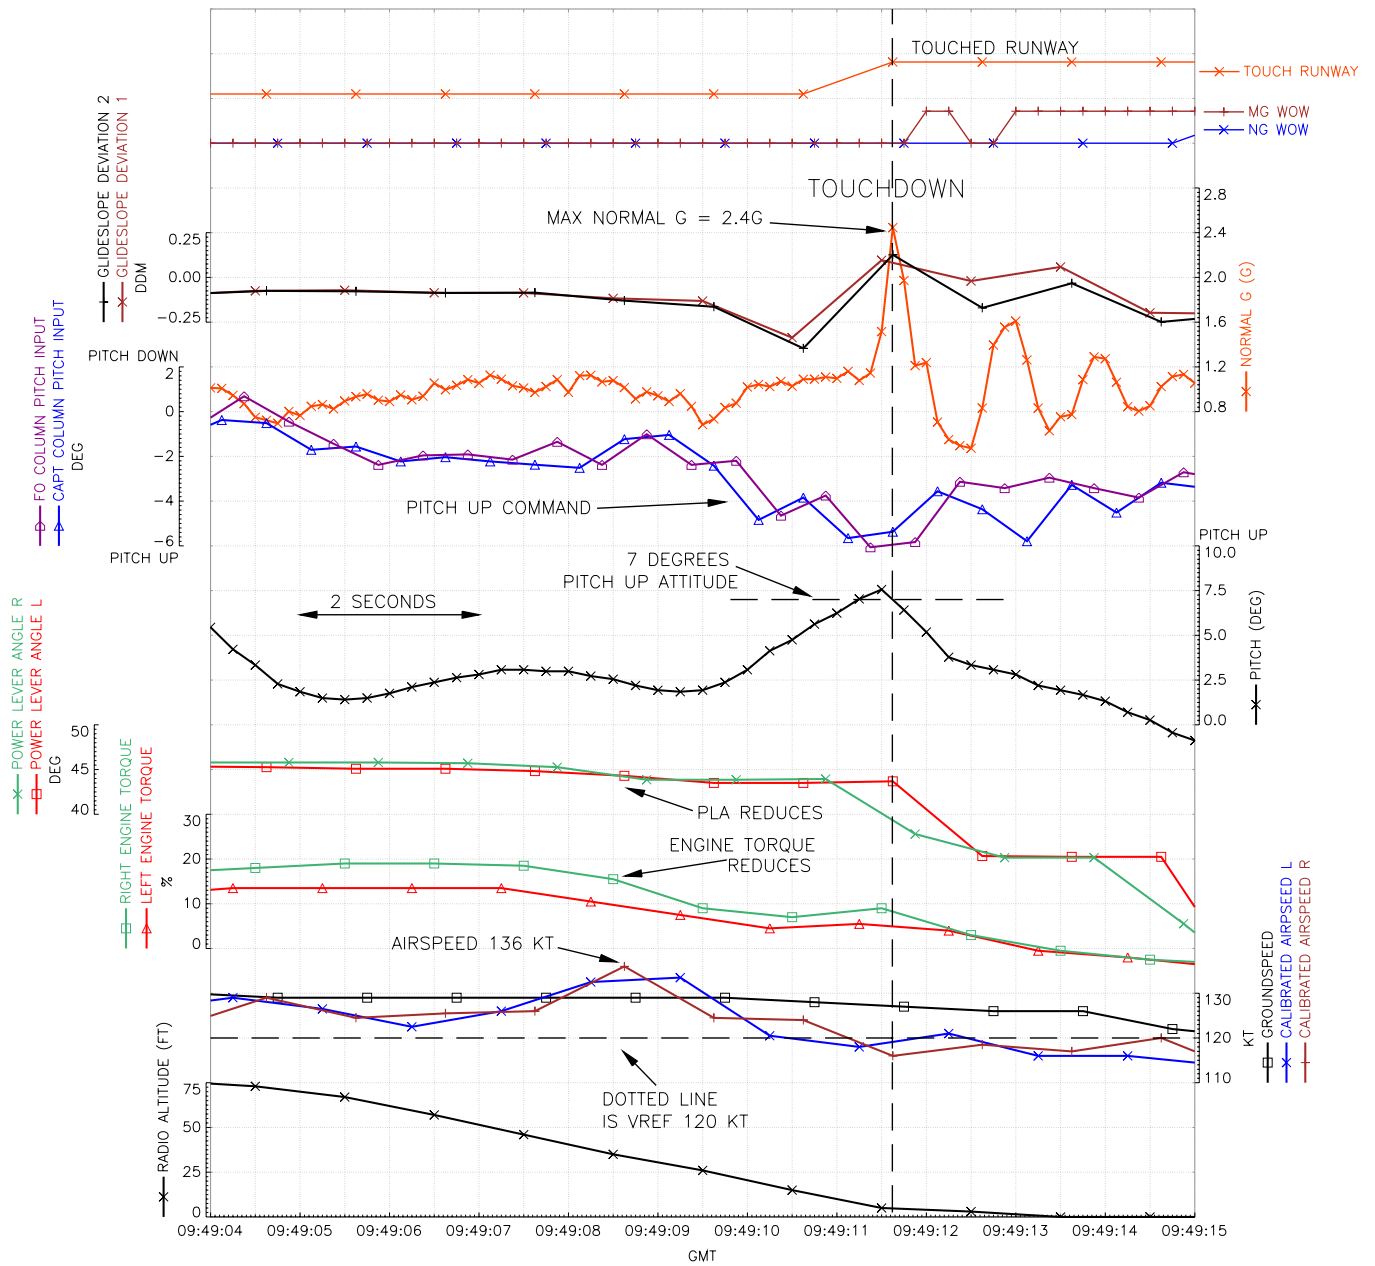
Figure 1

At about 40 ft agl the recorded data showed an indicated airspeed increase to 137 kt. The commander responded by reducing torque to 8%. The aircraft speed decreased to V_{REF} and stabilised with the rate of descent initially remaining constant at about the normal rate of 600 fpm. The aural radio altimeter counted down from 50 ft, in 10 ft increments, at a rate which sounded normal to the crew. At 25 ft agl, the commander became aware of an increasing sink rate and initiated a flare which increased the aircraft pitch from about 2.5° to 7.5° over three seconds. The FDR shows that the aircraft now had a significant tailwind with a groundspeed 10 kt greater than its airspeed. The flare did not arrest the

rate of descent and the aircraft touched down heavily on both main gear and the aft fuselage.

The aircraft was equipped with a digital flight data recorder (DFDR) and cockpit voice recorder (CVR), both of which were successfully downloaded at the AAIB. Pertinent FDR data is included in the History of the Flight section and in Figure 1.
