ACCIDENT

Aircraft Type and Registration:	Cessna F150L, G-AZXC
No & Type of Engines:	1 Continental Motors O-200-A piston engine
Year of Manufacture:	1972
Date & Time (UTC):	25 May 2006 at 1440 hrs
Location:	500 metres south-west of Netherthorpe Airfield, Nottinghamshire
Type of Flight:	Private
Persons on Board:	Crew - 1 Passengers - 1
Injuries:	Crew - 1 (Minor) Passengers - 1 (Minor)
Nature of Damage:	Beyond economic repair
Commander's Licence:	Private Pilot's Licence
Commander's Age:	65 years
Commander's Flying Experience:	656 hours (of which 642 were on type) Last 90 days - 6 hours Last 28 days - 3 hours
Information Source:	Aircraft Accident Report Form submitted by the pilot and further enquiries by the AAIB

Synopsis

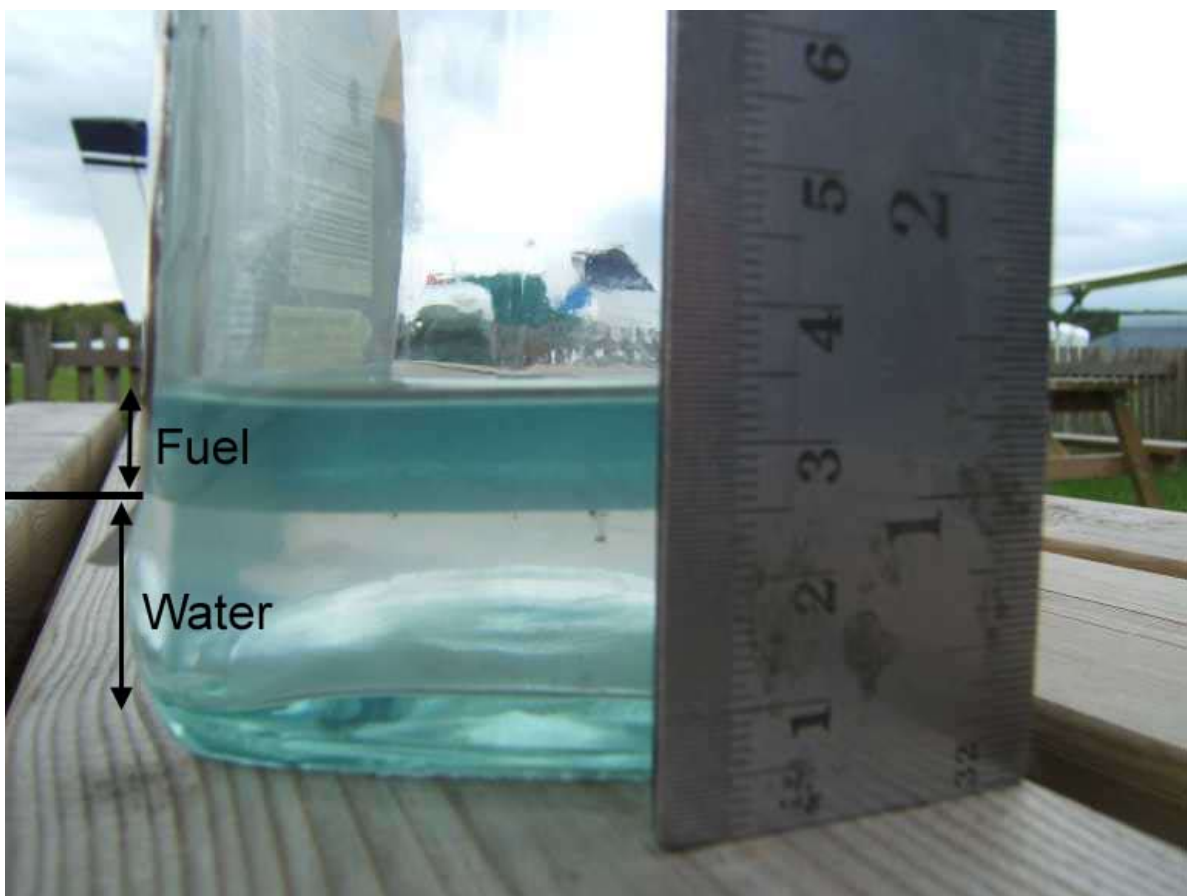
Figure 1

Contents of the fuel gascolator bowl

The maintenance engineer for the flying club recovered the aircraft to a hangar and drained the fuel from the wing tanks into a container which already contained some fuel. The aircraft was then left to await inspection by an insurance assessor. The insurance assessor removed the fuel gascolator bowl and emptied the contents into a jar (see Figure 1). Approximately two-thirds of the gascolator bowl's contents was water and only one-third was fuel. A few days later the maintenance engineer removed the wings of the aircraft and when the right wing was placed on the ground a small amount of a water/fuel mixture drained out of the right wing tank's fuel line. No fuel or water was seen to drain from the left tank when the left wing was removed. The pilot reported that the aircraft had been parked slightly right wing down.

The sudden engine failure after takeoff was probably caused by excessive water in the fuel. Water is heavier than aviation fuel and will settle in the bottom of a fuel tank. The pilot reported that he carefully drained both wing tanks and the gascolator but did not find any water. However, the aircraft had been parked right wing low and therefore it is possible that the right tank drain was not at the lowest location when the sample was taken. It was not possible to determine how the water entered the fuel but it is probable that the heavy rainfall during the week leading up to the accident flight, while the aircraft was parked outside, was a contributory factor.
