ACCIDENT

Aircraft Type and Registration:	Cameron O-120 hot air balloon, G-BVXF	
Year of Manufacture:	1994	
Date & Time (UTC):	1 January 2011 at 0947 hrs	
Location:	Midsomer Norton, Somerset	
Type of Flight:	Private	
Persons on Board:	Crew - 1	Passengers - 1
Injuries:	Crew - 1 (Fatal)	Passengers - 1 (Fatal)
Nature of Damage:	Balloon destroyed	
Commander's Licence:	Private Pilot's Licence (Balloons and Airships)	
Commander's Age:	42 years	
Commander's Flying Experience:	194 hours on balloons Last 90 days - 2 hours Last 28 days - 0 hours	
Information Source:	AAIB Field Investigation

Synopsis

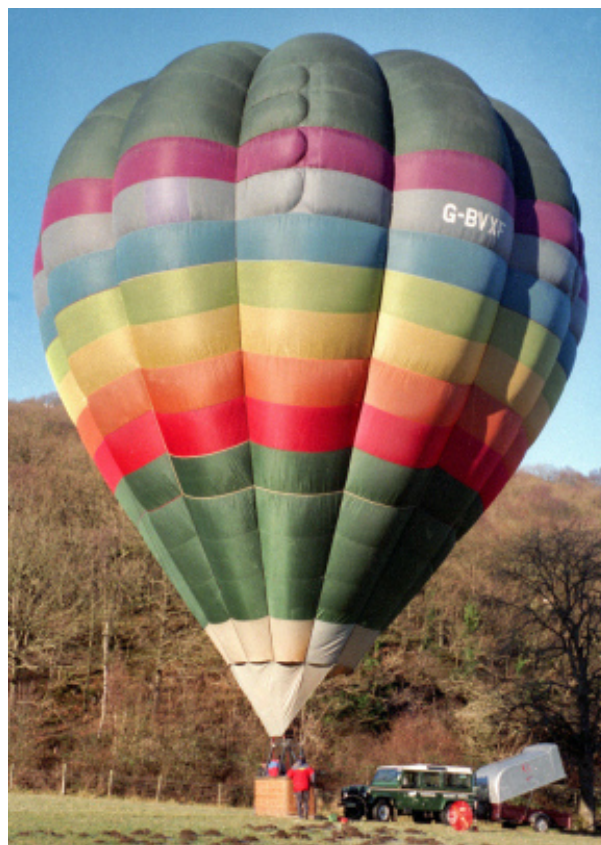
Figure 1
Envelope, G-BVXF

The envelope was a Cameron O-120 which has a volume of 120,000 cubic feet (Figure 1). This type of envelope has a 'parachute valve' which allows the controlled release of hot air (venting) and, for landing, the complete deflation of the envelope. It takes the form of a circular parachute-style panel that seals on a circular opening in the top of the envelope (Figure 2). The parachute valve is held in place by a combination of the internal pressure of the hot air and a set of centralising lines inside the balloon (12 for this design of balloon). For venting, a red line is pulled in the basket and the valve is held open for a few seconds, whereas for deflation it is pulled further and held open until the envelope deflates.

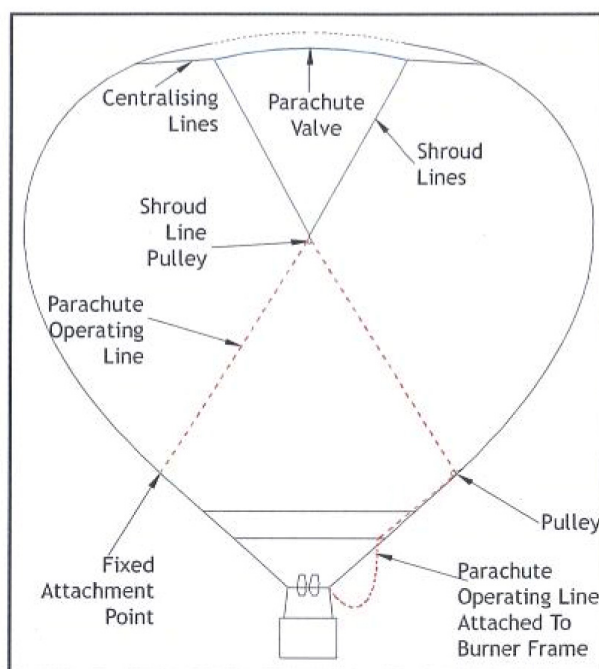
Figure 2
Parachute valve

area of the parachute valve had been destroyed by fire. There was a small tear, approximately 35 cm long, across the central circular panel, a complicated tangle of line around the snap shackle and several areas of damage to the loading tapes. All these areas of damage could be explained by turbulent aerodynamic forces on the collapsed envelope taking place over a significant period of time, possibly several minutes. The snap shackle was found to operate correctly, and it was concluded that for the complicated tangle to occur the snap shackle would have to have been open for a significant portion, if not most, of the descent. It was also concluded that the parachute may have exited through the crown aperture during the descent, the mechanism for this being the parachute capturing a small amount of air and the main envelope ‘concertina-ing’ in the turbulent flow.

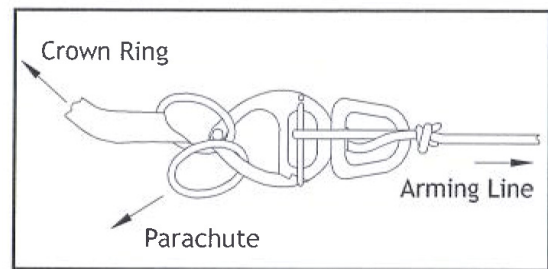
Figure 3

On the final approach to land a yellow and black 'arming line' is pulled to release the snap shackle and a flag marker appears inside the envelope to indicate visually that the system is armed. With the system armed, the red vent line can then be pulled down to a position where the hot air will vent rapidly. Shortly after this point, re-inflation of the envelope will not be possible.

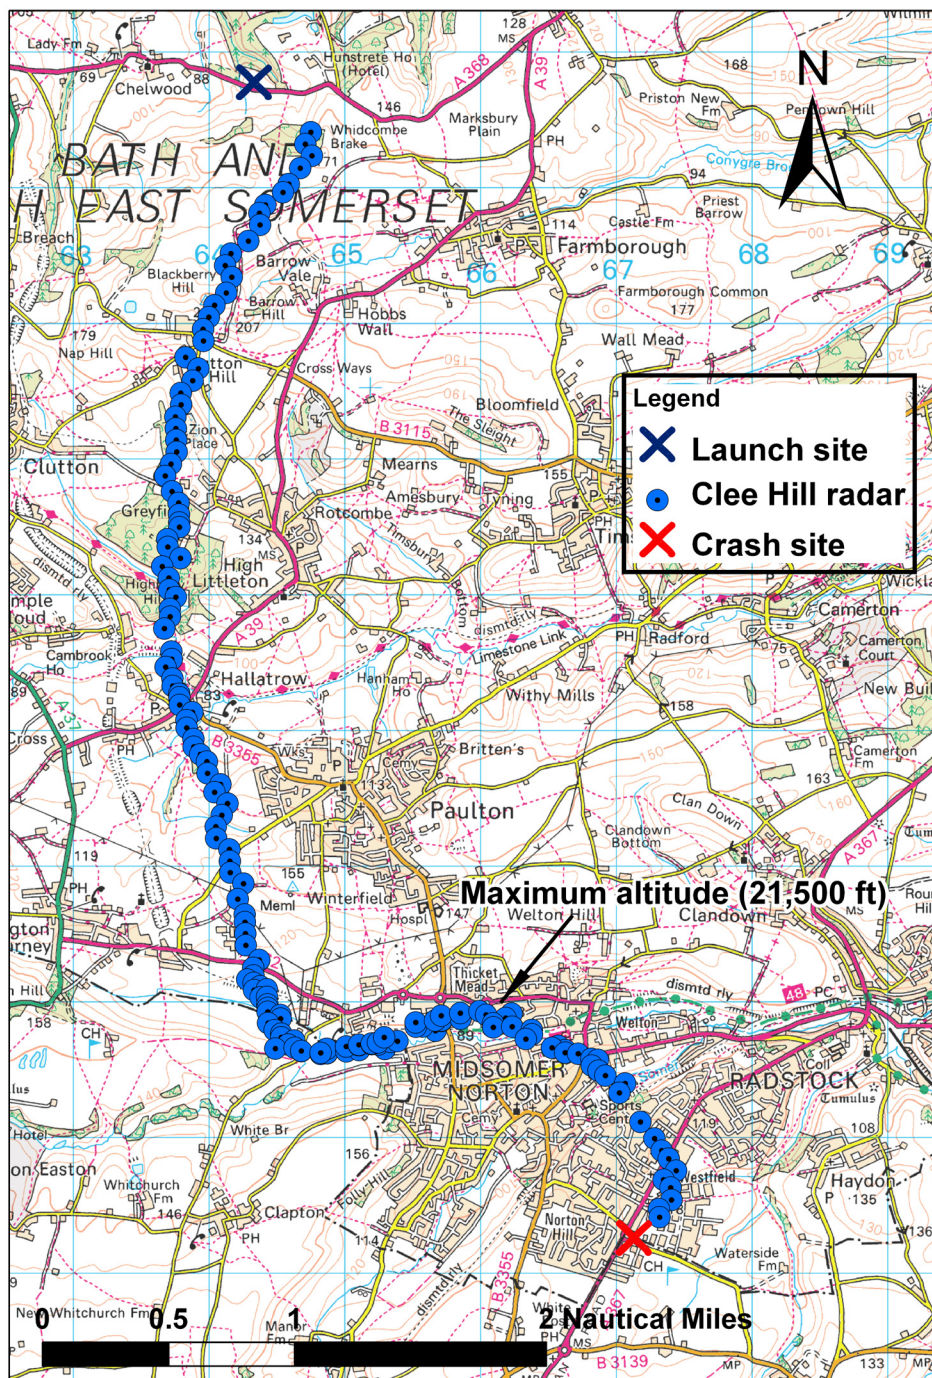
Figure 4

starts at 0923:10 hrs just to the south-east of the launch site with the first altitude returns starting 4½ minutes later as the balloon passed through 6,300 ft amsl (probably when the transponder was switched on). The

track ends at 0946:30 hrs north-east of the accident site with the balloon at 2,000 ft amsl (ie about 1,600 ft agl), descending rapidly.

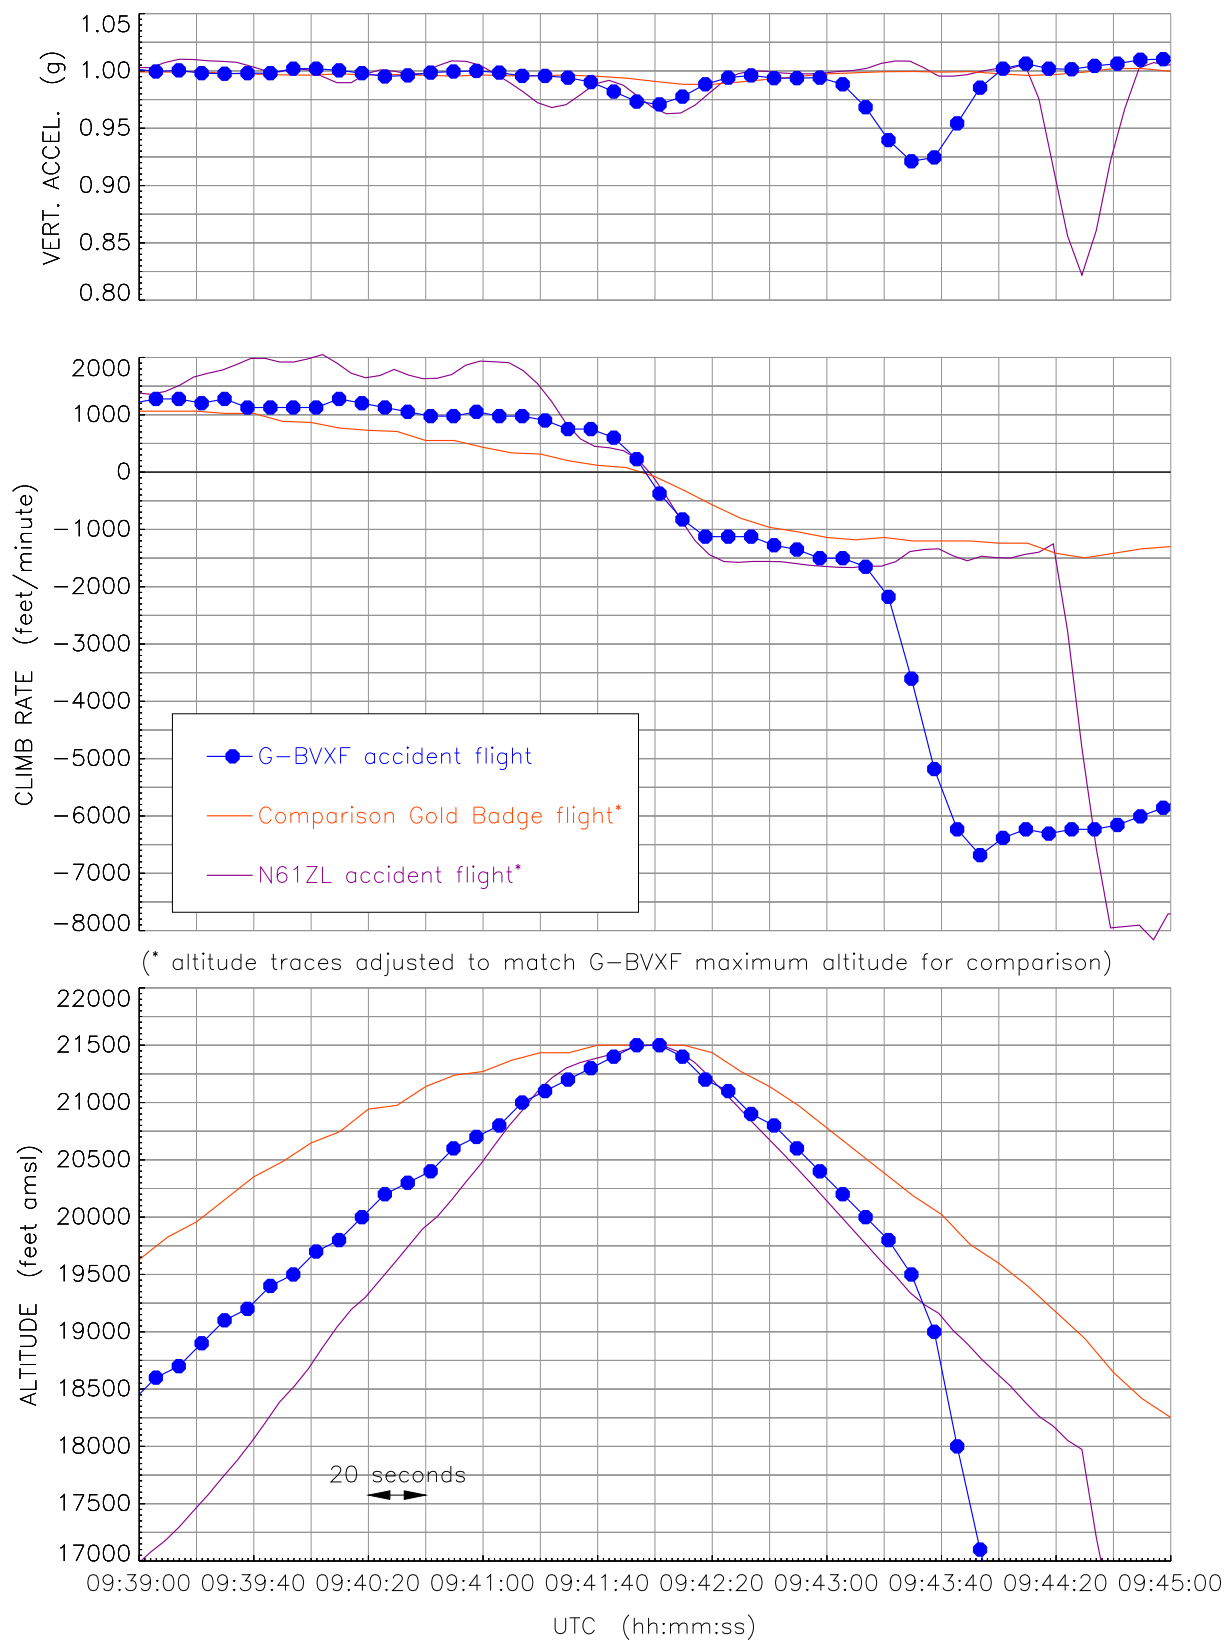
**Figure 5**

The altitude profile of the accident flight, near the top of climb, is shown in Figure 5 and shows that a maximum altitude of 21,500 ft amsl was reached just before 0942 hrs. The vertical climb rate and acceleration, calculated from the altitude and time information is also shown. During the ascent the rate of climb exceeded the 1,000 ft/min maximum specified in the Flight Manual.

Of note is that the transition from climb to descent for G-BVXF was more marked than the gradual transition on the comparison Gold Badge flight, which was made by turning off the burners and waiting for cooling to initiate a ‘cold descent’ and was without any venting.

There are broad similarities between the data for the G-BVXF and N61ZL accident flights. In the case of G-BVXF there were approximately 80 seconds of descent (after the maximum altitude) at approximately 1,500 ft/min before it commenced a high-speed descent at around 5,500 ft/min. This high-speed descent from 19,750 ft to the ground took approximately 3½ minutes. It was confirmed by calculation that the gradual decrease in rate of descent was consistent with the air density increasing closer to the ground and hence the balloon was almost certainly ‘streamered’ for these 3½ minutes.

A key piece of evidence was the height profile from the radar, Figure 5. Comparing the altitude profiles of the accident flight with another Gold Badge flight (for which the descent was initiated by not using the burners and not venting) strongly suggests either the envelope of G-BVXF was vented or there was a significant leakage of hot air due to an envelope failure. The high rate of ascent, which reduced only slightly prior to the apogee at 21,500 ft, is indicative of an intact balloon envelope at that stage; it is likely that the CAA approval to FL210, already passed, could have led the pilot to decide to initiate a more rapid descent than he had originally planned.

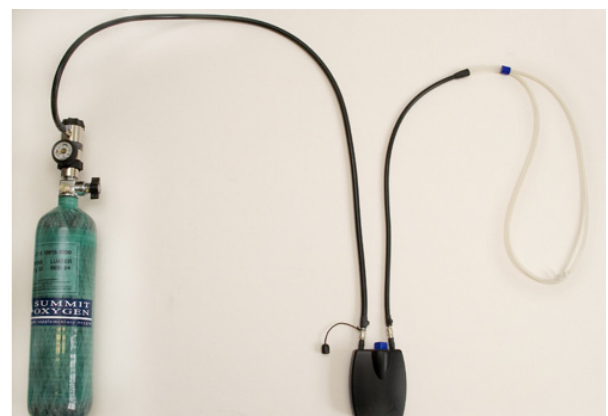
Figure 6

main valve and the regulator were closed. Either one of these being closed would result in no oxygen being supplied to either pulse dose meter.

There was no oxygen left in the cylinder and there was damage to the housing for the main valve. This damage, and the fact that the connecting rod for the hand wheel had been found approximately 10 m from the oxygen cylinder at the wreckage site, was strong evidence that the oxygen cylinder had contained gas at pressure when the balloon struck the ground, and that the pressure had been released as a result of the post-impact fire.

Another key piece of evidence was that the main valve, and the regulator, on the oxygen cylinder were found in the closed position. It is possible that these had been opened at high altitude but were closed during the descent. However, given that both valves were found closed, that the valves were located in a rucksack and hence not readily accessible, and that the pilot and passenger were probably focussed on trying to re-inflate the envelope during the rapid descent, the closing of the valves during this descent is unlikely.
