**ACCIDENT**

<b>Aircraft Type and Registration:</b>	Reims Cessna F152 Aerobat, G-BFZT	
<b>No &amp; Type of Engines:</b>	1 Lycoming O-235-L2C piston engine	
<b>Year of Manufacture:</b>	1979	
<b>Date &amp; Time (UTC):</b>	2 November 2007 at 1445 hrs	
<b>Location:</b>	Near Weston, Shropshire	
<b>Type of Flight:</b>	Private	
<b>Persons on Board:</b>	Crew - 1	Passengers - None
<b>Injuries:</b>	Crew - 1 (Minor)	Passengers - N/A
<b>Nature of Damage:</b>	Nosewheel broken off. Damage to fuselage, wings and propeller	
<b>Commander's Licence:</b>	Student Pilot	
<b>Commander's Age:</b>	59 years	
<b>Commander's Flying Experience:</b>	102 hours (of which 97 were on type) Last 90 days - 37 hours Last 28 days - 18 hours	
<b>Information Source:</b>	Aircraft Accident Report Form submitted by the pilot

**Synopsis**

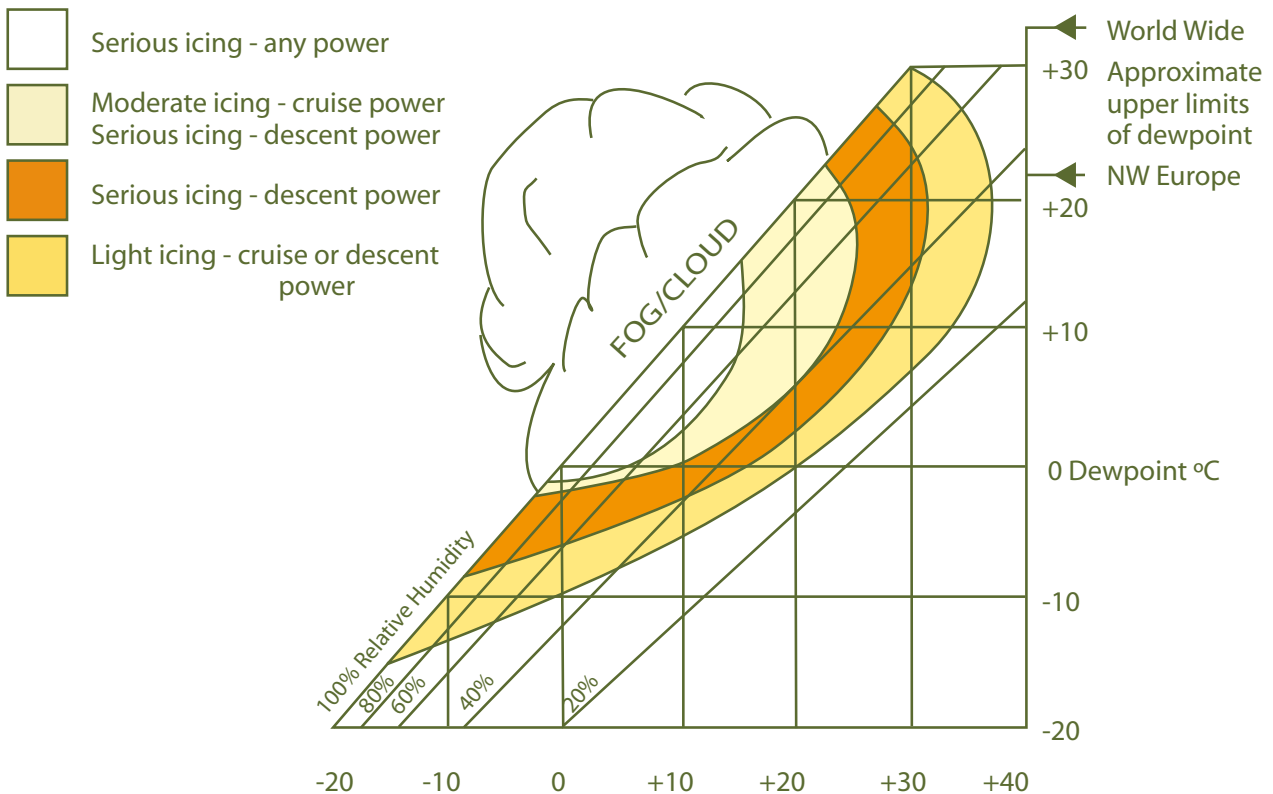
**Figure 1**

The forecast weather for the route predicted a temperature of +12°C and a dew point of +11°C.

This gives the potential for serious carburettor icing, irrespective of the power setting used (see Figure 1). The instructor had considered this when deciding whether the weather was suitable for the exercise. He decided the weather was suitable because the student had been trained to deal with carburettor icing and had dealt with it correctly the previous day. The instructor has now revised his briefing to students on the use of carburettor heat to include the fact that should the engine initially run more roughly, carburettor heat should still be maintained until the ice has cleared and the engine returns to normal.
