ACCIDENT

Aircraft Type and Registration:	Piper PA-28-151 Cherokee Warrior, G-BOTF	
No & Type of Engines:	1 Lycoming O-320-E3D piston engine	
Year of Manufacture:	1975 (Serial no: 28-7515436)	
Date & Time (UTC):	9 September 2012 at 0818 hrs	
Location:	Southend Airport, Essex	
Type of Flight:	Private	
Persons on Board:	Crew - 1	Passengers - 2
Injuries:	Crew - None	Passengers - None
Nature of Damage:	Fire damage to engine and cowling	
Commander's Licence:	Private Pilot's Licence	
Commander's Age:	24 years	
Commander's Flying Experience:	130 hours (of which 3 were on type) Last 90 days - 5 hours Last 28 days - 4 hours	
Information Source:	Aircraft Accident Report Form submitted by the pilot

Synopsis

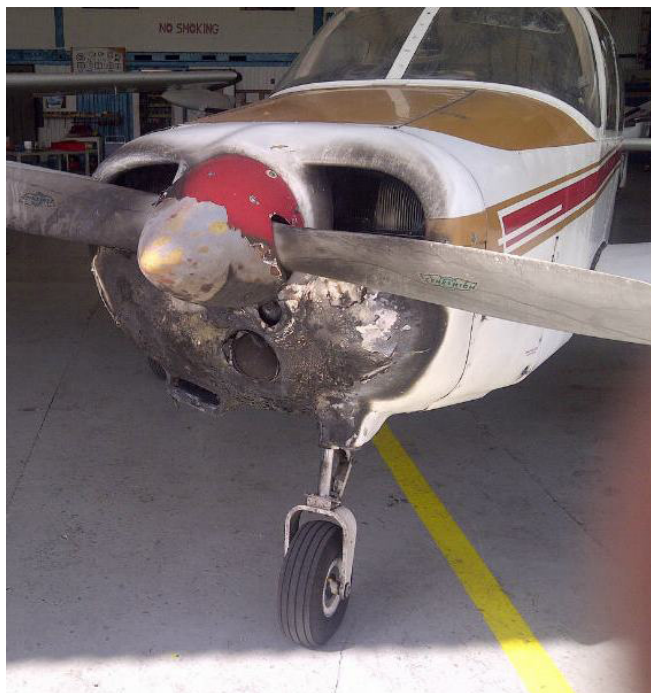
Figure 1

The forward lower section of the engine cowling and the inside of the engine bay were extensively fire damaged, Figure 1, with the seat of the fire appearing to have been located at the bottom of the engine, close to the carburettor. An engineering inspection of the fuel system within the engine bay did not reveal loose fittings, split fuel hoses or other pre-existing defects.

The source of fuel for the fire was likely to have been fuel pumped into the carburettor venturi by the carburettor accelerator pump, which operates when the throttle lever is advanced swiftly forwards. The induction of the fuel into the engine relies on airflow to move the fuel upwards into the engine inlet manifold. However, if the engine is stopped when the throttle lever is advanced, excess fuel will drip downwards from the carburettor and pool in the carburettor heat box. The heat radiated by the hot exhaust system can then cause the pooled fuel to vaporise and can also act as an ignition source for the fuel vapour.

Fire damage to the forward lower section of the engine bay
