# Embraer EMB-145EP, G-ERJE

AAIB Bulletin No: 5/2003

Ref: EW/C2002/07/02

## INCIDENT

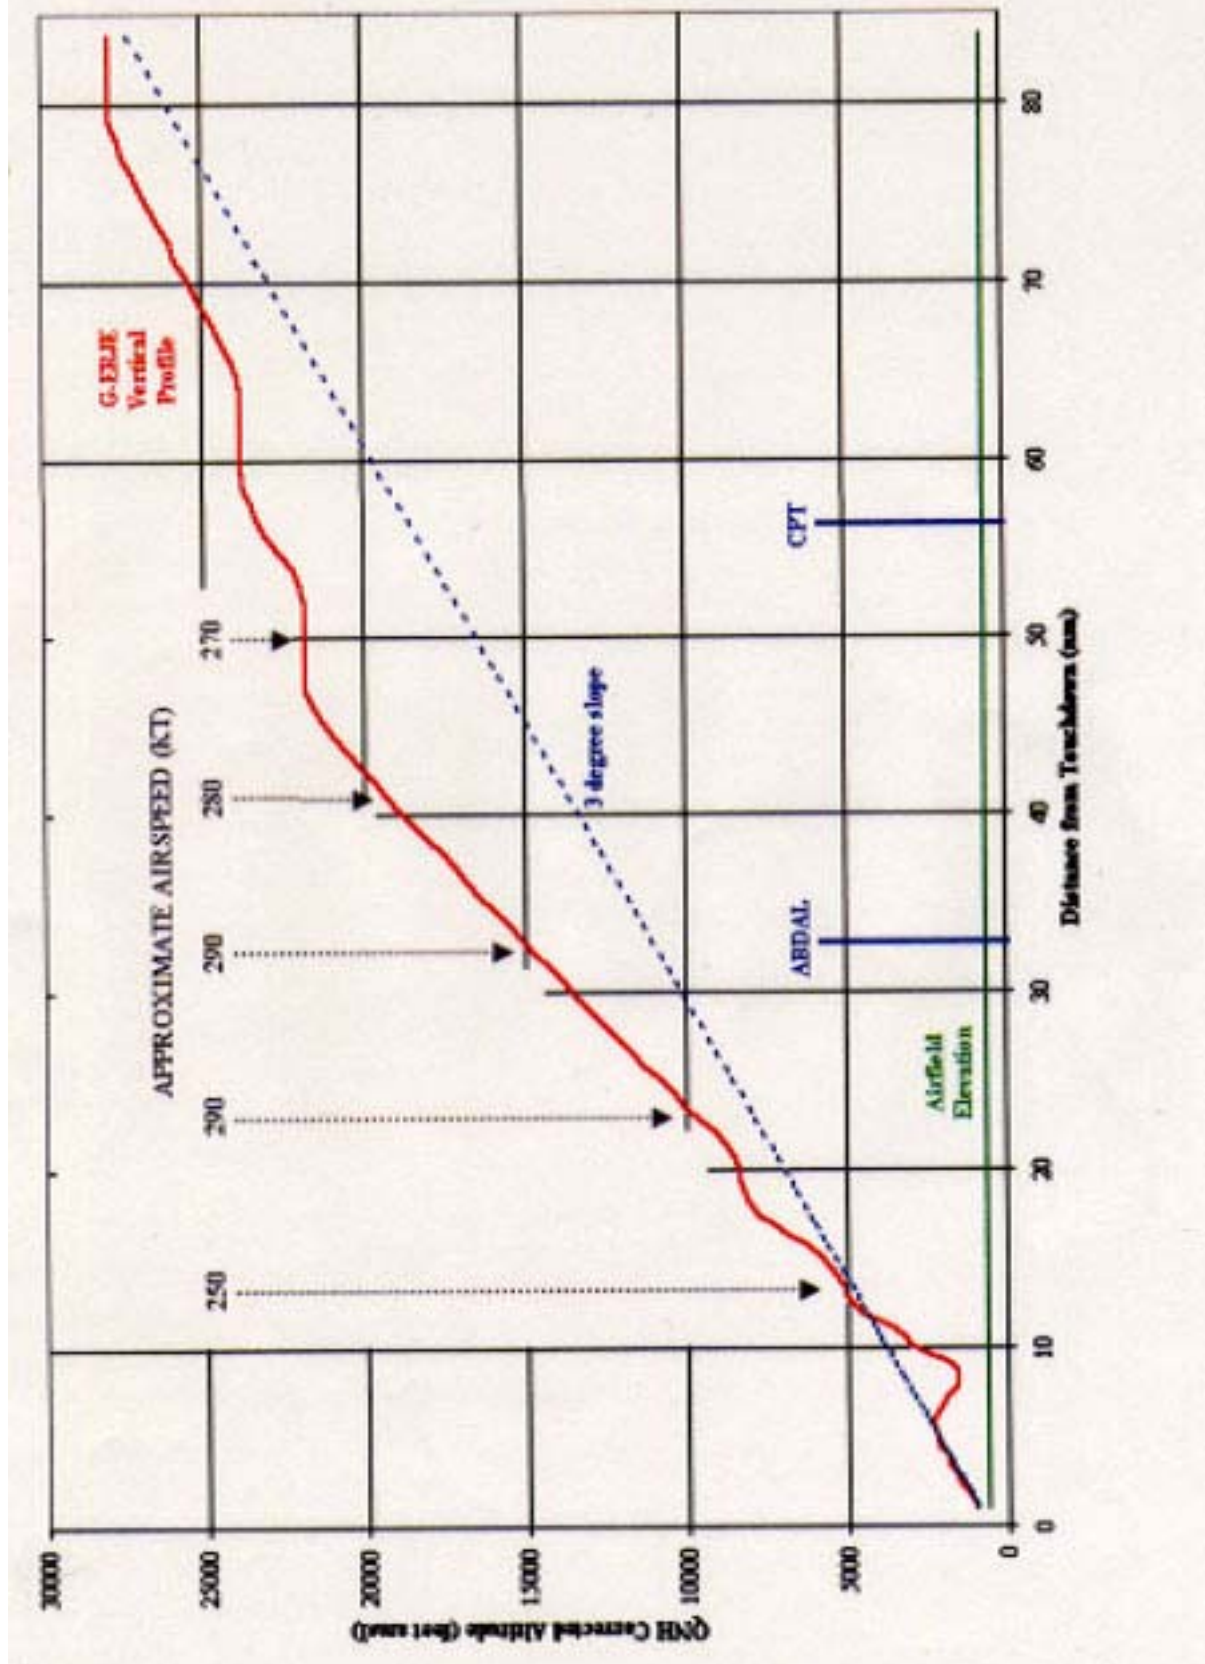
Figure 1  
G-ERJE Descent Profile

Further descent clearance was given to the aircraft by Bristol Approach, initially to FL45 and then to altitude 2,500 feet referenced to the QNH of 1007 mb. At a distance of 30 nm from the airport, the aircraft passed through FL140. Speedbrakes were deployed when passing FL100. When the aircraft was below FL100, there was a "HIGH SPEED" audio overspeed warning and the commander responded by selecting 'Speed' mode with a target of 240 kt. The rate of descent reduced to zero at FL80 for a short time and then, at a distance of 20 nm from touchdown, descent continued.
