## ACCIDENT

| <b>Aircraft Type and Registration:</b> | Hawker Hurricane IIB, G-HHII | |
| <b>Date &amp; Time (UTC):</b> | 28 August 2011 at 1200 hrs | |
| <b>Location:</b> | North Weald Airfield, Essex | |

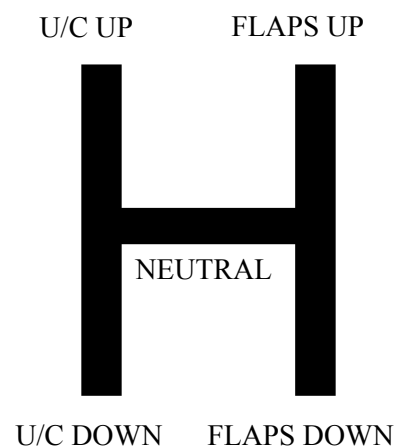
**Figure 1**

The Hawker Hurricane has two retractable MLGs and a fixed tailwheel. Actuation of the MLGs and the flaps uses hydraulic power supplied by an engine driven pump. The selector in the cockpit is a combined flap and MLG lever working in an 'H' shaped gate, much like the selector in a four-speed manual gearbox car (Figure 1). When no flap or MLG selections are being made, the lever should be placed in the 'neutral' position. If flap selection is required, the lever is moved to the right and down and returned to neutral when the flaps have extended. If the MLG is then required to be

lowered, the lever is moved to the left and down and returned to neutral when gear extension is confirmed by the illumination of two green lights on a unit to the left of the main instrument panel. A spring-loaded thumb-latch needs to be released each time the selector lever is moved from one of the operating positions but this is not the case when making a selection from neutral.

Schematic representation of the hydraulic selector lever gate

The aircraft was found with the hydraulic selector lever in the U/C DOWN detent but the MLG was found in the locked UP condition. When the aircraft was recovered, the foot lever was activated to release the uplock and
