ACCIDENT 1

Aircraft Type and registration:	EC225 LP Super Puma, G-REDW
Date & Time (UTC):	10 May 2012 at 1114 hrs
Location:	20 nm east of Aberdeen

Aircraft Type and registration:	EC225 LP Super Puma, G-CHCN
Date & Time (UTC):	22 October 2012 at 1425 hrs
Location:	Approximately 32 nm southwest of Sumburgh, Shetland Islands
Information Source:	AAIB Field Investigations

This Special Bulletin contains information on the progress of the investigation into the emergency lubrication systems and the Crash Position Indicators (CPI) for the accidents to G-REDW on 10 May 2012 and to G-CHCN on 22 October 2012. This follows the publication of previous Special Bulletins S2/2012, S3/2012, S5/2012, S6/2012 and S7/2012.

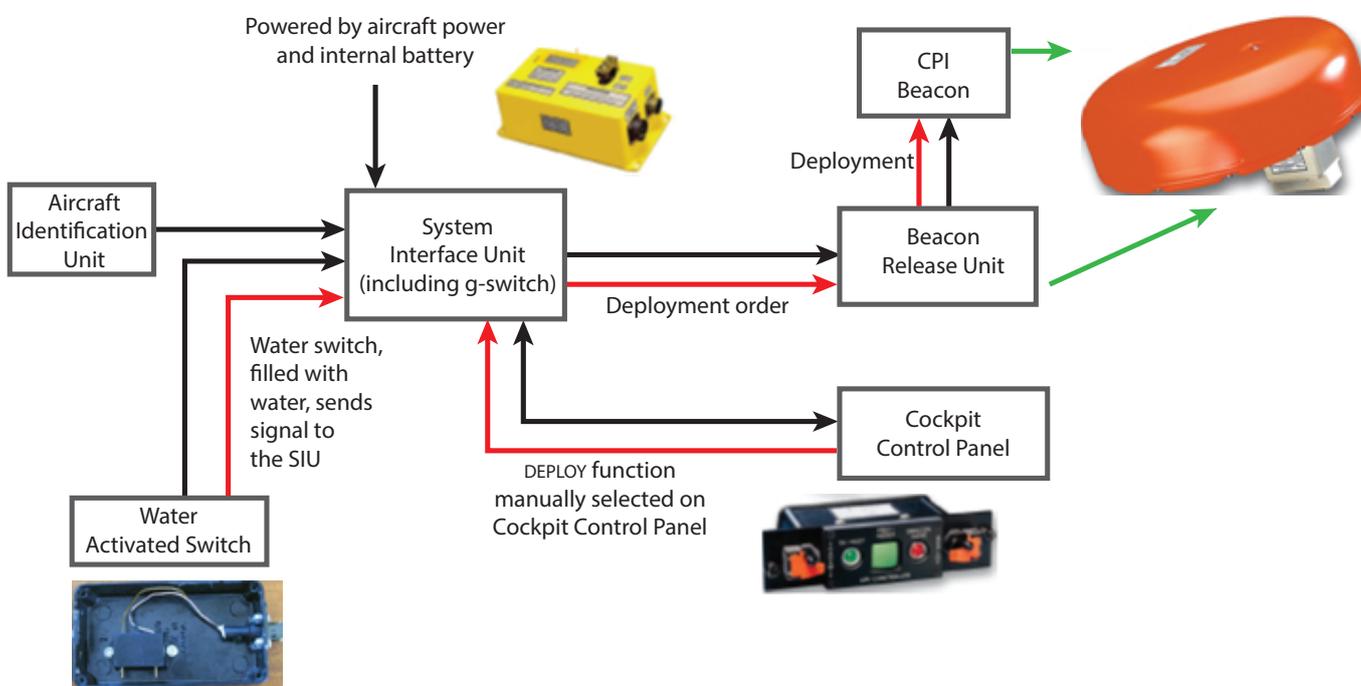
Figure 3
Schematic of Crash Position Indicator system

The CPI system consists of the CPI beacon, a beacon release unit, a system interface unit, a cockpit control panel, a water activated switch and an aircraft identification unit (Figure 3). These components are located in various positions around the helicopter, and are connected by wiring which is integrated with the rest of the helicopter's wiring looms, and is therefore not specifically protected against water ingress. The
