AAIB Bulletin No: 1/96

Ref: EW/C95/10/8

Aircraft Type and Registration: Piper PA-34-200-2 Seneca, G-BADL

History of the flight

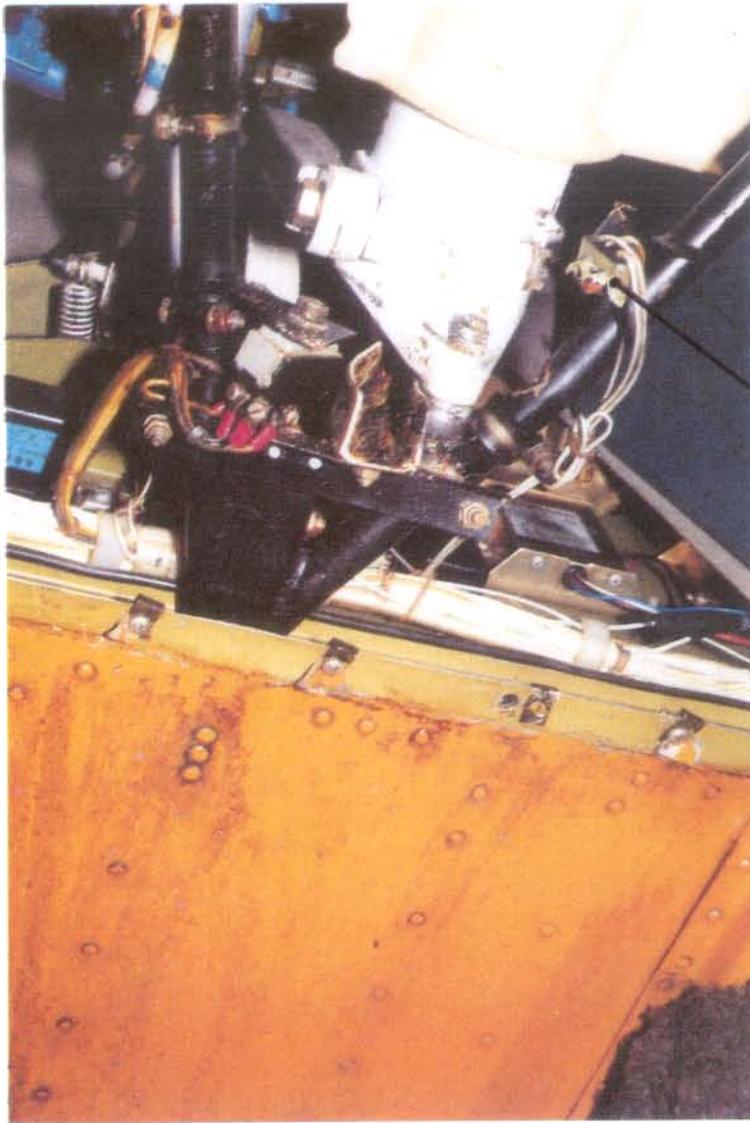
Figure 1

After the aircraft had been recovered to a nearby maintenance organisation, the owners carried out a preliminary examination. It was quickly determined that the nose gear had overtravelled and that the centring roller had become free from the end of the guide channel. This had allowed the roller to become misaligned with the channel such that, as the gear was lowered, it travelled for a short distance along the outside of the channel before becoming jammed between the channel and a tubular member of the gear support structure. After the nose of the aircraft had been supported, the roller was

reengaged into the guide channel whereupon, when the gear was manually lowered, it locked into the down position. A photograph showing the roller in the jammed position is shown in Figure 1. Examination of the aircraft by the AAIB, in conjunction with the maintenance organisation, revealed that the gear operating system was serviceable but that damage associated with the nose gear had occurred prior to the landing.

View from below, showing top of nose gear leg in up position but with steering roller jammed against the outside of the guide channel.

Up limit microswitch, damaged by nose gear overtravel.

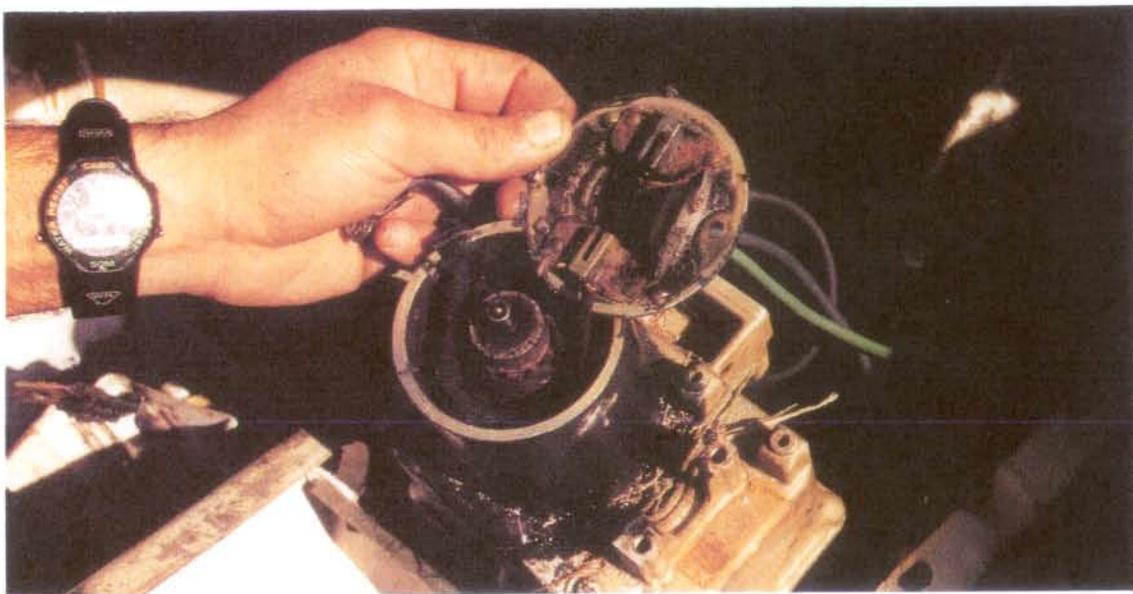
Figure 2

The motor driving the hydraulic pump was unserviceable in that it would not run when power was applied directly. When partially stripped, evidence was revealed of slight overheating and it was evident that both carbon commutator brushes had been completely worn away. Also, the interior of the motor was covered in carbon dust (Figure 2). Both its operating relays were functioned and determined to be serviceable. The up-limit microswitch, and its mounting bracket, had been severely damaged by the nose gear and a failure had occurred to the externally mounted microswitch operating leaf spring. Close examination of this failure, which is arrowed in Figure 3, revealed evidence that a fatigue crack had been present, extending over approximately 75% of the leaf section, and that this crack was located at the start of a sharp bend. The nature of this bend, and the general condition of the spring, suggested that it was pre-existing and had not been caused by the nose gear overtravel and subsequent contact with the switch. It was estimated from the fracture surface that the crack had been growing for some hundreds of cycles. Despite damage to the switch, the gear 'not up' contacts were found in the made position.

View of hydraulic pump motor showing worn away commutator brushes.

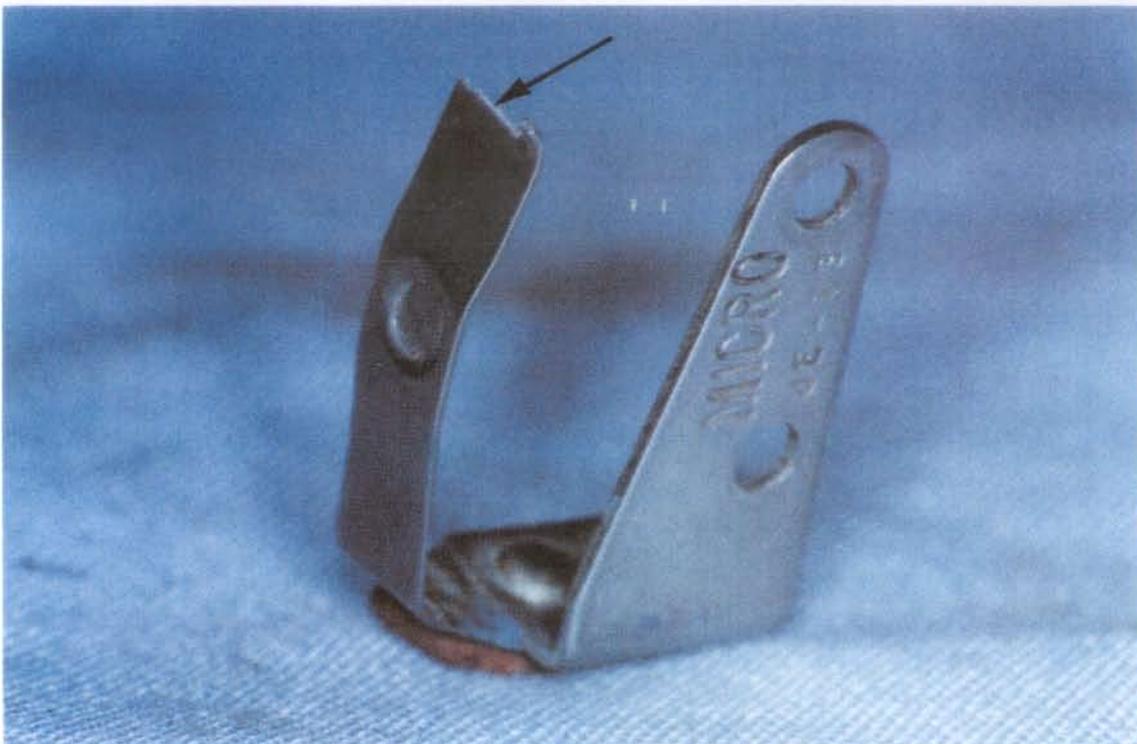
Figure 3

The above evidence thus indicated that at some time after takeoff, probably as the gear retracted, the leaf spring on the nose gear up limit switch failed, thereby allowing the nose gear to overtravel, damaging the up-limit microswitch, and becoming jammed. Throughout the flight to Edinburgh, continual cycling of the motor driving the hydraulic pump, and the pressure limiting switch, probably occurred resulting in a motor failure during the attempts to lower the gear prior to landing. The condition of the motor prior to the aincident was not established. Satisfactory retraction checks of the landing gear on this aircraft were carried out during the Annual check in May 1995, and again in July 1995 after both main gear trunnions had been replaced. Since that time, some 18 flights were recorded to have taken place. The most recent maintenance was a 50 hour check, carried out by the owner on 11 October 1995, since when the aircraft had flown four times.

General view of the fractured micro switch operating leaf spring (fracture arrowed).

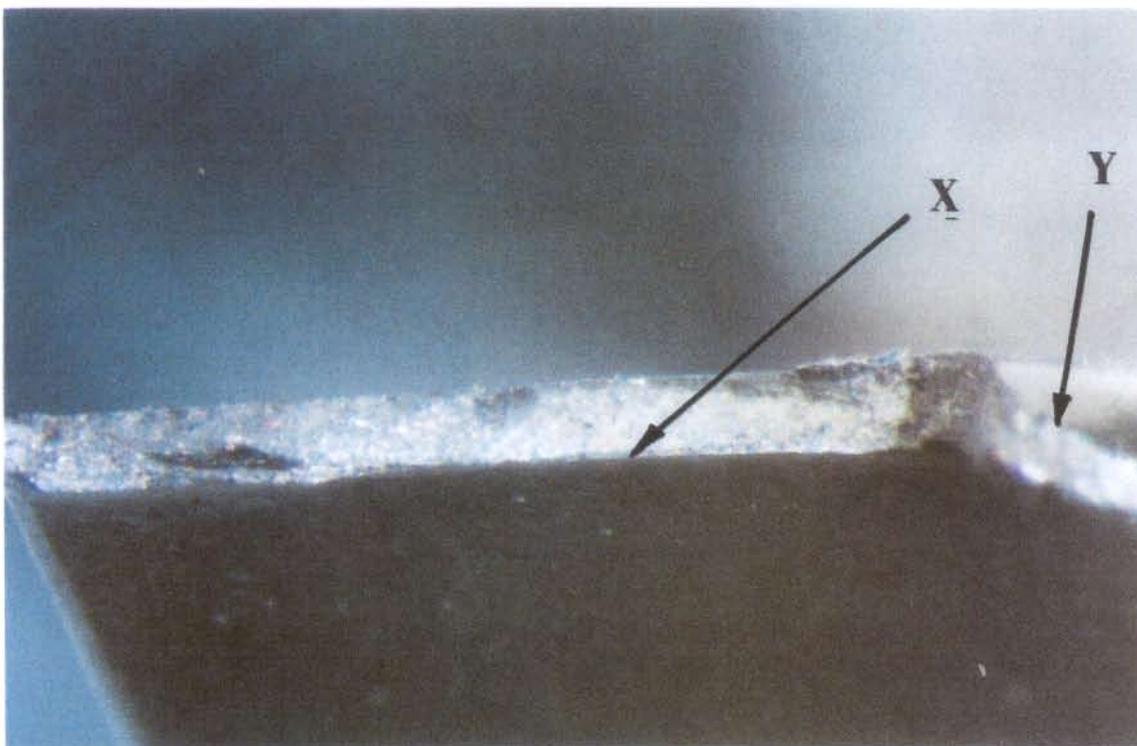
View on fracture face - initiation region arrowed X. Overload tearing occurred at the right hand end - arrowed Y.
