## Lake LA-4-200 Amphibian, G-SKID

<b>AAIB Bulletin No: 5/2004</b>	<b>Ref: EW/C2003/08/02</b>	<b>Category: 1.3</b>
<b>Aircraft Type and Registration:</b>	Lake LA-4-200 Amphibian, G-SKID	
<b>No &amp; Type of Engines:</b>	1 Lycoming IO-360-A1B piston engine	
<b>Year of Manufacture:</b>	1975	
<b>Date &amp; Time (UTC):</b>	1 August 2003 at 1155 hrs	
<b>Location:</b>	2 Miles South West of Hawarden Airport, Clywd	
<b>Type of Flight:</b>	Private	
<b>Persons on Board:</b>	Crew - 1	Passengers - 1
<b>Injuries:</b>	Crew - 1 (Serious)	Passengers - 1 (Minor)
<b>Nature of Damage:</b>	Aircraft destroyed	
<b>Commander's Licence:</b>	Commercial Pilot's Licence	
<b>Commander's Age:</b>	60 years	
<b>Commander's Flying Experience:</b>	10,920 hours (of which 13 were on type)	
	Last 90 days - 140 hours	
	Last 28 days - 60 hours	
<b>Information Source:</b>	AAIB Field Investigation

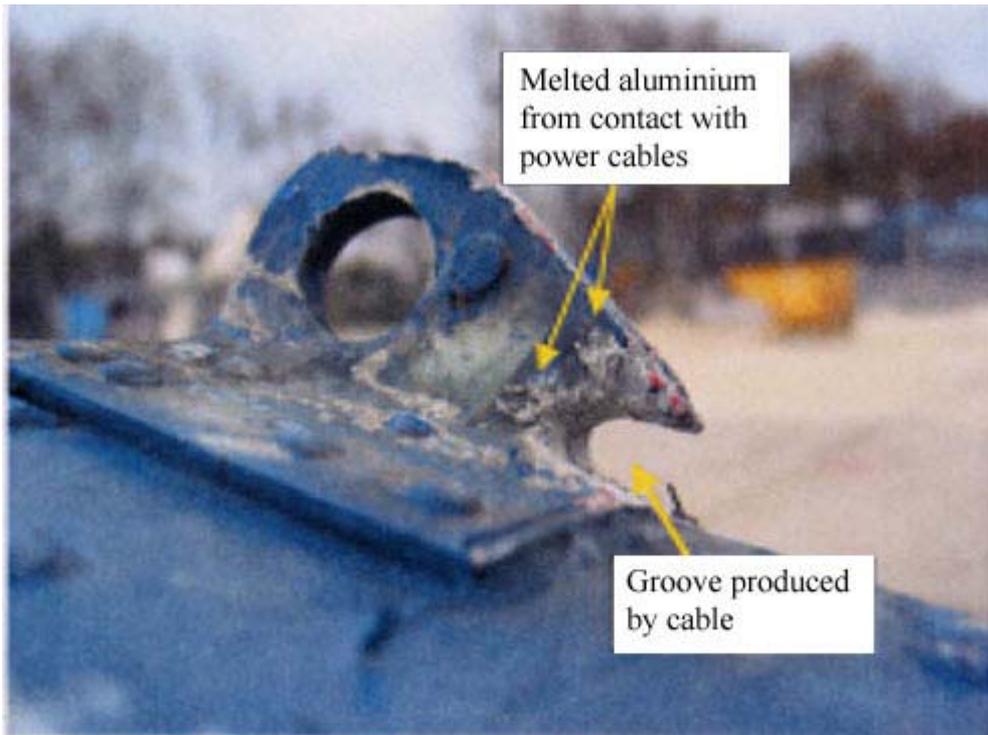
Inspection of the fuselage revealed that a 7 mm deep groove had been produced in the leading edge of the tail 'tie down' fitting Figure 1. Melted aluminium around the edges of the groove suggested that this damage was probably caused by the power cables becoming snagged on the fitting.

**Figure 1:** Tail tie down fitting damage due to contact with power cables

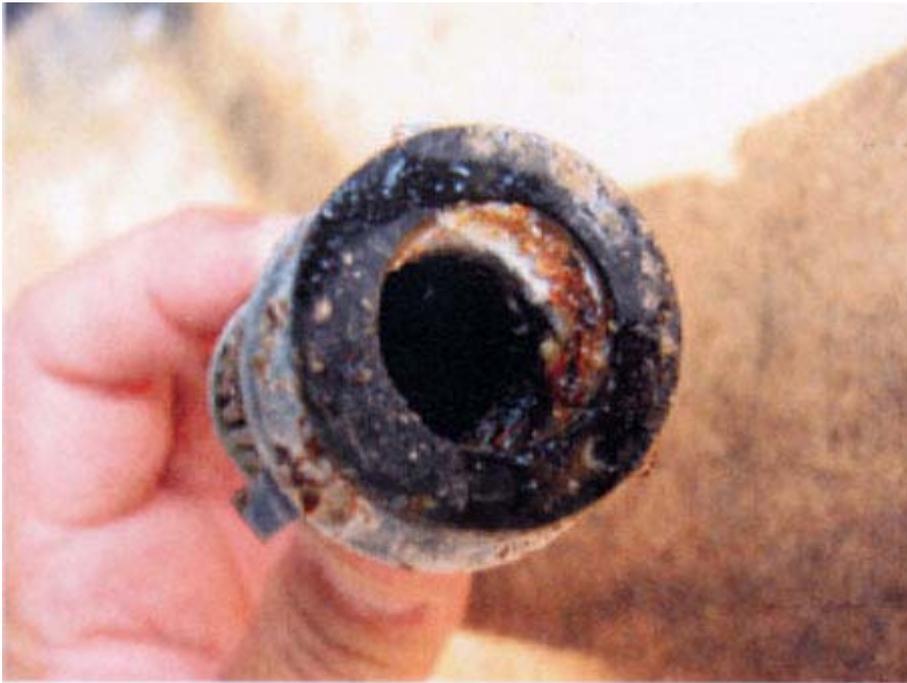
Examination of the fuel system revealed residual fuel in the fuel lines. A sample of fuel taken from the fuel filter was found to contain approximately 0.5 cc of brown-coloured water. The fuel filter bowl and the filter element itself, Figure 2, were heavily corroded and the filter element appeared to be partially blocked with corrosion products.

**Figure 2:** Corrosion on fuel filter element

The widespread evidence of corrosion in the fuel system, the sample of brown tinged water from the fuel filter bowl and the indication on the spark plugs of lean running, all suggested that water contamination of the fuel system was the most likely cause of the engine failing to produce adequate power. The extreme levels of corrosion found on the fuel filter element, the mechanical and electric fuel pumps shows that water had been present in the fuel system for a considerable period of time. Water can collect in the fuel tanks of an aircraft due to the long term accumulation of moisture from condensation, which can form on the tank walls when an aircraft is parked for long periods of time with the tanks partly full, or by coming out of solution, particularly in cold conditions. If not regularly drained, this water can accumulate in the fuel tank sump in increasing quantities and may eventually be drawn into the fuel lines, and would likely result in a significant power loss.

It was a requirement of the LAMS maintenance schedule for this aircraft that, on the Daily Check, a fuel sample was taken from the fuel system to check for water and other contaminants, and to ensure that the colour for the type of fuel permitted to be used in the aircraft was correct. The 50-Hour Check contained a requirement for inspecting the fuel filter in addition to sampling the fuel. As the pilot stated that he had no recollection of the flight or the events leading up to it, it could not be established if a fuel sample had been taken on the day of the accident. However, the pilot was sure that he would have made this check, as that was his normal practice so to do. Notwithstanding this, had the 50-Hour Check been carried out between April 2003, at which time the check would have been necessary for the aircraft to continue flying, and the date of the accident, then it is possible that the corrosion of the fuel filter and the presence of water in the fuel would have been identified.

It is important that aircraft owners and operators of low utilisation aircraft take precautions against the accumulation of water due to condensation in the tanks, by ensuring that regular water drain checks are performed during storage and by storing the aircraft with the fuel tanks full.

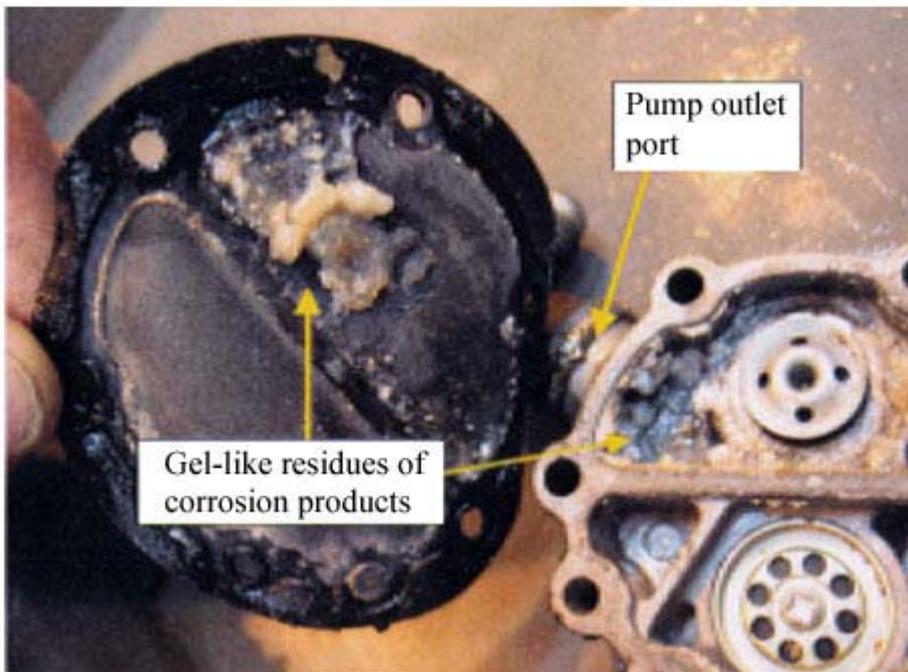
The mechanical fuel pump was also found to contain large accumulations of corrosion products and a thick white gel in the outlet chamber Figure 3. The electric boost pump failed to run when tested and, on disassembly, the pump rotor was found to have seized due to corrosion. Strip examination of the major fuel injection system components did not reveal any anomalies.

**Figure 3:** Corrosion products in mechanical fuel pump outlet chamber
