- Annex I** **Chart with flight paths**
- Annex II** **Wreckage distribution**
- Annex III** **Plan of wing, indicating separation**
- Annex IV** **Diagram of the crack distribution**
- Annex V** **Engine outer rib and reinforcing plate**

SITE : Buena Esperanza Plateau, 35 km North of Cutral-Có (Neuquén)

AIRCRAFT : AVRO 748 - Registration L V-HHB

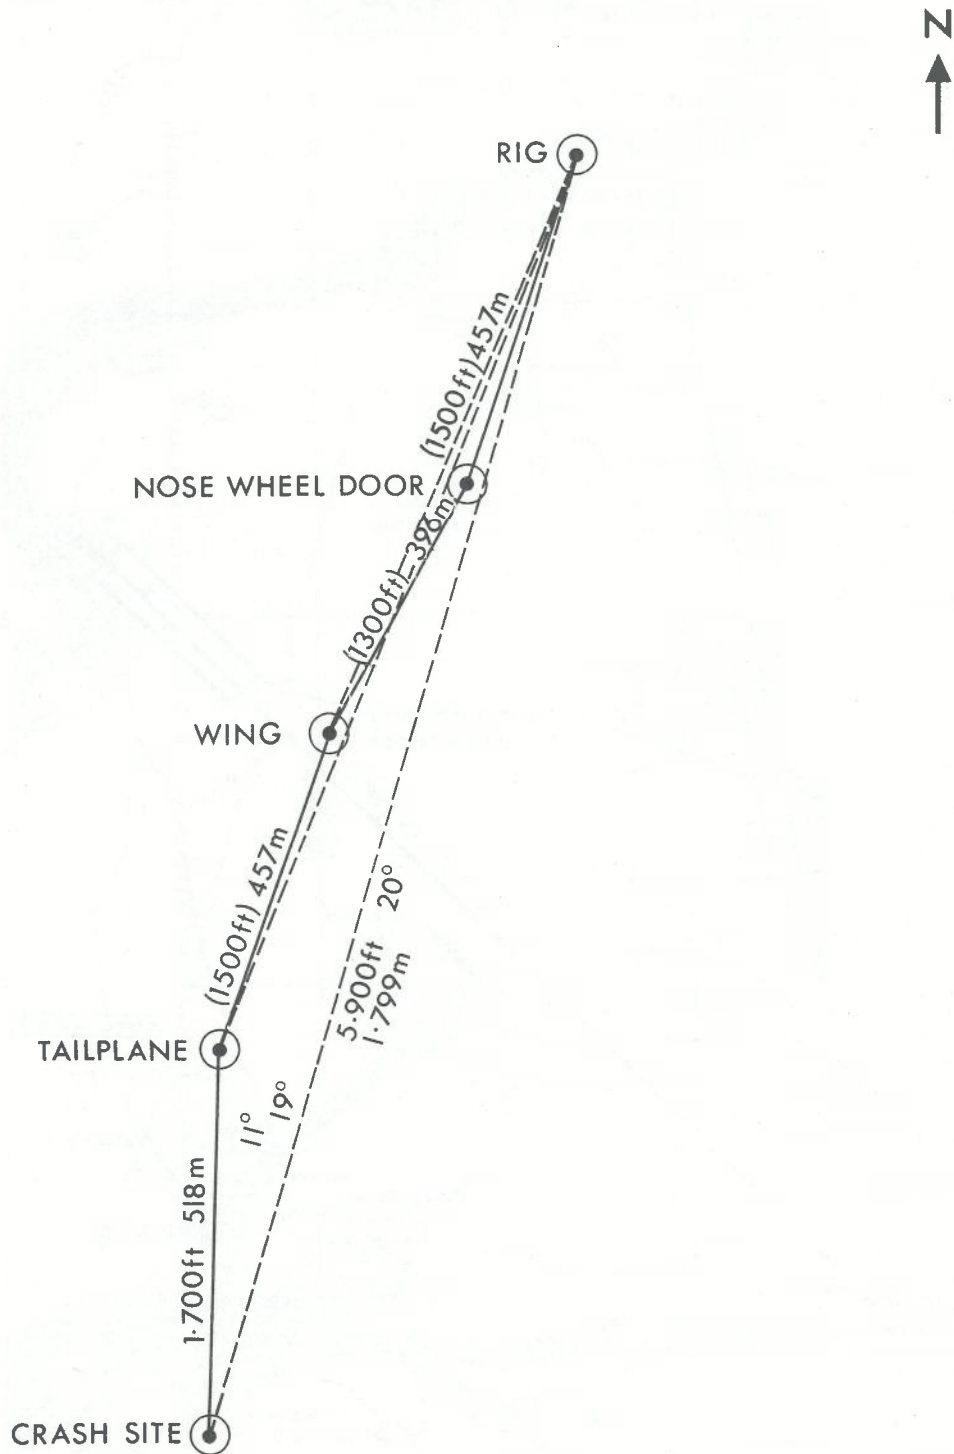
WRECKAGE DISTRIBUTION

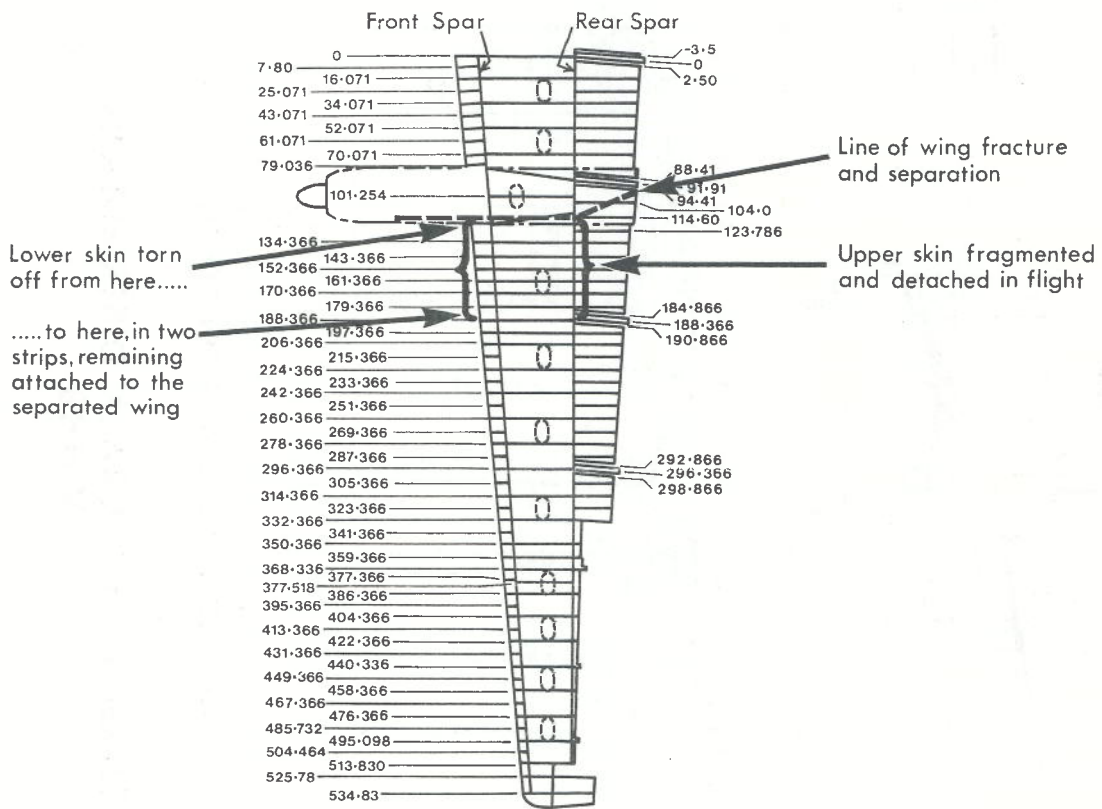
PLAN VIEW OF WING, SHOWING SEPARATION

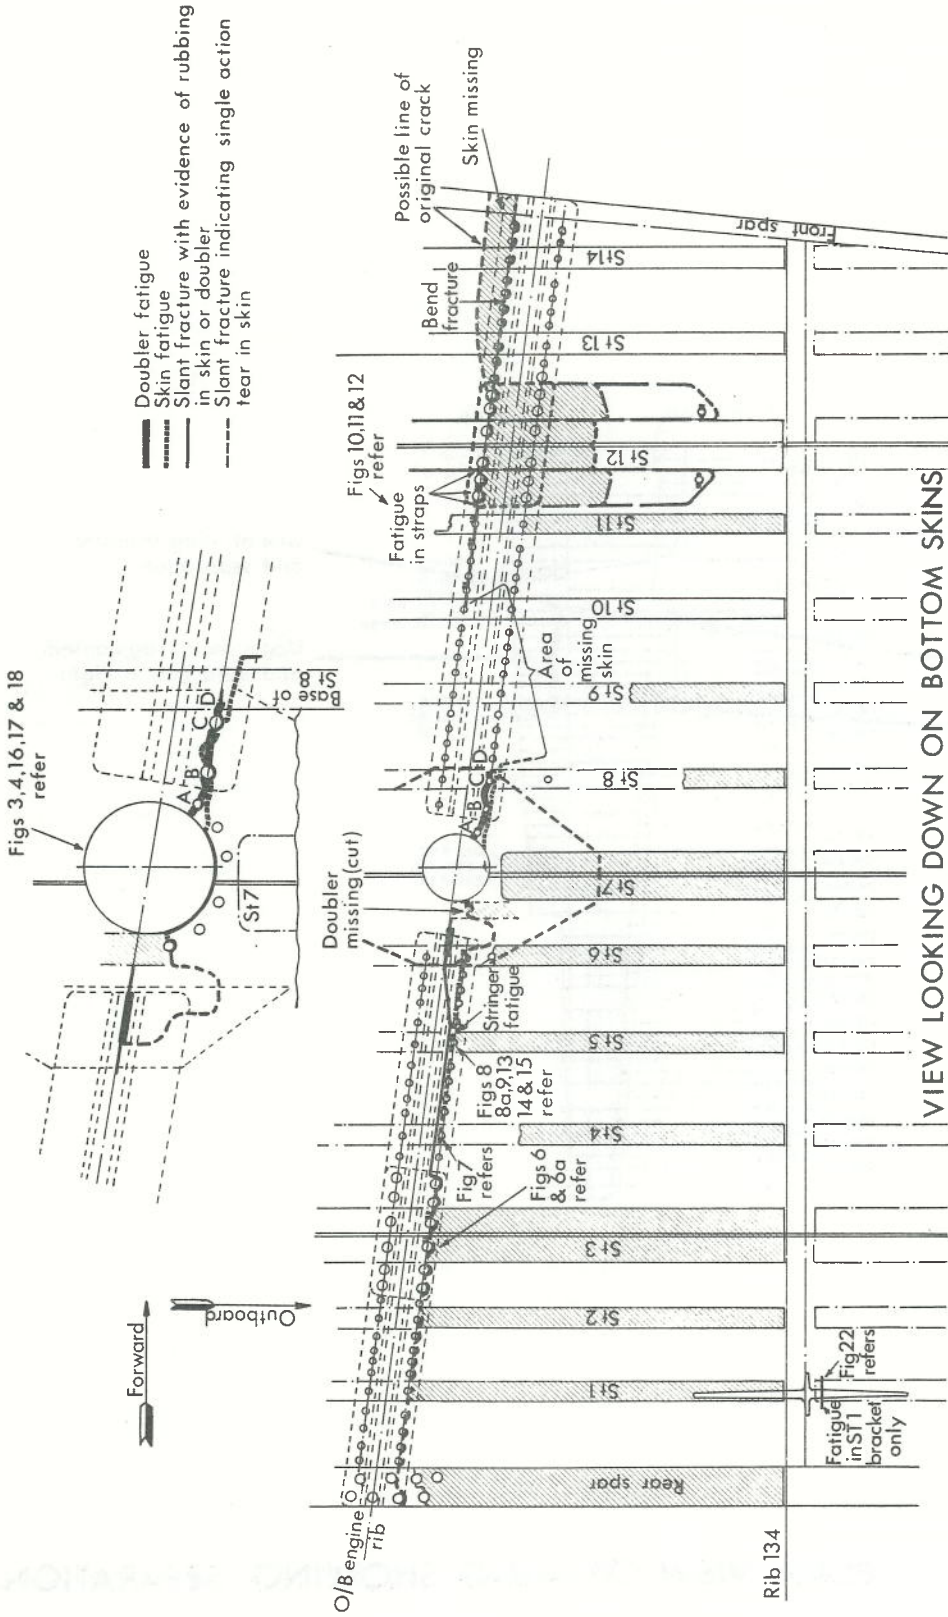
DIAGRAM PREPARED BY RAE

VIEW LOOKING DOWN ON BOTTOM SKINS

DIAGRAM OF CRACK DISTRIBUTION
LV-HHB

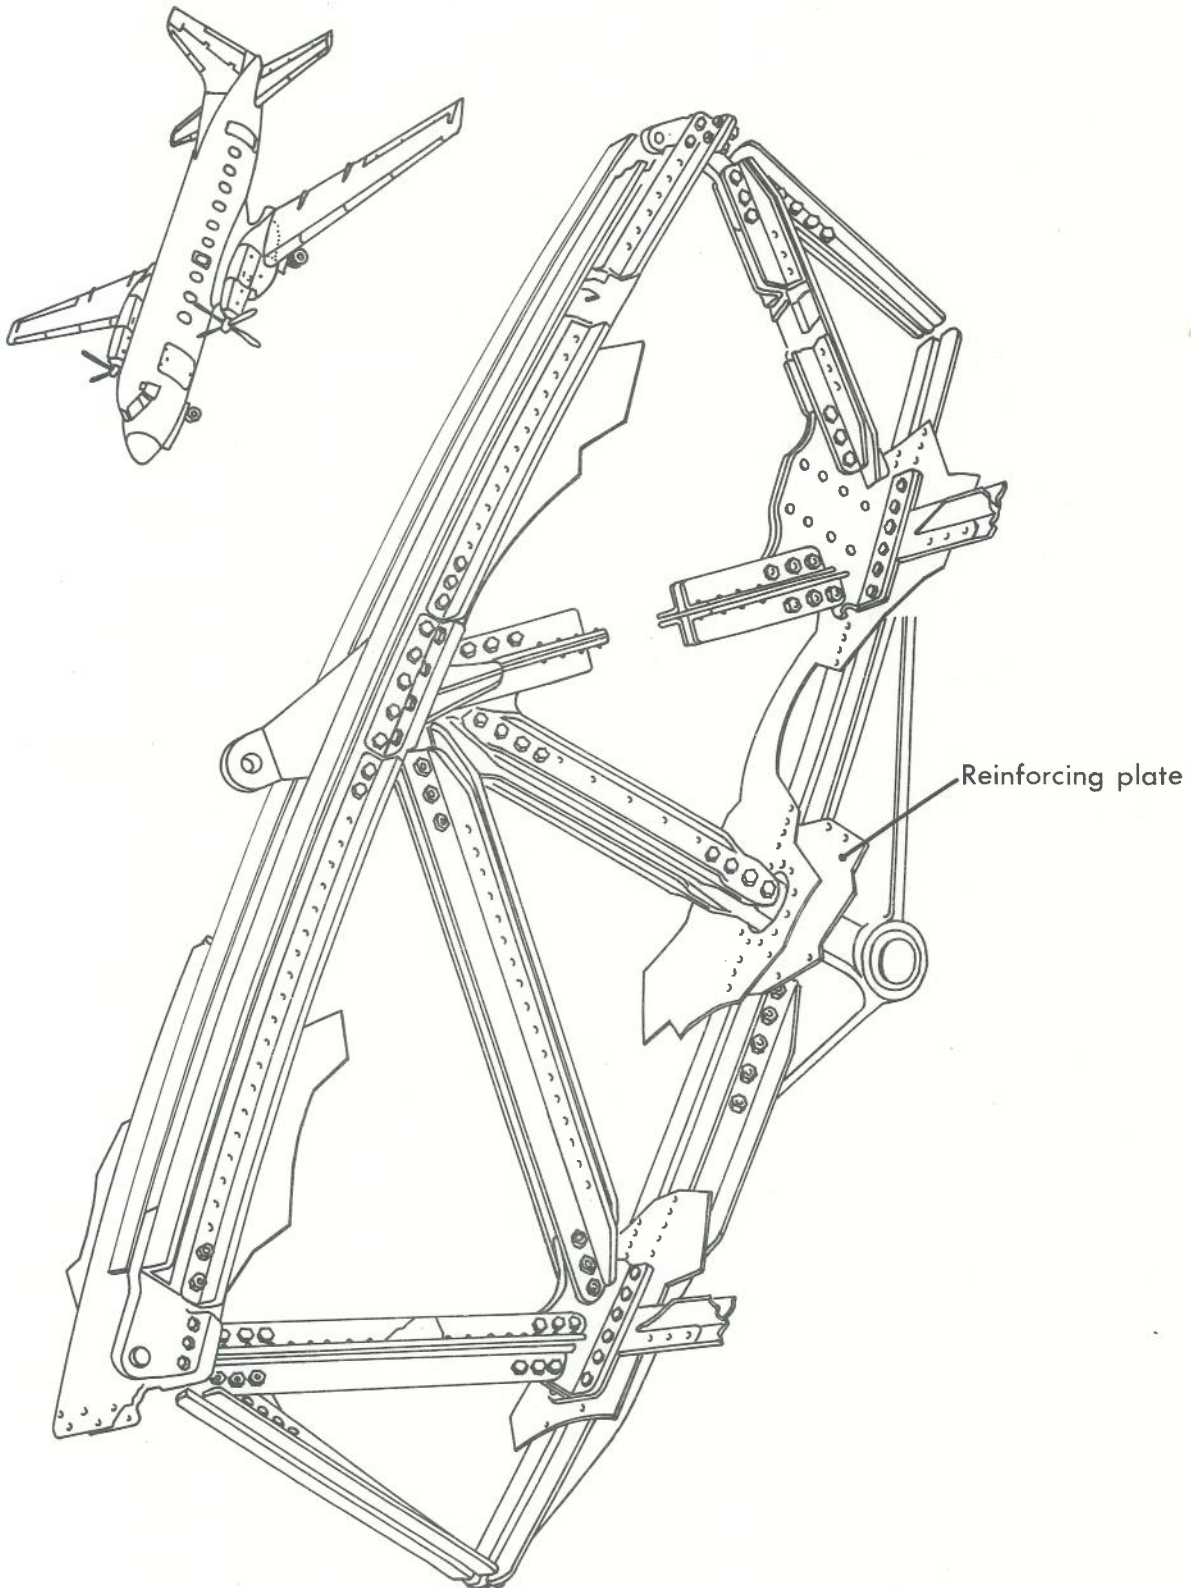
ENGINE OUTER RIB
& REINFORCING PLATE
