**Air Accidents Investigation Branch**

**Report on the accident to  
Antonov AN 28, HA-LAJ  
at RAF Weston-on-the-Green, Oxfordshire  
on 28 August 1993**

**Aircraft Accident Report No: 4/95**

**(EW/C93/8/5)**

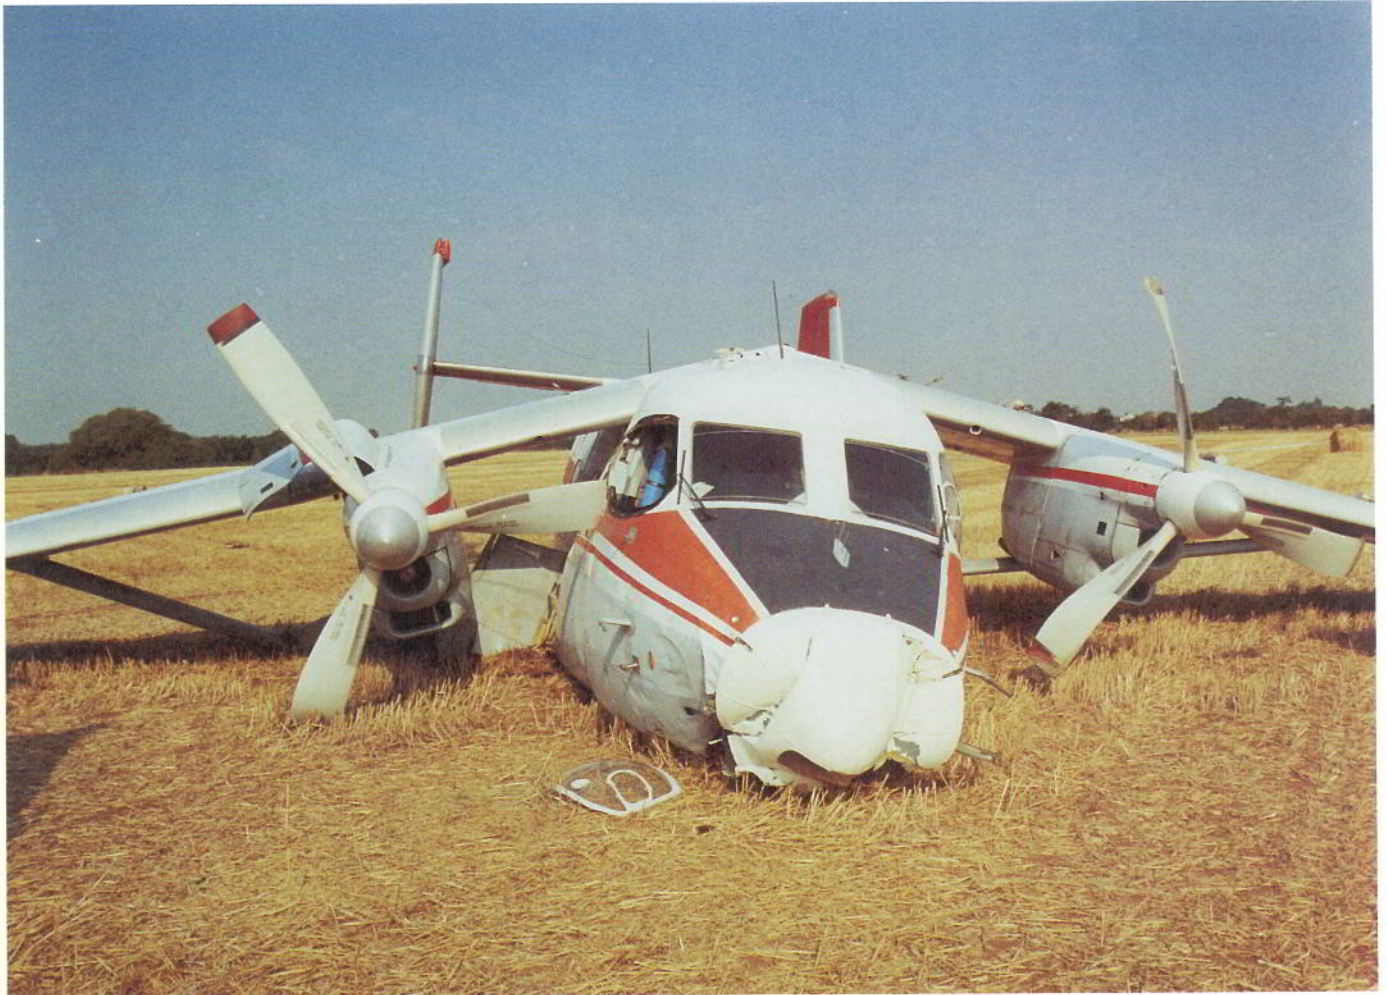
Showing damaged aircraft on site after forced landing

The aircraft suffered very substantial damage to the landing gear, wings, fuselage and propellers which rendered it beyond economic repair.

The aircraft was found to have struck the ground in a nose up, slightly right-wing low attitude with a high rate of descent and sufficient forward speed to achieve a ground slide of some 120 metres. All three landing gear units appeared to have collapsed on initial ground contact. Structural failure within the sponsons caused disruption of the struts supporting the outer wings and consequent gradually increasing anhedral of the wing structure as the aircraft slowed during the ground slide. This resulted in both wingtips and both aileron mass balance weights contacting the ground. The latter contact caused the outboard sections of both of the fabric covered ailerons to be torn off.

Although the damage was such that the underside of the fuselage was disrupted (particularly in the region of the main landing gear sponsons) and the cross-sectional shape of the fuselage was considerably altered, the floor remained almost intact and no significant penetration of the cabin occurred.
