**INCIDENT**

<b>Aircraft Type and Registration:</b>	Boeing 737-59D, G-BVKC	
<b>No &amp; Type of Engines:</b>	2 CFM56 turbofan engines	
<b>Year of Manufacture:</b>	1990	
<b>Date &amp; Time (UTC):</b>	1 September 1994 at 0628 hrs	
<b>Location:</b>	Stand B19, London Heathrow Airport	
<b>Type of Flight:</b>	Public Transport	
<b>Persons on Board:</b>	Crew - 7	Passengers - 52
<b>Injuries:</b>	Crew - None	Passengers - None
<b>Nature of Damage:</b>	Slight damage to left engine cowling	
<b>Commander's Licence:</b>	Airline Transport Pilot's Licence	
<b>Commander's Age:</b>	54 years	
<b>Commander's Flying Experience:</b>	8,000 hours (of which 3,000 were on type) Last 90 days - 230 hours Last 28 days - 75 hours	
<b>Information Source:</b>	AAIB Field Investigation

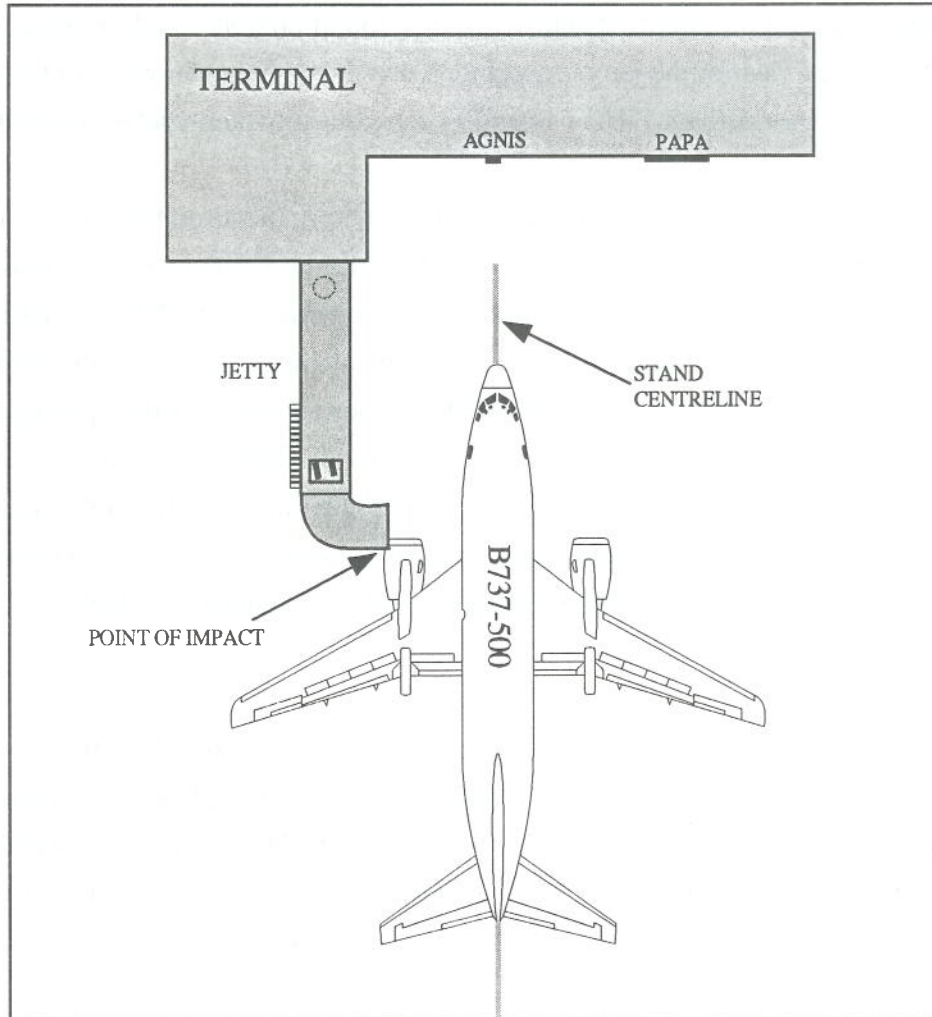
completed the shutdown checks. A ground engineer, who had been in his vehicle parked near the jetty as the aircraft arrived on stand, approached the aircraft and pointed towards the left engine. The commander opened the Direct-Vision (DV) window and saw the left engine cowling just resting beneath the rubber sill of the jetty. He contacted the cabin crew and made a PA to the passengers instructing them to remain on board. Meanwhile the ground engineer had organised a tug and the aircraft was pushed back clear of the jetty. It was then that the commander realised that the left engine cowling had suffered minor damage. The passengers were disembarked via the forward airstairs.

DIAGRAMATIC REPRESENTATION OF STAND B19 INCIDENT

Airfield Operations Standards Officers, in discussion with the AAIB after the incident, were considering publication of an Operational Safety Instruction, in the near future, to re-emphasise the fact that aircraft commanders are not to self-position on stands when the automatic stand entry guidance system is unserviceable.
