Piper PA-31 Navajo, G-ILEA

AAIB Bulletin No: 11/2003	Ref: EW/A2003/05/01	Category: 1.2
Aircraft Type and Registration:	Piper PA-31 Navajo, G-ILEA	
No & Type of Engines:	2 Lycoming TIO-540-A2C piston engines	
Year of Manufacture:	1978	
Date & Time (UTC):	18 May 2003 at 2046 hrs (local time -4hrs)	
Location:	54 miles west of Barbados	
Type of Flight:	Private	
Persons on Board:	Crew - 1	Passengers - 1
Injuries:	Crew - 1 (Missing)	Passengers - 1 (Missing)
Nature of Damage:	Aircraft lost at sea	
Commander's Licence:	Private Pilot's Licence	
Commander's Age:	56 years	
Commander's Flying Experience:	390 hours (approx) (of which 70 hrs (approx) were on type)	
	Last 90 days - unknown	
	Last 28 days - 1.6 hours	
Information Source:	Air Accidents Investigation Branch Field Investigation

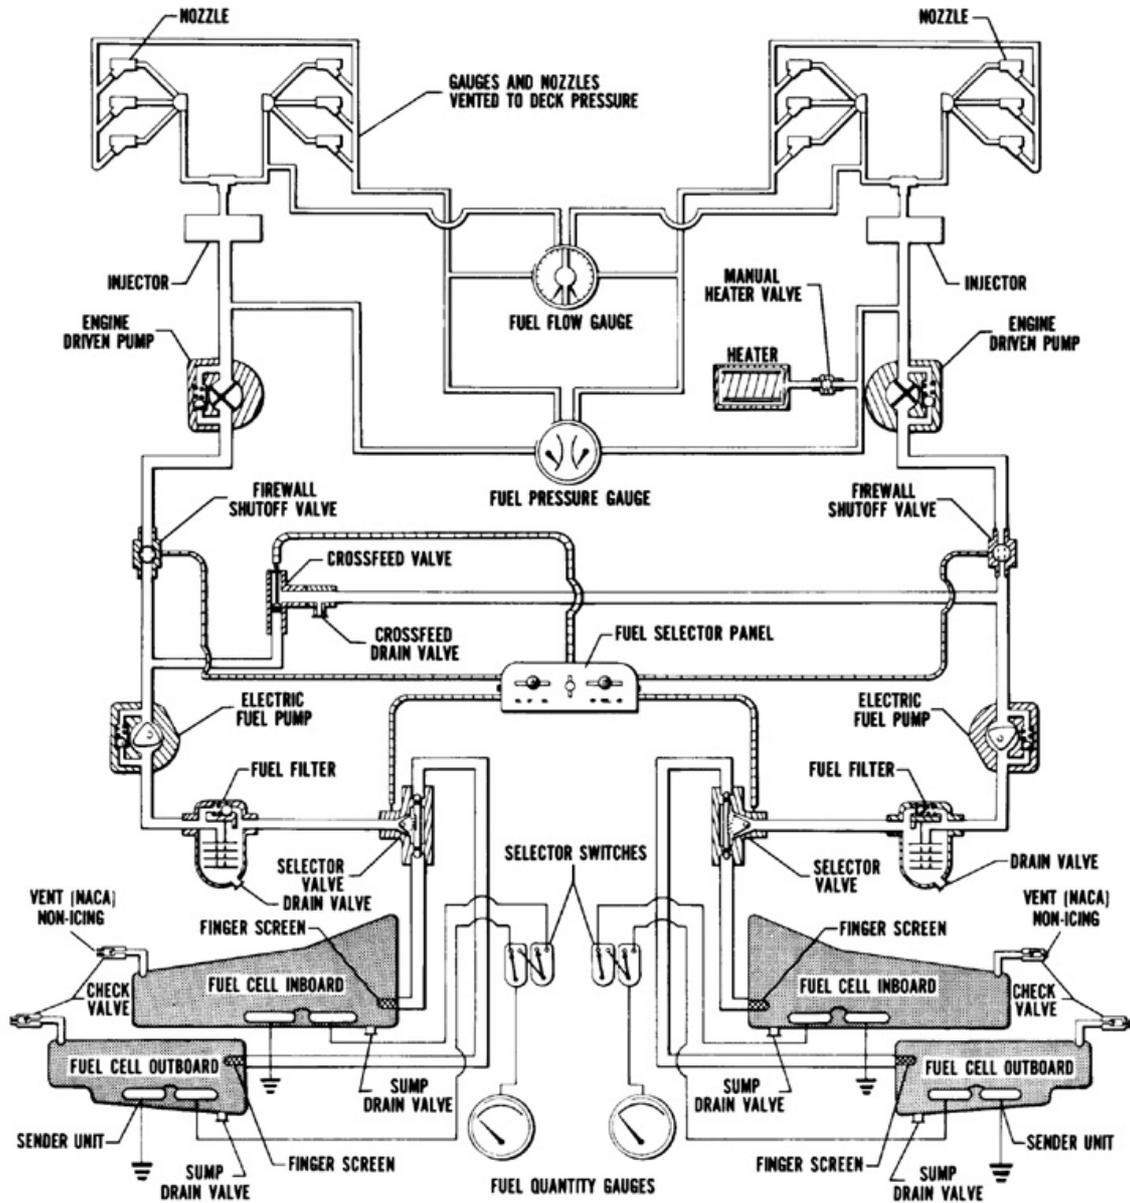
Aircraft Fuel System, Figure 1

Fuel is stored in four bladder type tanks in inboard and outboard cavities within each wing. Selection of the fuel supply to the engines is made via a fuel selector control panel located between the two pilot seats. The fuel selector, for each engine may be set to either inboard or outboard tanks, and the fuel from the selected tank is then supplied to the engine. The engine fuel supply may be interconnected by a crossfeed valve which, in an emergency, allows fuel from one side to be used by the engine on the opposite side. This aircraft was also fitted with nacelle tanks from which the fuel can be transferred into the inboard tanks by gravity feed. Each inboard tank has a capacity of 56 US gallons and each outboard tank has a fuel capacity of 40 US gallons. Each nacelle tank holds 27 US gallons.

There are three fuel drains on each wing, one at the bottom of each of the outboard and inboard tanks and one located on a pipe at the base of the fuel filter in each engine compartment. There is an

additional fuel drain located at the crossfeed valve under the left wing. The accident pilot's business partner recalled that the left inner fuel drain had a tendency to stick open after use.

Two fuel contents gauges, one for each side, are mounted on the instrument panel and are connected to their respective fuel selector, such that each gauge displays the selected tank contents as a proportion of its full capacity. Thus there is no quantitative indication of fuel contents; the pilot must relate the indicated proportion to the capacity of the tank selected in order to calculate fuel remaining. The contents of each tank can only be checked by the appropriate selection of that tank.
