AAIB Bulletin No: 1/94

Ref: EW/C93/11/1

Aircraft Type and Registration: Piper PA-31-350 Navajo Chieftain, G-VIPP

Date & Time (UTC): 4 November 1993 at 1144 hrs

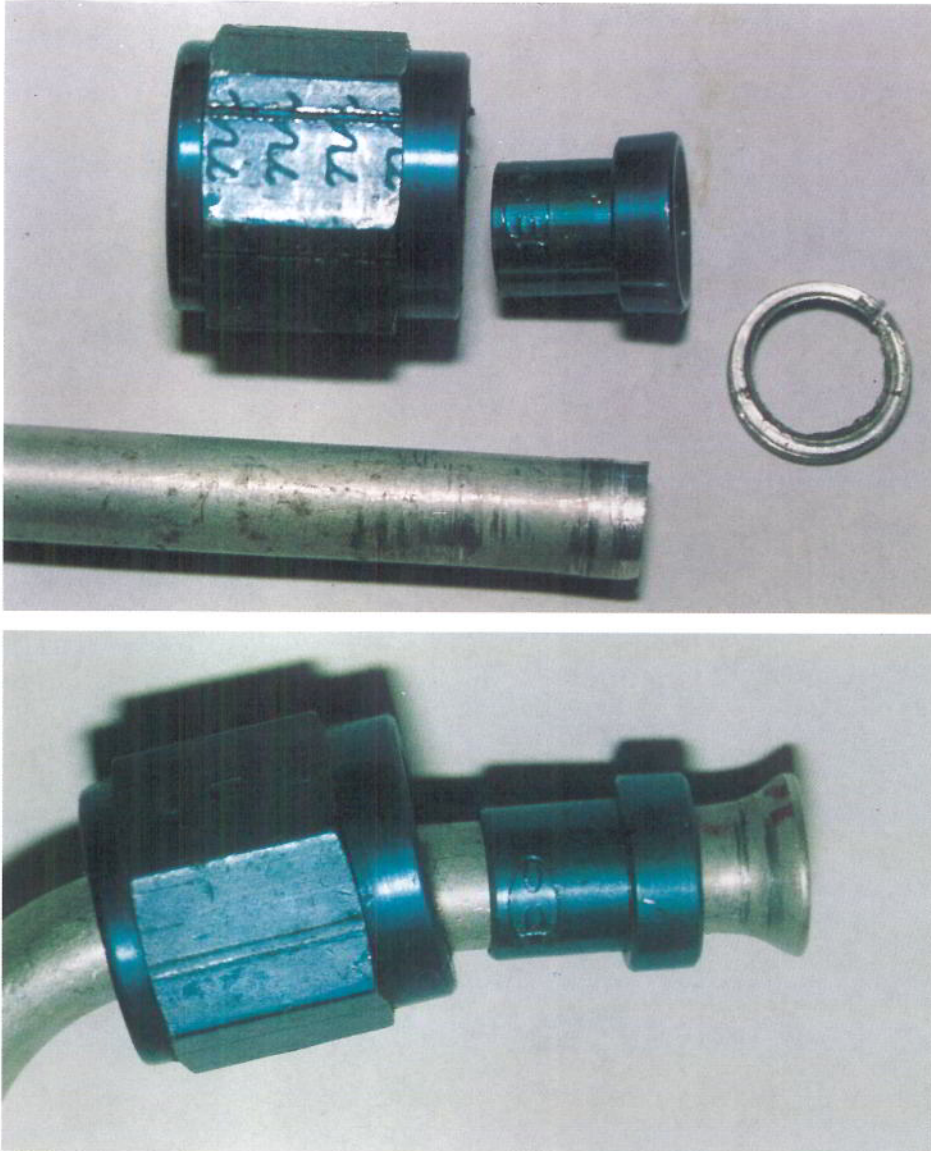
The coupling was a typical hydraulic union in that the nut, when tightened onto the male connector, caused the bellmouth to become clamped between the olive and the collar, thereby forming a seal. The separated portion of the bellmouth, which was approximately 2 mm in length, was found within the nut. A photograph of the constituent parts of the coupling (excluding the male connector), together with the intact end of the pipe, is shown at Figure 1.

It was noted that the two fracture halves could not be mated together as the internal diameter of the separate fragment was greater than the outside diameter of the fractured end of the pipe. It was also noted that the separated portion had various steps and chamfers where it had been in contact with the threads in the nut, and with the 'lipped' end of the collar, although it was not possible to exactly reconcile these features with the surface angles on the fittings. It is possible that this reflected a continuing plastic deformation (due to tightening of the nut) following partial separation.

Examination of the separated portion of the pipe revealed that it had been considerably deformed in the axial direction, and it did not exhibit the smoothly curved bell shape evident at the undamaged end. The fracture had occurred where the tube wall was very thin compared with the nominal wall thickness

FIGURE 1. Failed end of pipe, showing detached section of bellmouth, together with intact end

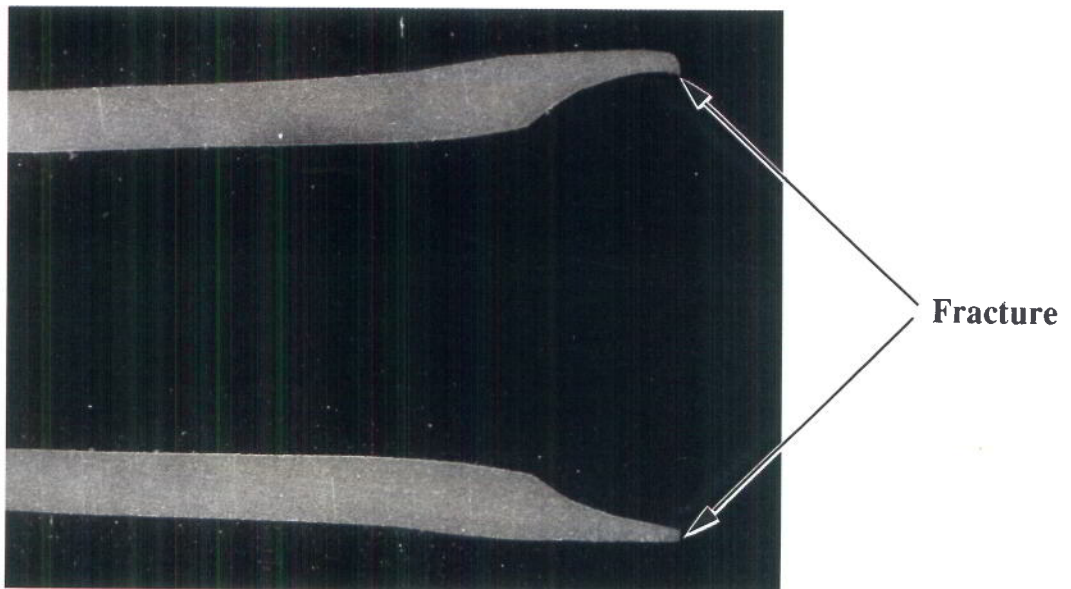
of 0.9 to 1.0 mm; this was measured as 0.12 to 0.18 mm on the separated portion and 0.2 to 0.3 mm on the major part of the pipe. The latter was sectioned longitudinally and the thinning of the tube wall towards the fracture was clearly visible (see Figure 2). The examination indicated that neither fatigue nor a material defect had played any part in the failure. The general appearance of the failure strongly suggested that the wall thinning effect was associated with a poorly executed flaring operation during manufacture.

FIGURE 2. Section through failed pipe, showing wall thinning
