**INCIDENT**

<b>Aircraft Type and Registration:</b>	Jetstream 4100, G-MAJA
<b>No &amp; Type of Engines:</b>	2 Garrett Airesearch (Honeywell) TPE331-14HR-802H Turboprop engines
<b>Year of Manufacture:</b>	1994
<b>Date &amp; Time (UTC):</b>	29 June 2005 at 1523 hrs
<b>Location:</b>	Manchester Airport, Manchester
<b>Type of Flight:</b>	Public Transport (Passenger)
<b>Persons on Board:</b>	Crew - 3                      Passengers - 10
<b>Injuries:</b>	Crew - None                      Passengers - None
<b>Nature of Damage:</b>	Nil
<b>Commander's Licence:</b>	Airline Transport Pilot's Licence
<b>Commander's Age:</b>	50 years
<b>Commander's Flying Experience:</b>	3,270 hours (of which 1,310 were on type) Last 90 days - 275 hours Last 28 days - 52 hours
<b>Information Source:</b>	AAIB Field Investigation

**Synopsis**

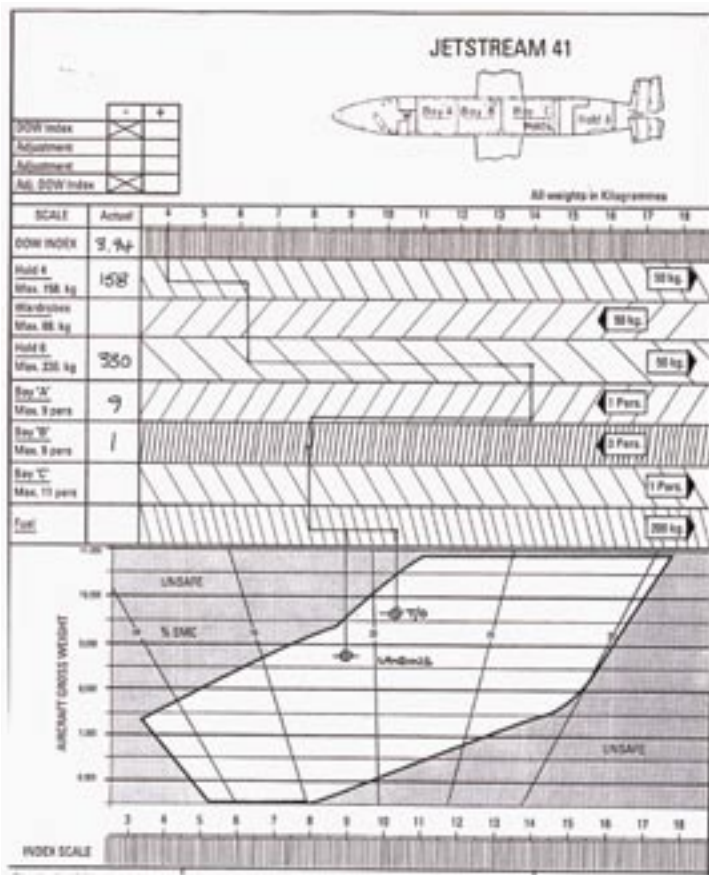
Figure 1 (Left)

had not been weighed and that they were not planning to weigh them. The bags were then loaded into the two baggage compartments; Holds 4 and 6 (see Figure 1). These were both filled to volumetric capacity and the remaining bags (approximately five) were stored in the passenger cabin. The commander appreciated that the centre of gravity would be positioned significantly aft as a result of the full baggage compartments and asked the cabin attendant to seat the passengers in the forward seats. All the loading information was then passed to the first officer who completed the manual loadsheet which the commander then signed. Throughout this period the first officer had remained on the flight deck. The passengers then boarded the aircraft and it was noted by the commander that they possessed a significant amount of hand baggage.

This particular variant of the Jetstream 4100 has a passenger cabin comprising nine rows of three seats and a tenth row of two seats. The cabin attendant's seat is immediately behind the tenth row, adjacent to the galley and a wardrobe is situated behind the first officer's seat. For loading purposes, the cabin is divided into three bays; Bay A contains seat rows 1-3, Bay B contains Rows 4-6 and Bay C contains rows 7-10. There are two cargo holds; Hold 4 just aft of the wing and Hold 6 towards the rear of the fuselage. The wardrobe, Bay A and Bay B all have a forward effect on centre of gravity whilst Bay C, both holds and the fuel load have an aft effect.

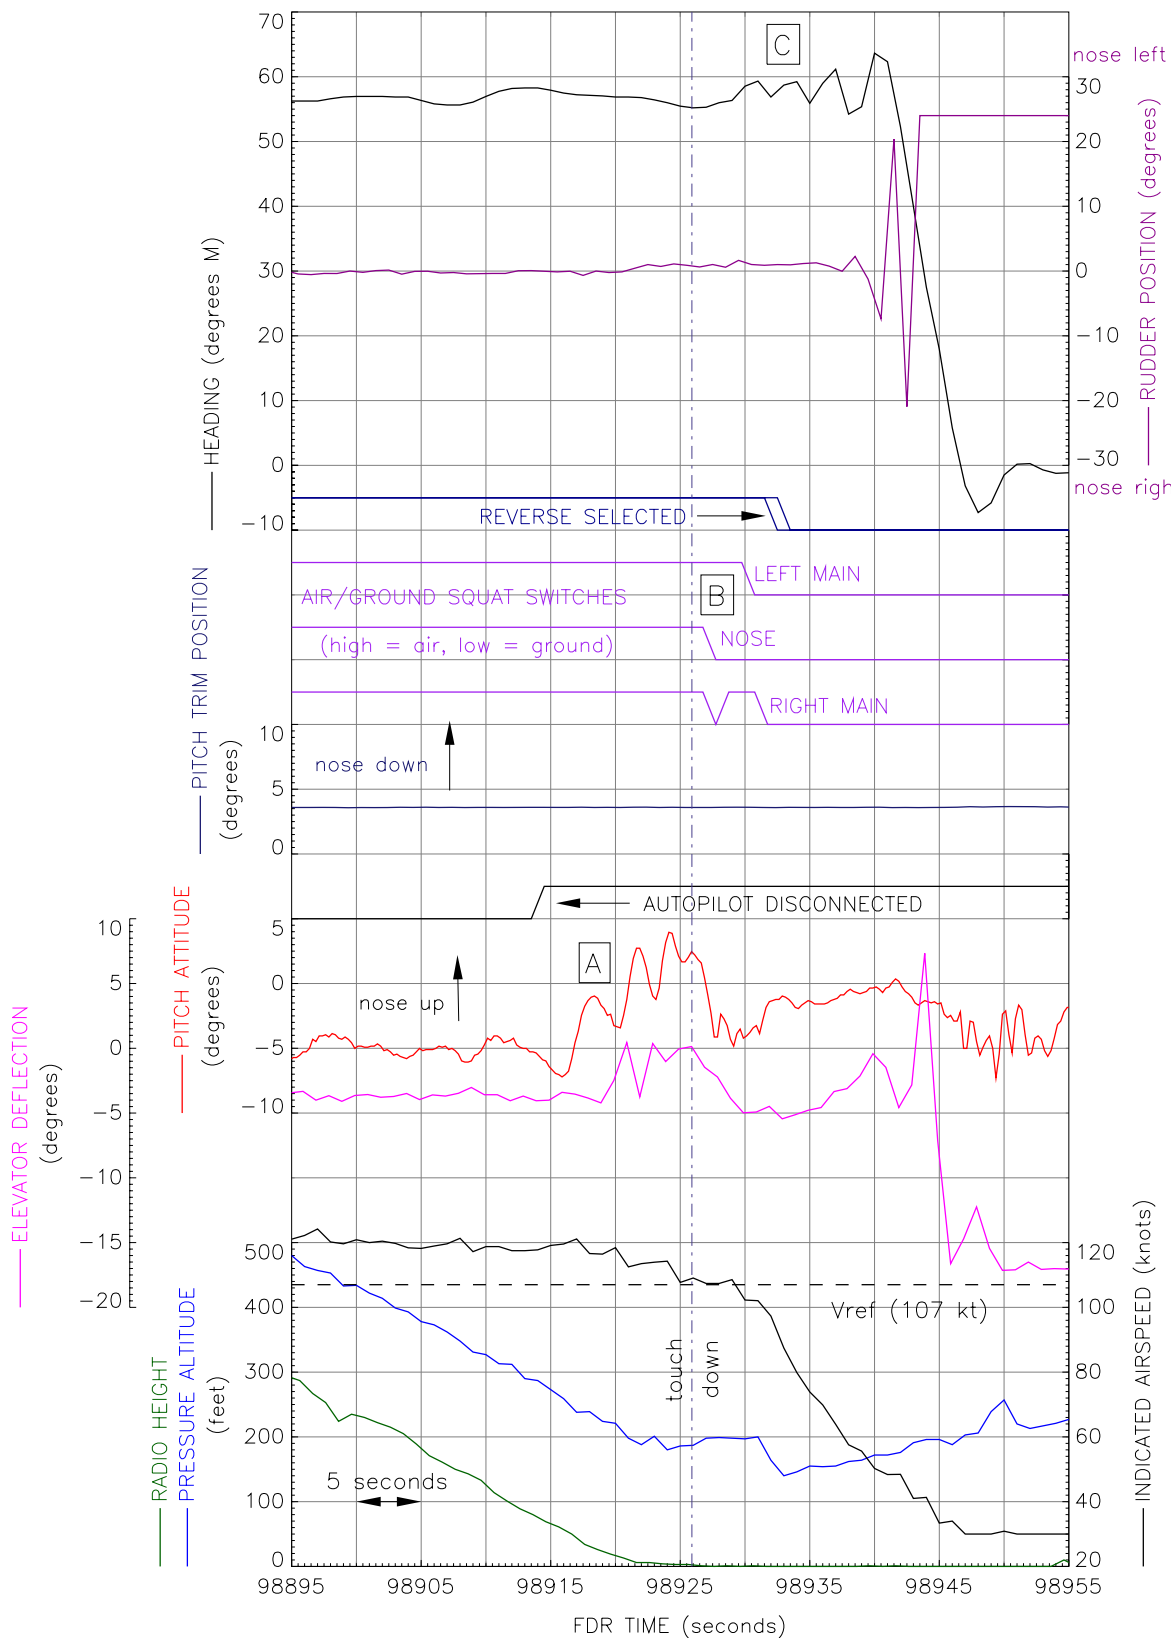
**Figure 3**  
 Salient FDR Parameters  
 (Serious Incident to G-MAJA on 29 June 2005)

A time-history of the relevant parameters during the incident landing is shown at Figure 3. The data presented

At approximately 80 ft agl the autopilot<sup>3</sup> was disconnected. Coincident with the autopilot disconnect, and about 12 seconds before touchdown, the aircraft pitched nose down from -5° to -7°. Following an application of nose up elevator the pitch angle increased by 6° to -1°. Two further pitch oscillations were recorded prior to the flare. These pitch oscillations are indicated by Point A at Figure 3.

Just before touchdown the aircraft had a yaw rate to the left of approximately 0.5°/s. The aircraft then banked to the right with a 2.5° roll attitude recorded at touchdown as the yaw rate reduced to zero. At touchdown, the pitch attitude was +2.5°, the airspeed was 107 kt IAS (ie  $V_{ref}$ ), and the normal acceleration peaked at 1.25 g. Immediately after touchdown the aircraft pitched nose-down to -4°.

air/ground landing gear squat switch positions after touchdown are indicated by Point B at Figure 3. Reverse thrust from the propeller blades was selected shortly after this without any noticeable change in aircraft pitch or heading.

Three seconds after touchdown, the aircraft yawed more sharply to the right (at just under 3°/s) before reversing the direction of yaw to the left. The aircraft yawed right then left another three times, each directional-oscillation growing in amplitude, before coming to a rest off to the left of the runway on a heading of 358°M. These oscillations in yaw are indicated by Point C at Figure 3. Increasing rudder deflections to a maximum of +24° were recorded (where positive indicates yaw to the right and ± 24° is full deflection); these rudder deflections commenced about 10 seconds after touchdown and were in phase with, but slightly lagging the oscillations, and in the same sense (ie driving the oscillation).
