ACCIDENT

Aircraft Type and Registration:	Piper PA-38-112 Tomahawk, G-BODP	
No & Type of Engines:	1 Lycoming O-235-L2C piston engine	
Year of Manufacture:	1981 (Serial no: 38-81A0010)	
Date & Time (UTC):	16 August 2012 at 1935 hrs	
Location:	Near Bruera, Cheshire	
Type of Flight:	Training	
Persons on Board:	Crew - 2	Passengers - None
Injuries:	Crew - 2 (Fatal)	Passengers - N/A
Nature of Damage:	Aircraft destroyed	
Commander's Licence:	Commercial Pilot's Licence	
Commander's Age:	50 years	
Commander's Flying Experience:	10,440 hours (estimated) (of which at least 150 were on type) Last 90 days - 135 hours (estimated) Last 28 days - 45 hours (estimated)	
Information Source:	AAIB Field Investigation

Synopsis

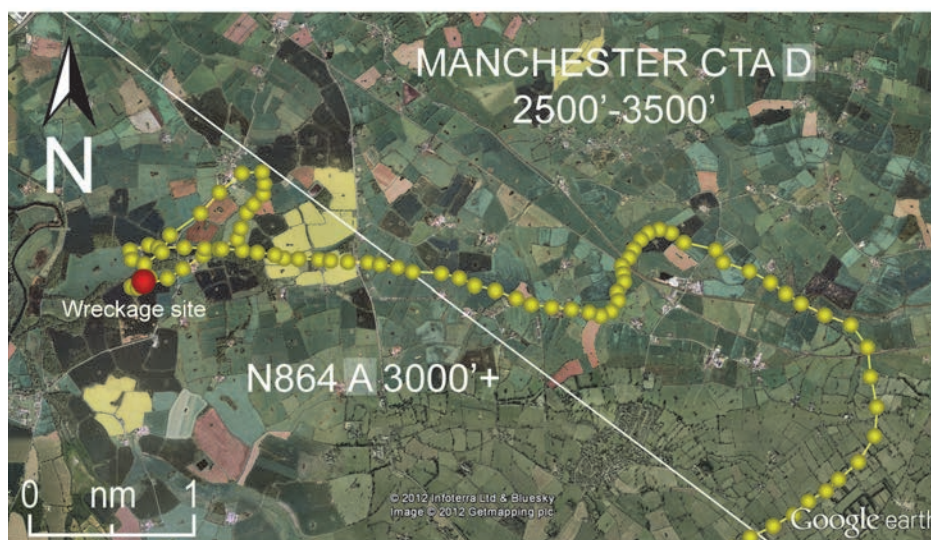
Figure 1

Clee Hill radar track for the last eleven minutes of the flight

about 30 kt, the aircraft was tracking about 200° ie into the nominal wind. In Figure 1, this corresponds to the section of the aircraft's track in the Manchester CTA where the radar returns appear to be overlapping and the aircraft turned 90° to the left, onto a south-south-westerly track, and then turned right onto a westerly track. Adjusting for a 30 kt wind from 200° gave an airspeed of approximately 60 kt.

Relevant controlled airspace, shown on Figure 1, comprised Airway N864 and the Manchester Control Area (CTA), both of which required ATC's permission for entry. The base of N864 was at 3,000 ft amsl and the base of the Manchester CTA was at 2,500 ft. Hawarden

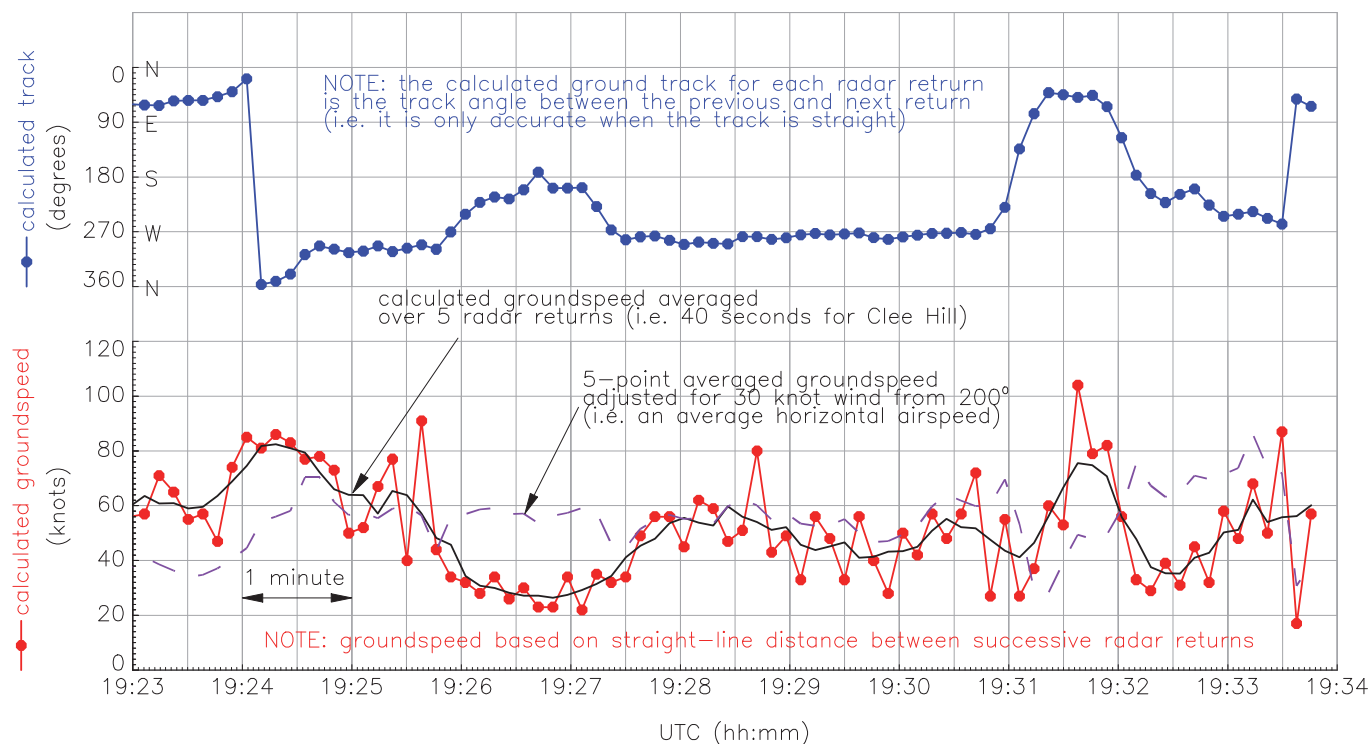
Variation in groundspeed and track for the last eleven minutes of the flight (Clee Hill radar)

corresponding aircraft track for this final portion of the flight. Figure 2 also includes a plot of the estimated horizontal component of the aircraft's airspeed, based on the five-point average groundspeed, corrected for a nominal wind of $200^{\circ}/30$ kt.

As an example, in Figure 2 between 1926 hrs and 1927 hrs, when the calculated average groundspeed was
