ACCIDENT

Aircraft Type and Registration:	Piper PA-28-181, N2405Y	
No & Type of Engines:	1 Lycoming O-360-A4M piston engine	
Year of Manufacture:	1985	
Date & Time (UTC):	10 April 2009 at 1123 hrs	
Location:	Near Steep, Petersfield, Hampshire	
Type of Flight:	Private	
Persons on Board:	Crew - 1	Passengers - 1
Injuries:	Crew - 1 (Fatal)	Passengers - 1 (Fatal)
Nature of Damage:	Aircraft destroyed	
Commander's Licence:	Private Pilot's Licence	
Commander's Age:	47 years	
Commander's Flying Experience:	225 hours on type since August 2006 Last 90 days - 16 hours Last 28 days - 7 hours	
Information Source:	AAIB Field Investigation

Synopsis

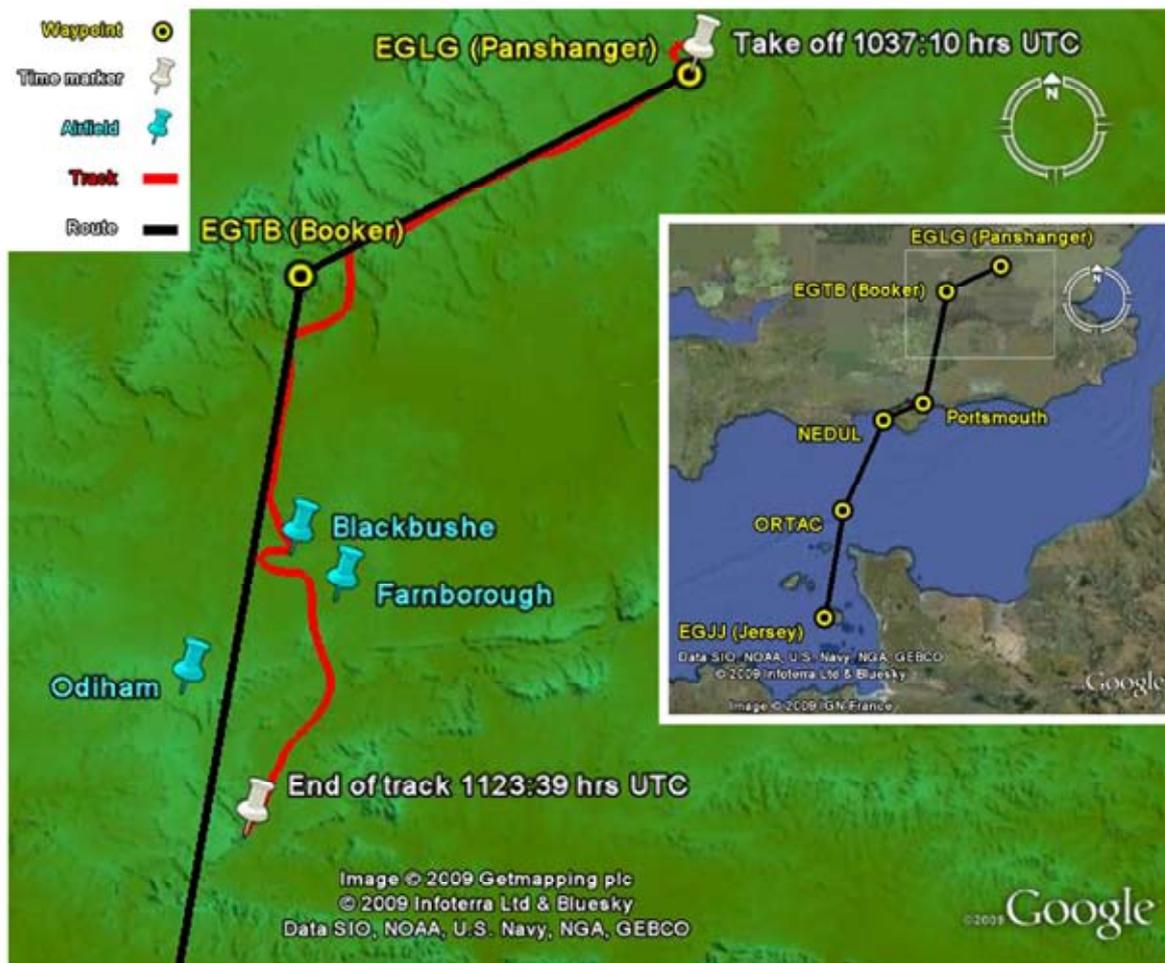
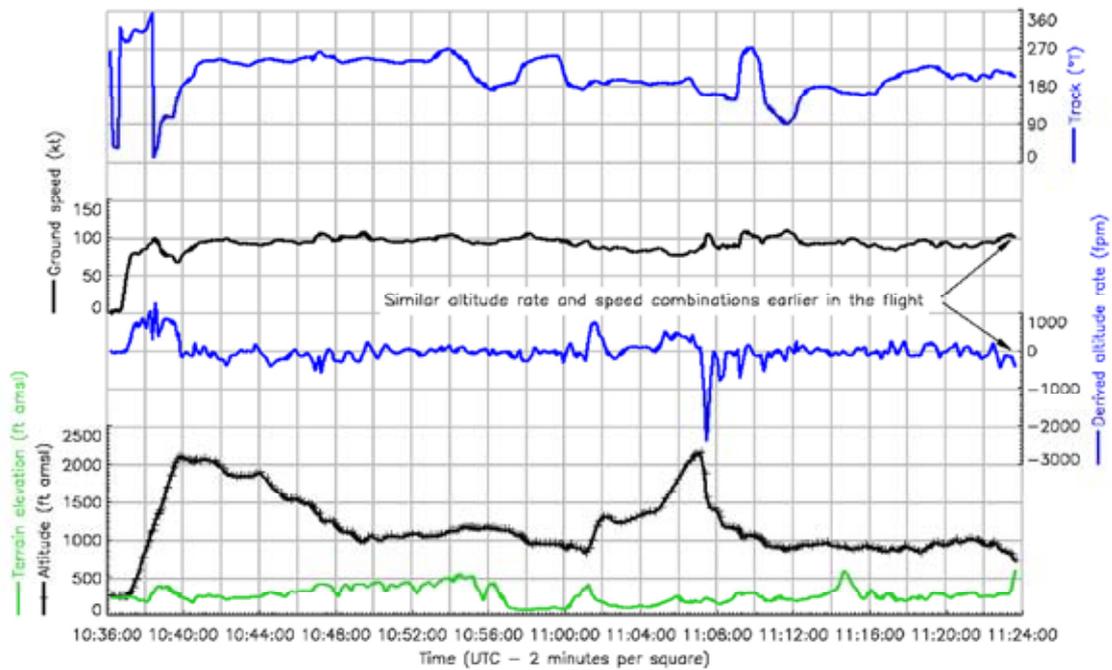
As well as the track, Figure 1 shows the altitude of the aircraft and the elevation of the ground below it. After the aircraft took off at 1037 hrs, it climbed to 2,000 ft amsl. It then carried out a slow descent to 1,000 ft amsl from 1040 to 1050 hrs. For the next 10 minutes, the aircraft flew at between 800 and 1,200 ft amsl corresponding generally to between 600 and 1,000 ft agl but at 1102 hrs it crossed a ridge at 460 ft agl. The aircraft climbed back to 2,000 ft amsl over the next five minutes but descended back to 1,000 ft amsl by 1110 hrs. For the next 12 minutes, the aircraft remained at 1,000 ft amsl, crossing one ridge at approximately 330 ft agl. Just after 1122 hrs, the aircraft began to descend to 750 ft amsl with an average rate of descent of 200 feet per minute. As the aircraft began its slow descent, the ground below it started to rise gently but in the last 10 seconds before impact the ground rose sharply.

Last flight recorded in the GPS, N2405Y

Once airborne, the pilot flew the majority of the route between 1,200 and 1,000 ft amsl, with the last 14 minutes flown essentially level at 1,000 ft amsl. The aircraft’s height above ground level varied as the elevation of the terrain over which it flew varied. On one occasion, its height over a ridge was about 330 ft.

This was consistent with the pilot flying just below a substantially level cloud base to maintain clear of cloud and to maximise terrain clearance. If this was the case, the descent towards the ridge was likely to have been in response to the cloud base lowering from about 1,000 ft amsl to about 720 ft amsl, as reported by the witness at the accident site.

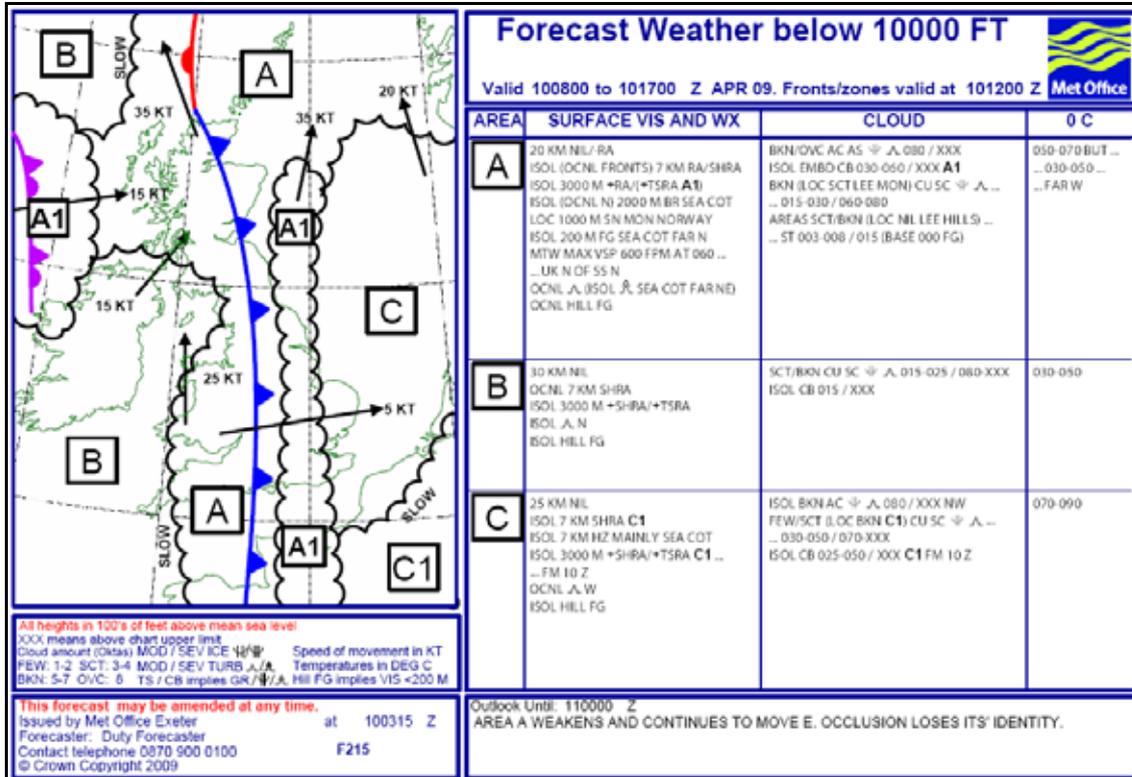
The worst weather expected for the route was isolated areas with visibility of 3,000 m in heavy rain or thunderstorms. Isolated areas of 2,000 m visibility in

mist were forecast over the sea and coastal areas. Areas of scattered or broken stratus were forecast with bases between 300 and 800 ft amsl. The tops of the cloud were forecast to be above 10,000 ft amsl.

Figure 2
The forecast weather below 10,000 ft

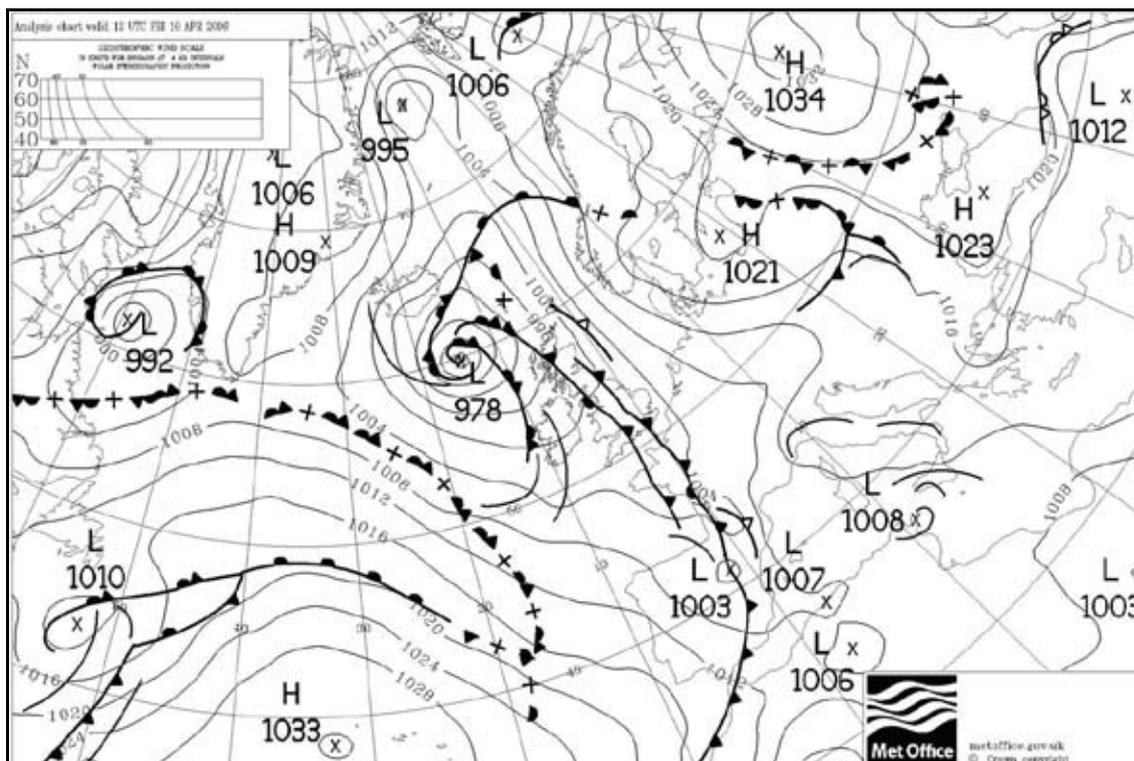
Figure 3

'It is evident that, whilst varying in time and space, cloud cover over the general area of the site was low. FEW to BKN stratus, base 300 FT to 1200 FT AMSL is estimated to have prevailed across the area and this would have covered the hills and high ground in the area. The area was affected by generally moderate rain or drizzle, which through direct evidence is reported as being between 5000 M and 12 KM. Isolated heavy rain or drizzle is evidenced on the radar, and empirically this might be expected to reduce visibility to 3500 M – though there is no direct evidence of this. Visibility in cloud, and hill fog, is likely to have been below 200 M and given the low cloud base such visibility would have been extant over hills and high ground above 300 FT AMSL.'

Synoptic situation at 1200 hr
