## ACCIDENT

<b>Aircraft Type and Registration:</b>	Cessna A152, G-BHAC	
<b>No &amp; Type of Engines:</b>	1 Lycoming O-235-L2C piston engine	
<b>Year of Manufacture:</b>	1978	
<b>Date &amp; Time (UTC):</b>	11 September 2006 at 1611 hrs	
<b>Location:</b>	Near Bethesda, Gwynedd, Wales	
<b>Type of Flight:</b>	Private	
<b>Persons on Board:</b>	Crew - 1	Passengers - 1
<b>Injuries:</b>	Crew - 1 (Serious)	Passengers - 1 (Fatal)
<b>Nature of Damage:</b>	Aircraft destroyed	
<b>Commander's Licence:</b>	Private Pilot's Licence	
<b>Commander's Age:</b>	60 years	
<b>Commander's Flying Experience:</b>	116 hours (of which 114 were on type) Last 90 days - 12 hours Last 28 days - 6 hours	
<b>Information Source:</b>	AAIB Field Investigation

## Synopsis

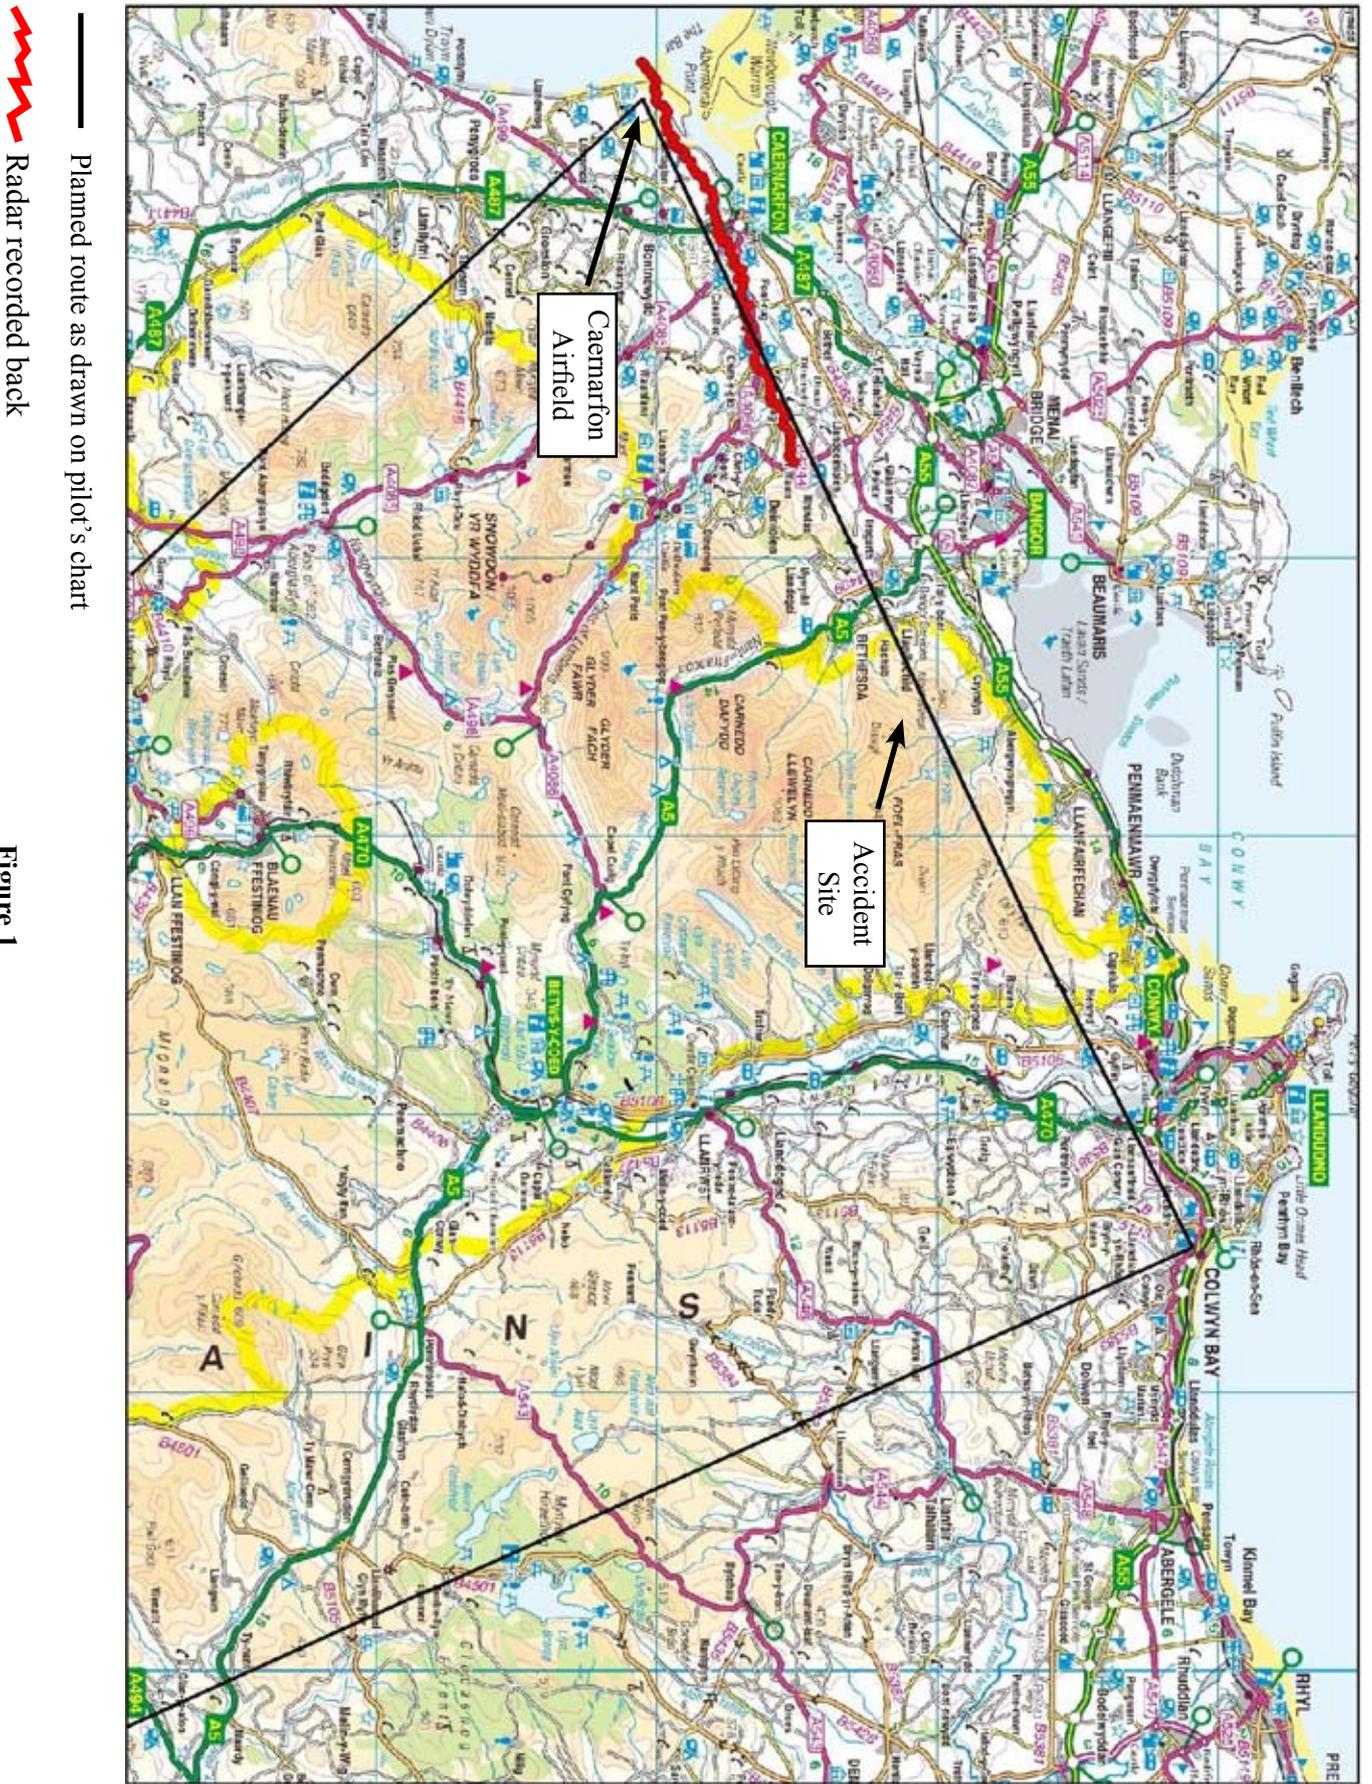
Figure 1

was the first time that the pilot had flown to Caernarfon Airfield although he had visited the airfield as a passenger three years previously. The weather was checked using the flying club's internet facilities and a flight log prepared for the route. The Minimum Safe Altitude (MSA) for the Colwyn Bay-Caernarfon leg of the route was noted as 4,900 ft on the flight log. On the pilot's chart a triangular route was drawn; Shobdon to Colwyn Bay to Caernarfon Airfield to Shobdon (see Figure 1). Wind corrected headings and timings were added to the chart for the first two legs of the route.

Blackpool recorded the aircraft's track until 1612 hrs and this is shown in Figure 1. At 1611 hrs, G-BHAC called RAF Valley ATC to request a Flight Information Service (FIS). The controller offered the pilot a FIS and passed the Holyhead regional pressure setting of 1009 mb. The pilot replied *'QNH 1019, G-BHAC IS A CESSNA 152 ROUTING CAERNARFON SHOBDON VIA COLWYN BAY CURRENTLY TO THE EAST OF CAERNARFON HEADING 190° AT 1,800 FT VFR'*. The controller corrected the inaccurately readback QNH and this was acknowledged by the pilot. Nothing more was heard from the aircraft.

After getting airborne the aircraft took up a track which diverged immediately from the stated routing towards the Menai Straits. The track followed was a direct line towards Colwyn Bay, which was also the routing transmitted to ATC at RAF Valley. The pilot's chart had a line drawn from Colwyn Bay to Caernarfon Airfield and the track followed back was coincident with this. The accident site was situated within one mile of this drawn line and its elevation (1,970 ft amsl) is only slightly higher than the height the pilot stated he was flying at (1,800 ft amsl) to ATC. The pilot, having no memory recall of this flight, was not in a position to say why this particular route was followed at a height below the minimum safe altitude into an area of cloud or low visibility. However, given his transmission to ATC that he was routing Caernarfon to Colwyn Bay, the line on his chart reflecting this routing and the radar recording showing that the flight actually proceeded along this route, it does appear that this route was the pilot's intention.
