ACCIDENT

Aircraft Type and Registration:	Europa, G-BWCV	
No & Type of Engines:	1 NSI Propulsion Systems EA-81 piston engine	
Year of Manufacture:	1997	
Date & Time (UTC):	16 July 2006 at 1115 hrs	
Location:	Near Portbury, North Somerset	
Type of Flight:	Private	
Persons on Board:	Crew - 1	Passengers -1
Injuries:	Crew - 1 (Minor)	Passengers - 1 (Minor)
Nature of Damage:	Extensive damage to composite fuselage structure	
Commander's Licence:	Private Pilot's Licence	
Commander's Age:	46 years	
Commander's Flying Experience:	977 hours (of which 31 were on type) Last 90 days - 30 hours Last 28 days - 14 hours	
Information Source:	AAIB Field Investigation

Synopsis

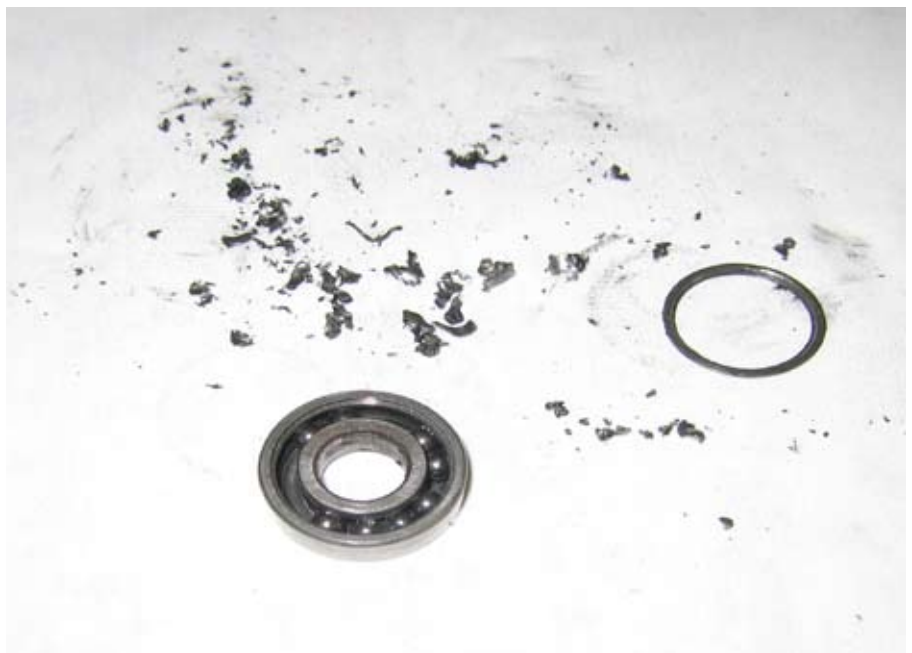
Figure 1

The alternator main bearing was found to have seized and was stripped for examination. The bearing was a sealed unit with caged balls. The cage was found to have failed; see Figure 1. A metallurgist with significant experience in investigating failed bearings concluded that the failure was due to lack of grease in the bearing. In addition to lubrication, grease dampens vibration between the balls and the cage pillars, and the lack of grease removed this damping, causing the cage to fail in overload. Typically such sealed bearings have a shelf-life since the grease can degrade with time. The pilot considered that the life of the grease might also have been adversely affected by elevated temperatures associated with the configuration of the installation.

The main bearing of the alternator had seized due to lack of grease. This engine was refurbished approximately 10 years ago as part of its conversion to an aircraft unit and it was not possible to determine the history of the alternator components.
