## ACCIDENT

<b>Aircraft Type and Registration:</b>	Boeing 747-443, G-VLIP	
<b>No &amp; Type of Engines:</b>	4 General Electric CF6-80C2B1F turbofan engines	
<b>Year of Manufacture:</b>	2001	
<b>Date &amp; Time (UTC):</b>	20 March 2007 at 0654 hrs	
<b>Location:</b>	London Gatwick Airport	
<b>Type of Flight:</b>	Commercial Air Transport (Passenger)	
<b>Persons on Board:</b>	Crew - 17	Passengers - 238
<b>Injuries:</b>	Crew - None	Passengers - None
<b>Nature of Damage:</b>	Damage to underside of the two right engine nacelles	
<b>Commander's Licence:</b>	Airline Transport Pilot's Licence	
<b>Commander's Age:</b>	54 years	
<b>Commander's Flying Experience:</b>	15,925 hours (of which 4,885 were on type) Last 90 days - 127 hours Last 28 days - 34 hours	
<b>Information Source:</b>	AAIB Field Investigation

### Synopsis

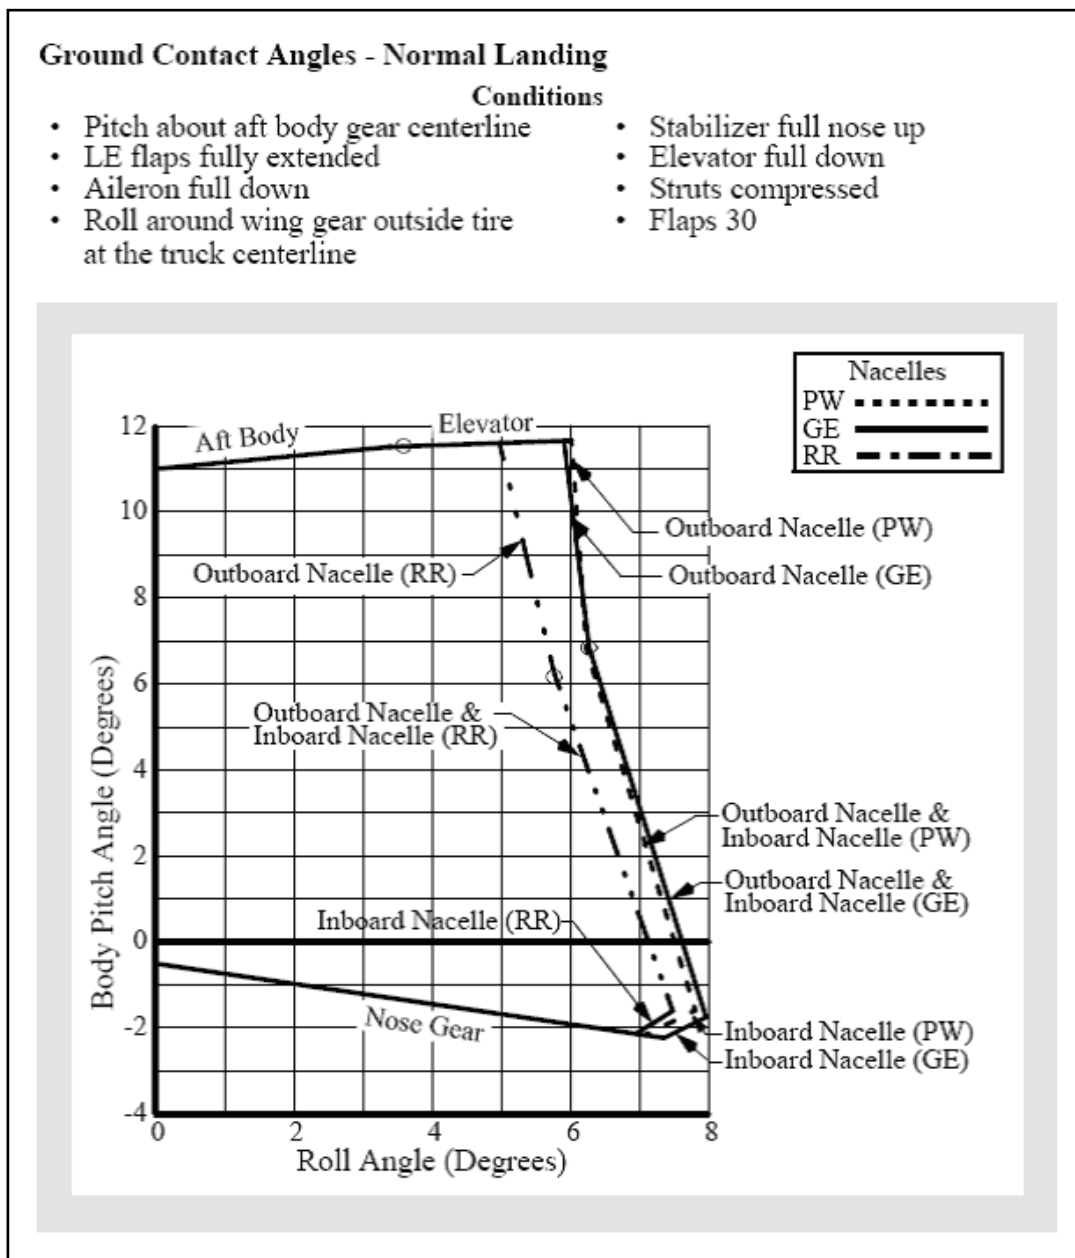
Figure 1

The aircraft attitude required for contact between the engine nacelles and the ground surface during a landing, as advised in the B747-400 FCTM, is shown in Figure 1. The diagram caters for the different makes of engine fitted to the aircraft type ie General Electric (GE), Pratt & Whitney (PW) and Rolls Royce (RR) and is based on a rigid wing, as opposed to one that flexes.

G-VLIP's pitch attitude at touchdown was lower than the 4° - 5° nose up attitude recommended in the B747-400 FCTM. However, information from the FCTM also indicated that the respective pitch and roll attitudes at landing (6.7° right bank and 1° nose down) had not exceeded the ground contact envelope of the nacelles. Instead, at a pitch attitude of 1° nose down,

the bank angle required to contact both the inboard and outboard nacelles was approximately 7.8°. The aircraft manufacturer advised that the FCTM ground contact envelope represented a rigid wing rotated about the wing gear outside tyre, with the landing gear struts compressed.

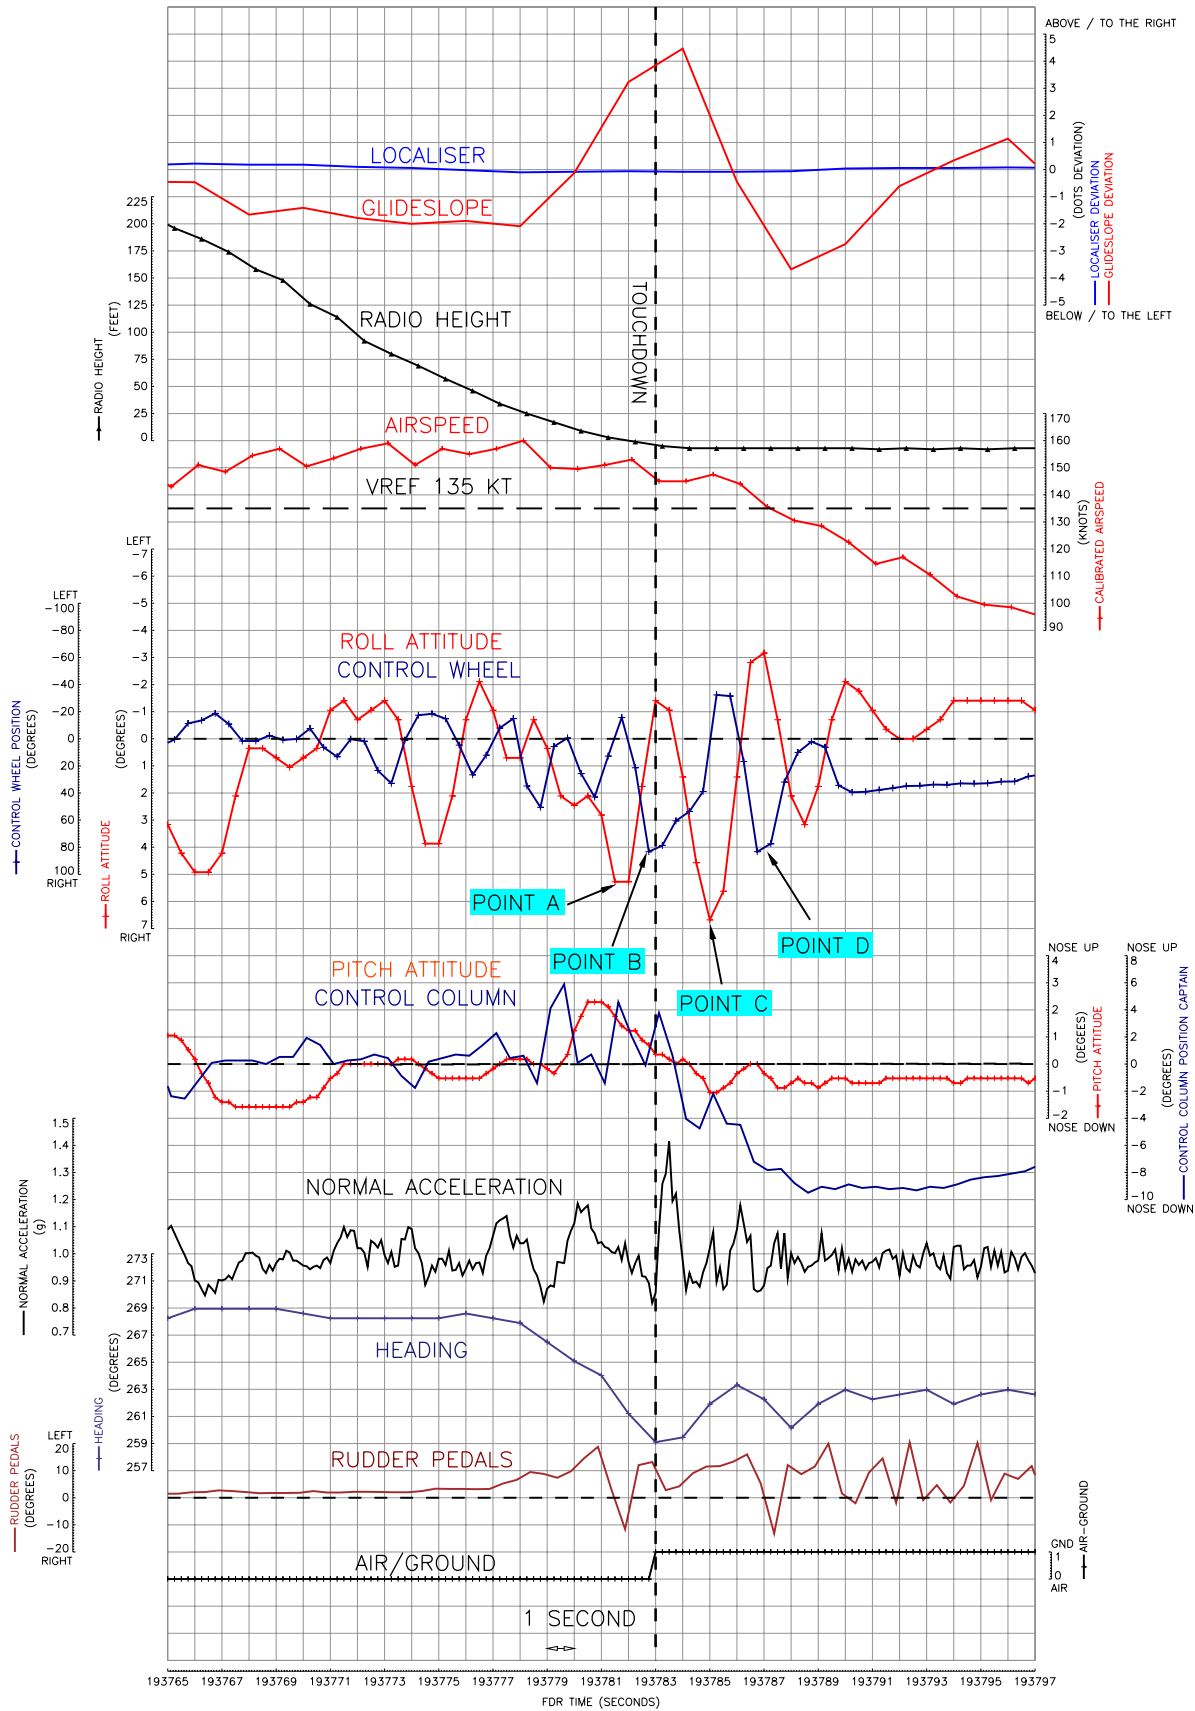
Figure 2  
Salient FDR Parameters

and pedals, pitch and roll attitude, wind speed and direction and landing gear. A plot of the FDR parameters during the landing is provided in Figure 2.

As the aircraft neared the ground, right rudder was quickly applied, from 25° left to 16° right in one second and the aircraft coincidentally rolled to 5° right wing down (see Figure 2, point A). Corrective left control wheel and left rudder inputs were made and the aircraft responded by rolling to the left. Countering the left roll, right control wheel was progressively introduced, reaching 83° just before the aircraft touched down (see Figure 2, point B). The control wheel has stops at +/- 90°.

The aircraft touched down with a small amount of left bank (1.5°) and at an almost nose level pitch attitude; airspeed was 145 KCAS and the normal acceleration at touchdown was at 1.43 g. The aircraft started to roll quickly to the right and about two seconds after touchdown the bank angle reached 6.7° right wing down (see Figure 2, point C). The pitch attitude was 1° nose down. A left roll was commanded and the aircraft rolled to the left quickly, before another almost full travel deflection of the control wheel to the right (see Figure 2, point D) was made. The aircraft continued in a rocking motion for a few more seconds before the roll attitude stabilised at about 2° left wing down, with right (into wind) control wheel applied.
